MARINE POLLUTION SURVEILLANCE REPORT

Analysis Provided by: The National Oceanic and
Atmospheric Administration/National Environmental
Satellite, Data and Information Service (NOAA/NESDIS)

REPORT DATE: AUGUST 26, 2012
REPORT TIME: 2315Z (1815 CDT)
ANALYST: RAMIREZ

DATA SOURCE: LANDSAT-7
MODE: MULTI-SPECTRAL
RESOLUTION: 30 METER
IMAGE DATE/TIME: 8/26/2012 1621Z (1121 CDT)

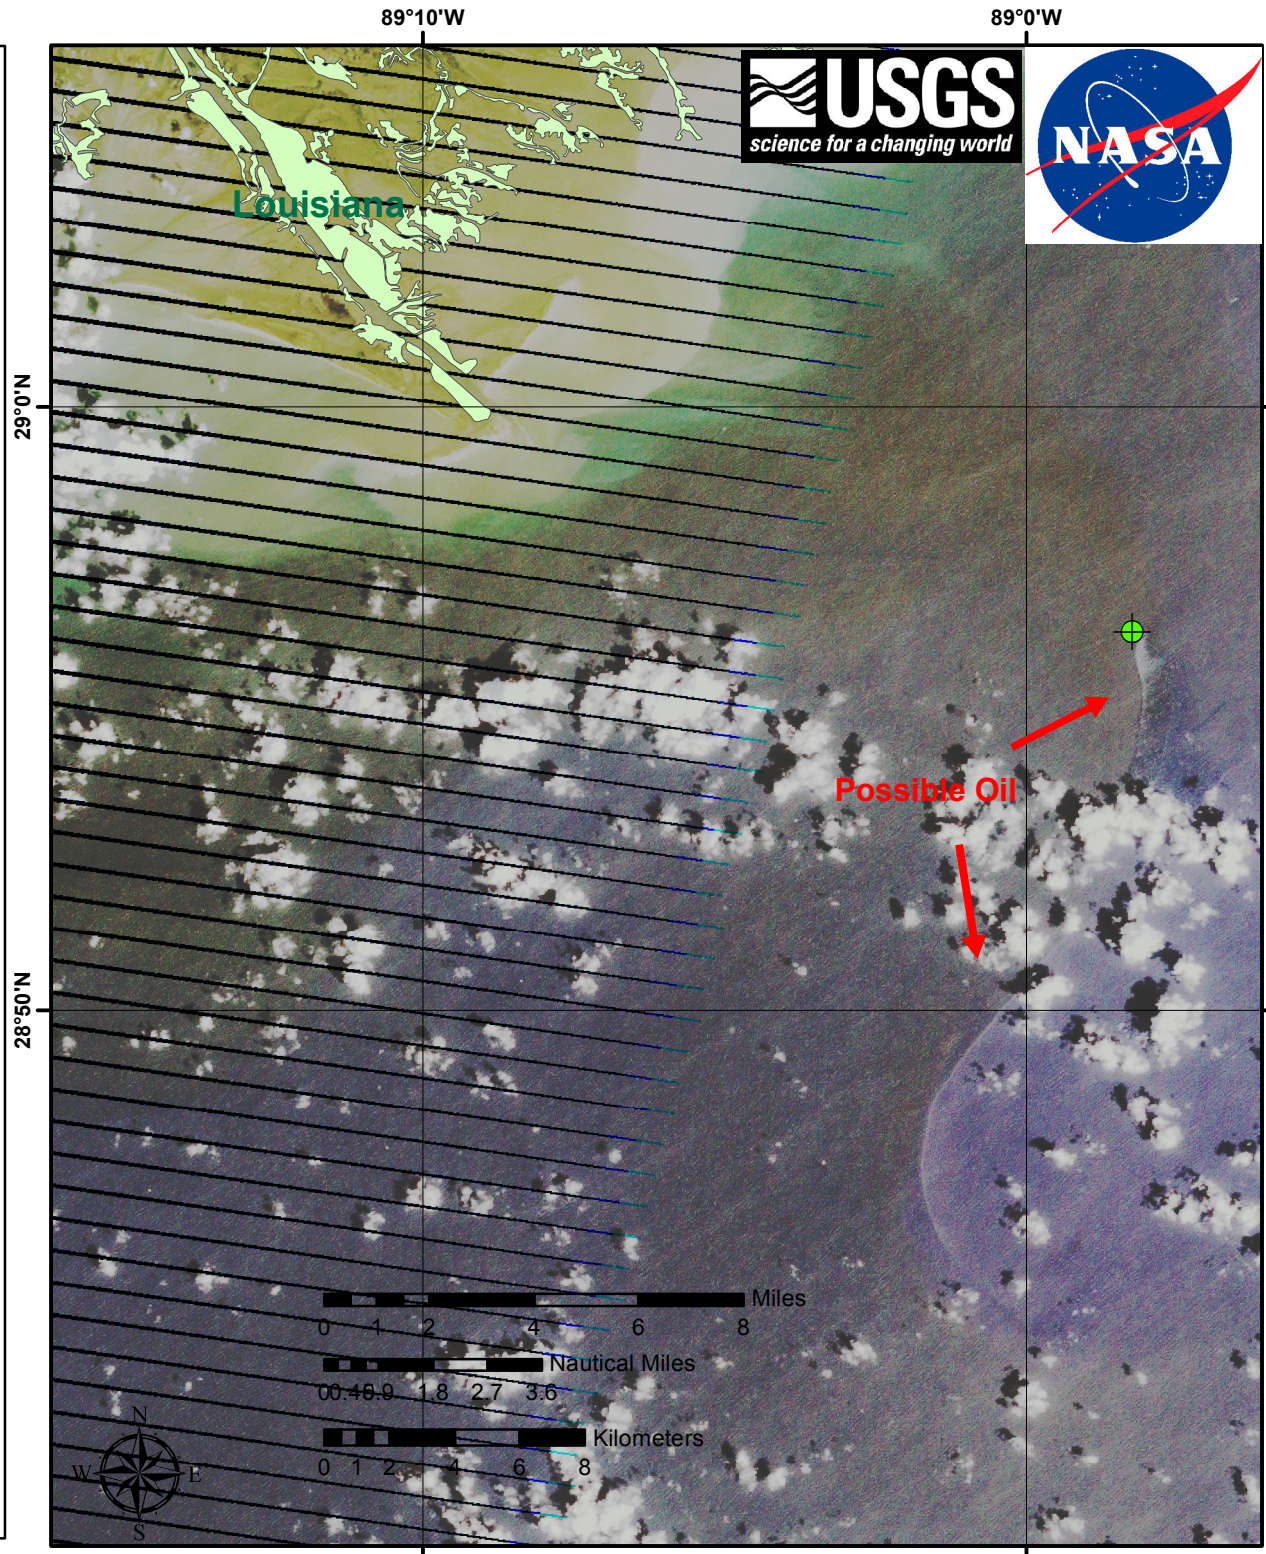
Destroyed Taylor Platform :
[28°56'9" N / 88°58'12" W]

A possible oil slick is seen extending SSW of the destroyed Taylor Platform for approximately 20km and is 1-2km in width. The widest part of the feature is located near the origin. The anomaly exhibits feathering, as the western edge of the slick is very sharp while the eastern edge of the slick tapers with distance. This is consistent with the OSCAT observation of winds from the east at 10kts.
