MARINE POLLUTION SURVEILLANCE REPORT

Analysis Provided by: The National Oceanic and
Atmospheric Administration/National Environmental
Satellite, Data and Information Service (NOAA/NESDIS)

REPORT DATE: JULY 1, 2012
REPORT TIME: 2330Z (1830 CDT)
ANALYST: MYRGA

DATA SOURCE: MODIS AQUA
MODE: MULTI-SPECTRAL
RESOLUTION: 250 METER
IMAGE DATE/TIME: 7/1/2012 1905Z (1405 CDT)

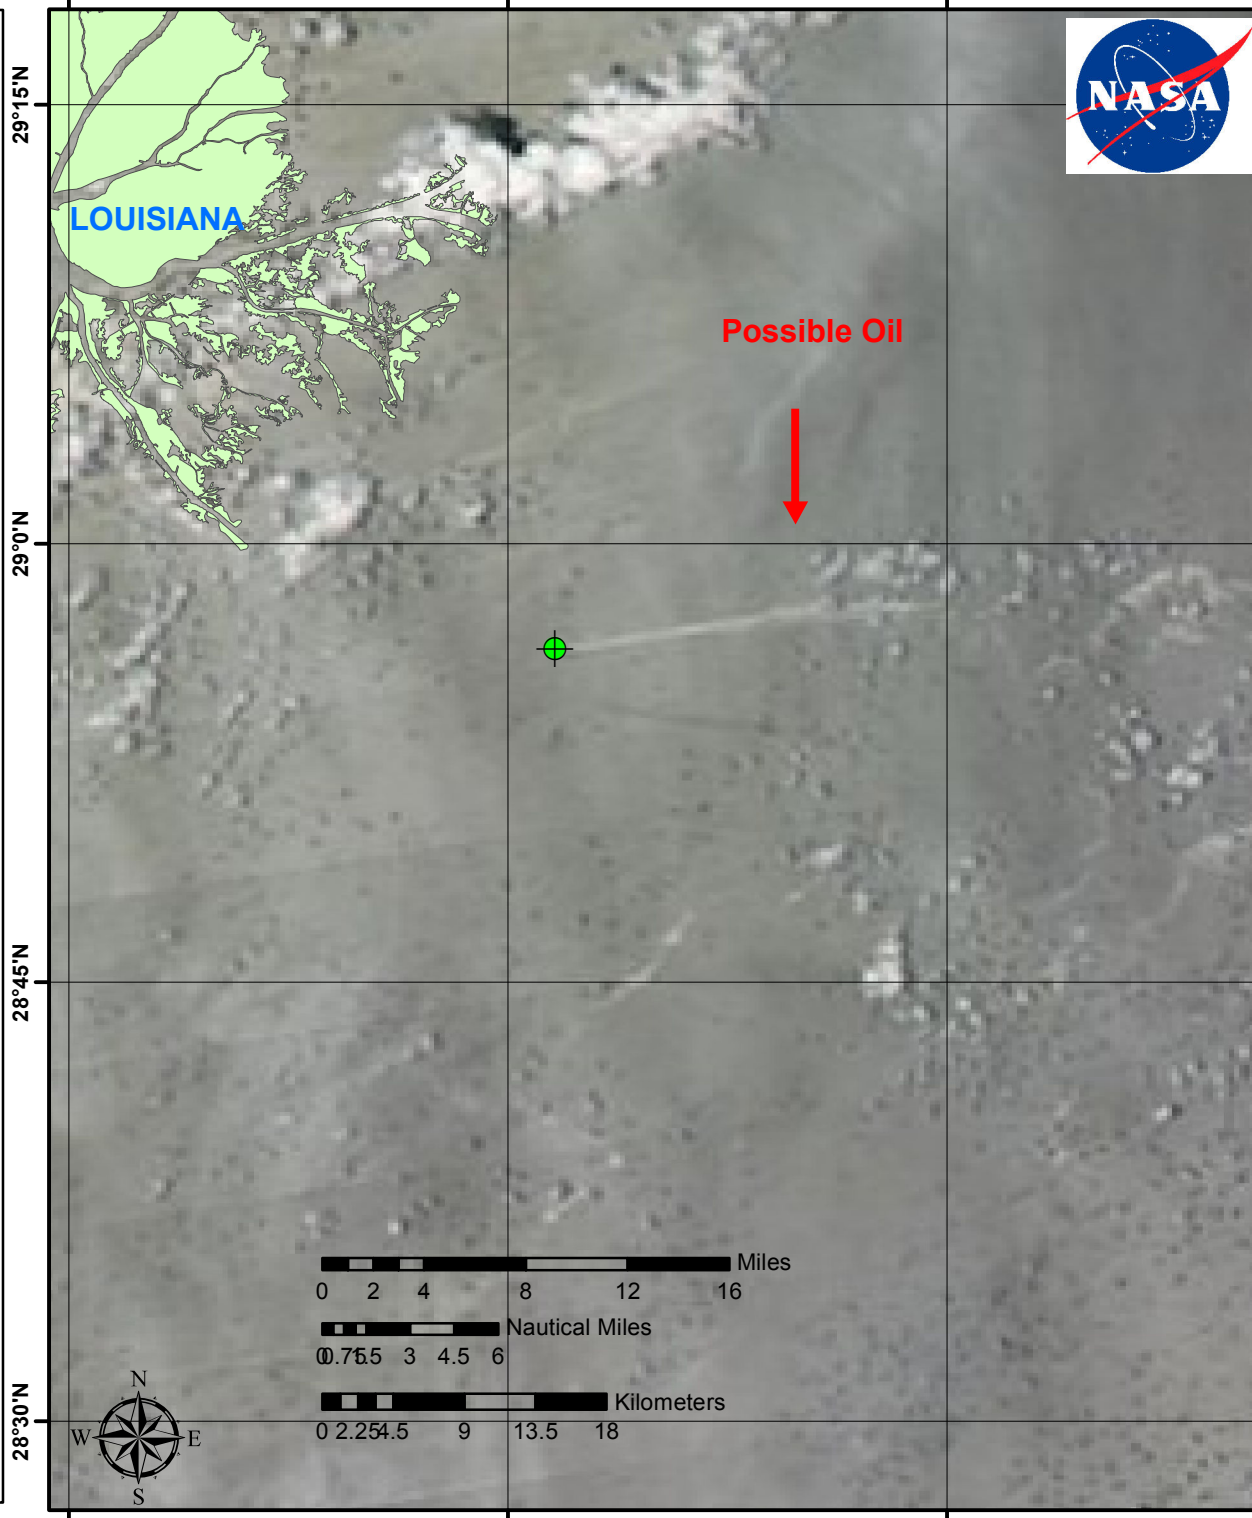
Destroyed Taylor Platform :
[28°56'9" N / 88°58'12" W]

A possible oil sheen extended approximately 13 miles
east of the destroyed Taylor platform. Winds were light
and from the west and sky conditions were mostly clear
at the time of the image - a few fair weather cumulus
clouds were present.
