# MARINE POLLUTION SURVEILLANCE REPORT

Analysis Provided by: The National Oceanic and  
Atmospheric Administration/National Environmental  
Satellite, Data and Information Service (NOAA/NESDIS)

REPORT DATE: AUGUST 04, 2013  
REPORT TIME: 1904Z (1404 CDT)  
ANALYST: JANKOT

DATA SOURCE: TERRA MODIS  
MODE: Multispectral  
RESOLUTION: 250 meter  
IMAGE DATE/TIME: 8/4/2013 1650Z (1150 CDT)

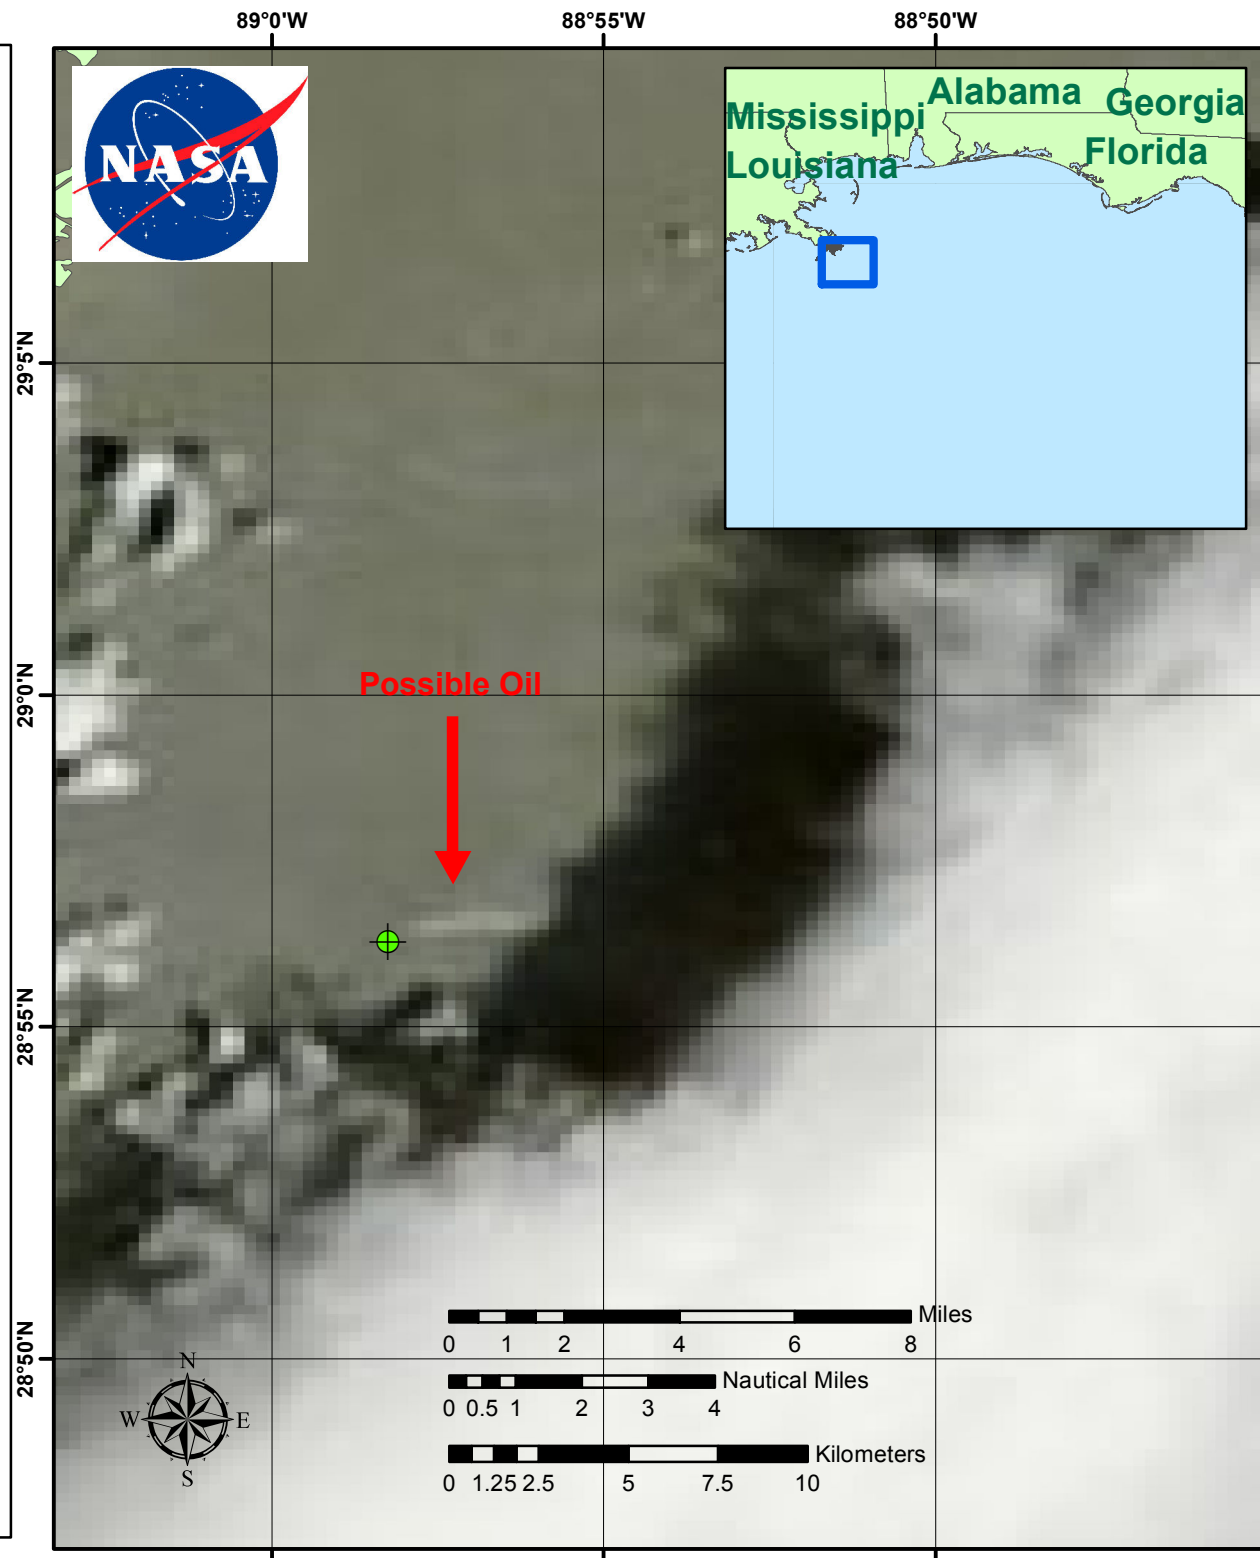
Destroyed Taylor Platform :  
[ 28°56'9" N / 88°58'12" W ]

1.95km<sup>2</sup> Area of Possible Oil

A narrow slick was seen extending east from the destroyed Taylor Platform for approximately 2 miles. Cloud cover prohibited detection on the east side portion of the anomaly suggesting the slick could extend beyond 2 miles. Ocean currents suggested a west to east flow, following pattern seen in the image. Surface winds were also weak from the northwest at 5-10 knots.
