MARINE POLLUTION SURVEILLANCE REPORT

Analysis Provided by: The National Oceanic and
Atmospheric Administration/National Environmental
Satellite, Data and Information Service (NOAA/NESDIS)

REPORT DATE: AUGUST 22, 2013
REPORT TIME: 0605Z (0105 CDT)
ANALYST: WARREN

DATA SOURCE: LANDSAT-8 OLI
MODE: Multispectral
RESOLUTION: 30 meter
IMAGE DATE/TIME: 8/21/2013 1628Z (1128 CDT)

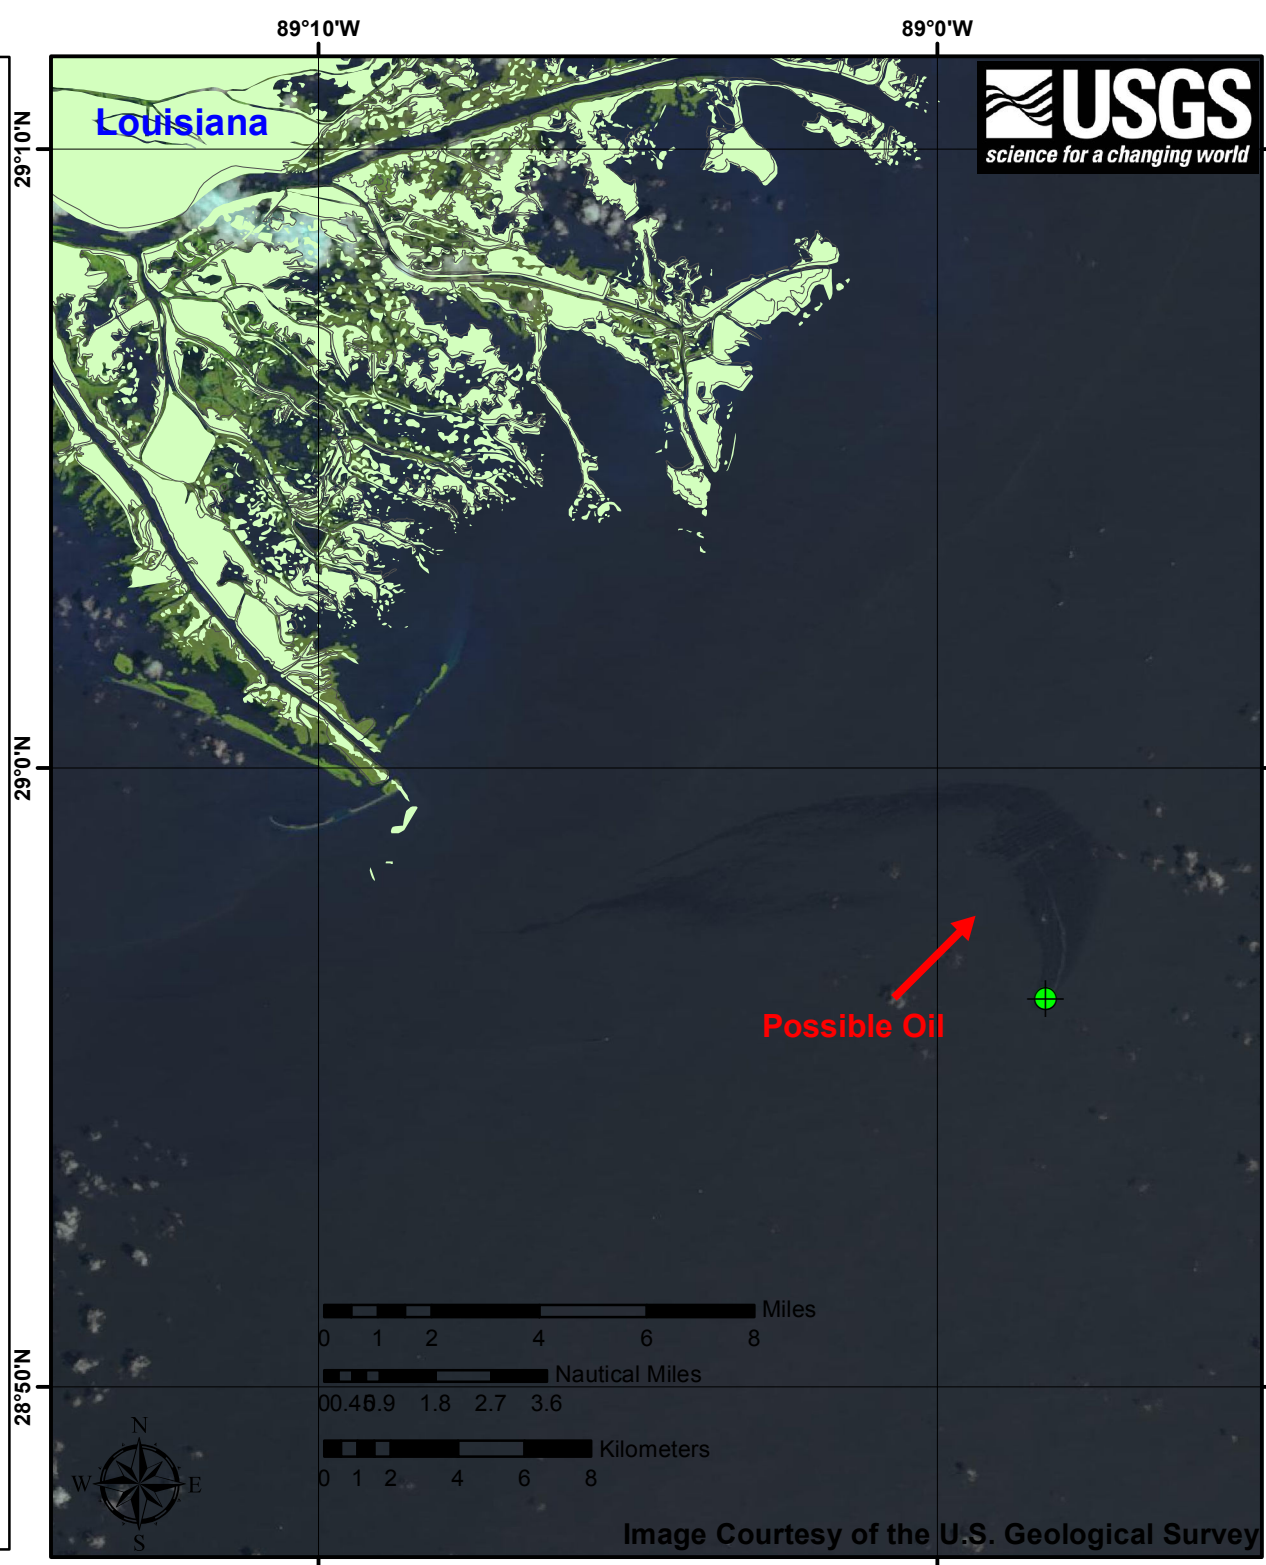
Destroyed Taylor Platform :
[28°56'9" N / 88°58'12" W]

27.2 km² Area of Possible Oil

Suspected oil sheen originated from destroyed Taylor site is seen located north and wrapping west. This signature pattern matches well with southeasterly winds near the time of the image. Sheen is estimated from satellite to be 13.6 miles long and 1.5 miles at its widest. Sheen has good dark contrast with its surroundings even without sunglint present.
