MARINE POLLUTION SURVEILLANCE REPORT

Analysis Provided by: The National Oceanic and
Atmospheric Administration/National Environmental
Satellite, Data and Information Service (NOAA/NESDIS)

REPORT DATE: AUGUST 30, 2013
REPORT TIME: 2335Z (1835 CDT)
ANALYST: VOGT

DATA SOURCE: AQUA MODIS
MODE: Multispectral
RESOLUTION: 250 meter
IMAGE DATE/TIME: 8/30/2013 1900Z (1400 CDT)

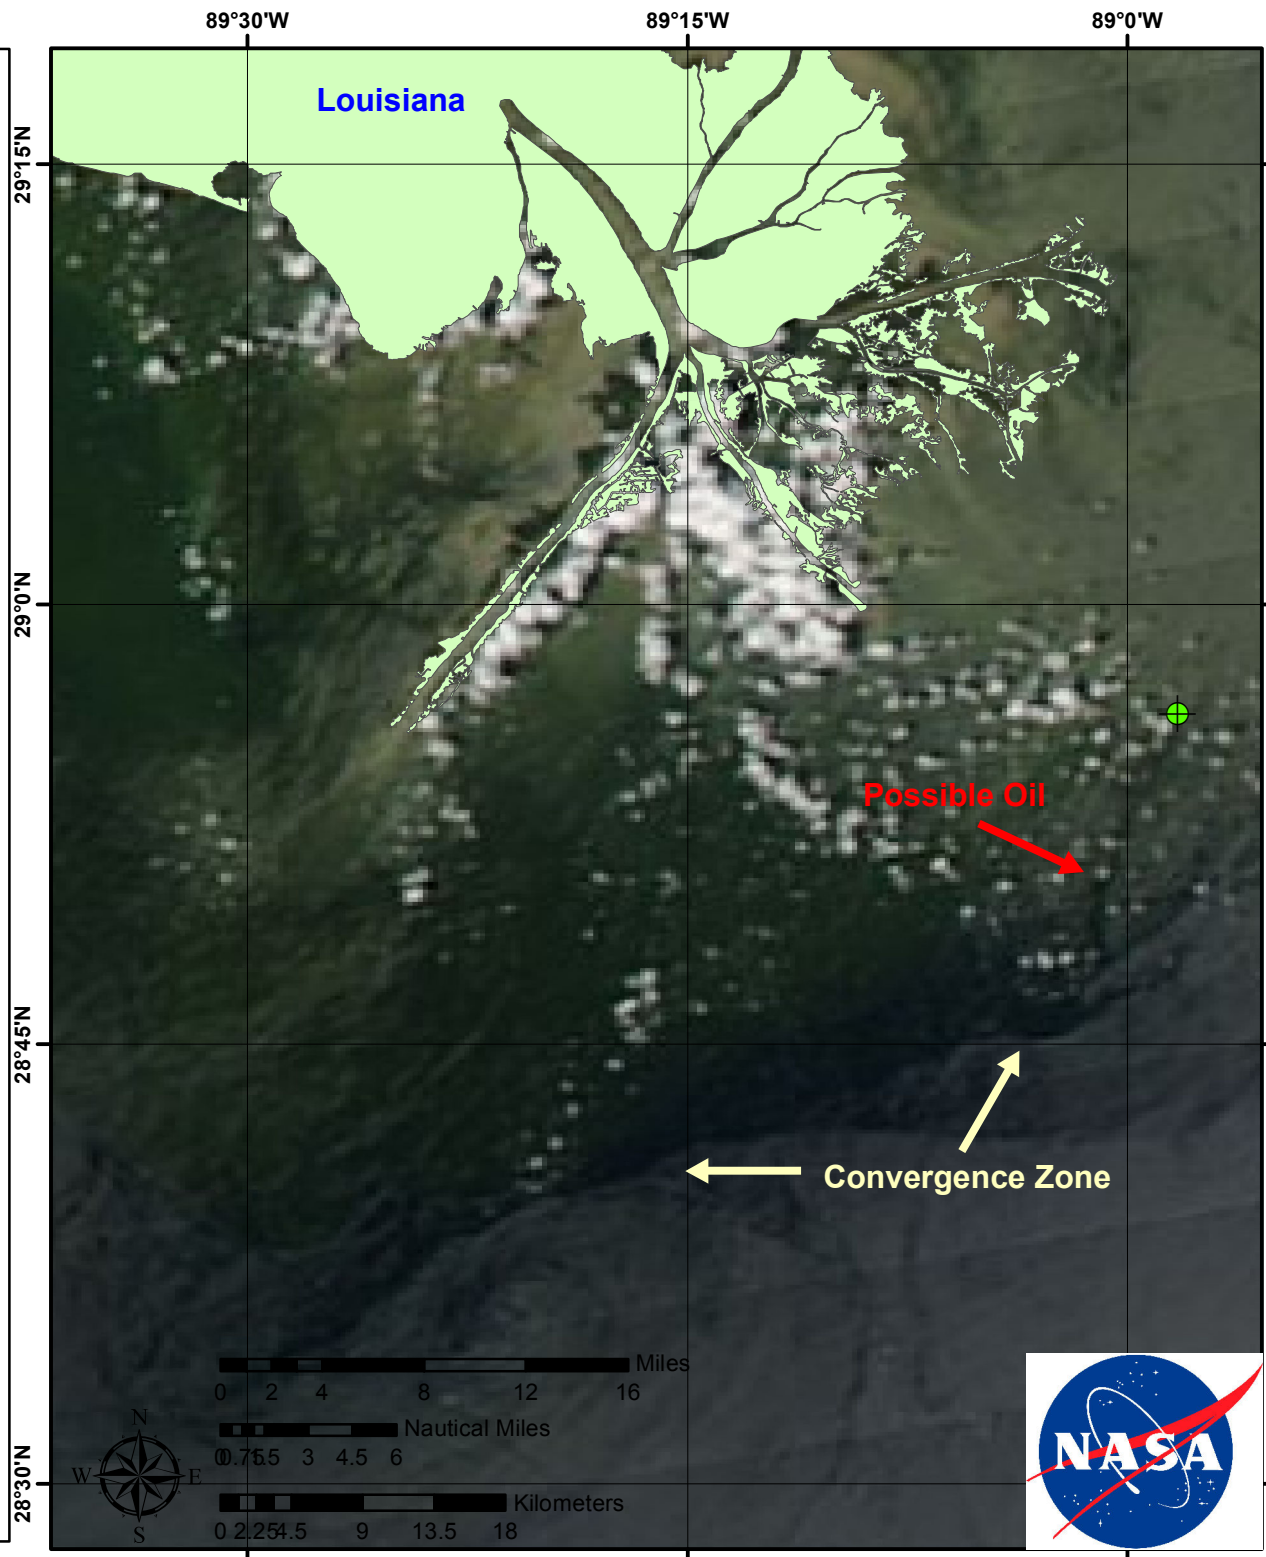
Destroyed Taylor Platform :
[28°56'9" N / 88°58'12" W]
-

14.6 km² Area of Possible Oil

An area of possible oil is seen originating from the Destroyed Taylor Platform. The slick is approximately 10 miles in length and extends to the southwest, consistent with northeasterly surface winds and ocean currents. At its widest, the slick is about 0.75 miles wide. Given the large extent of oil that was detected yesterday and the fact that there are fairly calm winds in the region, it is possible that additional oil has gotten caught up within the convergence zone and spread southwestward along the convergence boundary. But given the lower resolution of the image, confidence is not high enough to analyze any additional areas as oil.
