MARINE POLLUTION SURVEILLANCE REPORT

Analysis Provided by: The National Oceanic and
Atmospheric Administration/National Environmental
Satellite, Data and Information Service (NOAA/NESDIS)

REPORT DATE: DECEMBER 03, 2013
REPORT TIME: 2200Z (1600 CST)
ANALYST: VOGT

Destroyed Taylor Platform :
[28°56'9" N / 88°58'12" W]

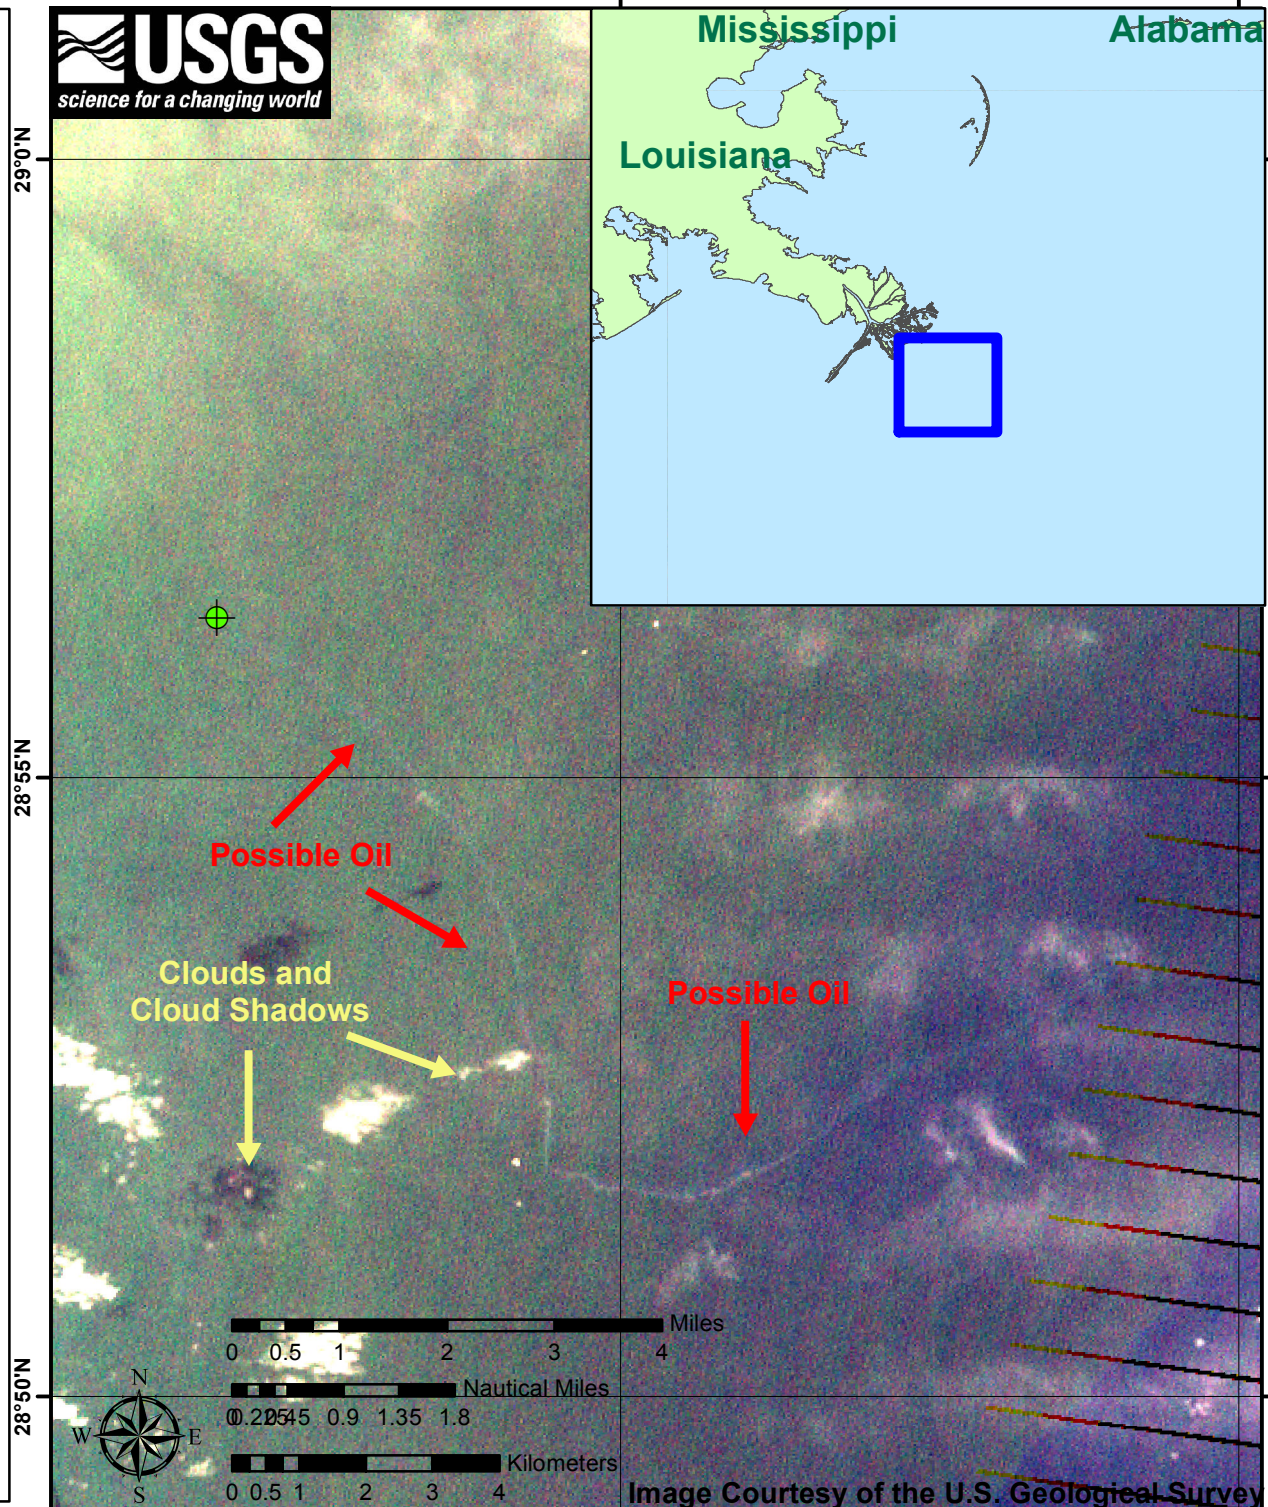
3.09 km² Area of Possible Oil

An area of suspected oil was detected originating from the Taylor Platform, extending southeast. The slick has some silver appearance to it with a moderate contrast to its surroundings. From the platform, the slick extends southward for 9.6 kilometers (km) then sharply turns eastward for an additional 7 km. The orientation of the slick is consistent with northerly surface winds as well as ocean currents at the time of the image. The slick's eastern-most extent is somewhat uncertain as clouds inhibited further detection.
