MARINE POLLUTION SURVEILLANCE REPORT

Analysis Provided by: The National Oceanic and
Atmospheric Administration/National Environmental
Satellite, Data and Information Service (NOAA/NESDIS)

REPORT DATE: JULY 04, 2013
REPORT TIME: 2305Z (1805 CDT)
ANALYST: TURK

DATA SOURCE: LANDSAT-8 OLI
MODE: Multispectral
RESOLUTION: 30 meter
IMAGE DATE/TIME: 7/4/2013 1628Z (1128 CDT)

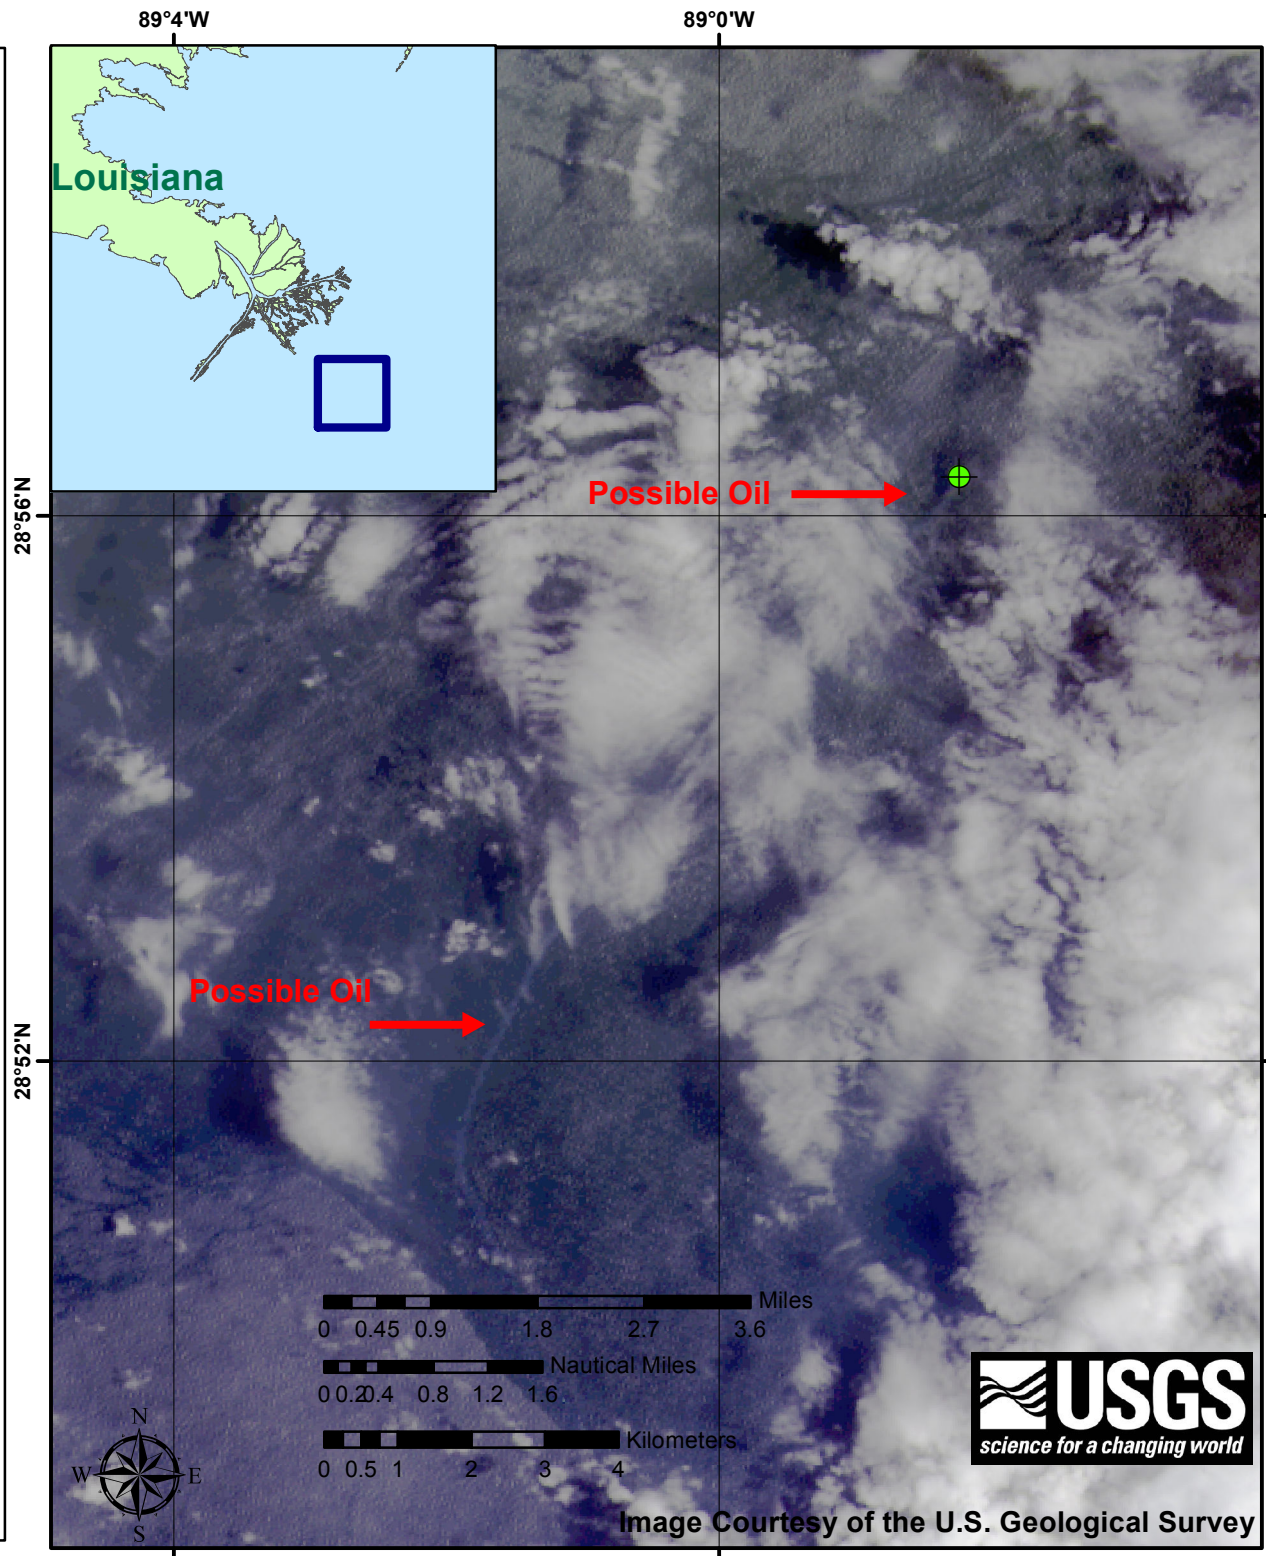
Destroyed Taylor Platform :
[28°56'9" N / 88°58'12" W]

1.16 km² Area of Possible Oil

A narrow slick was seen extending southwest from the destroyed Taylor platform. Cloud cover prohibited detection of a portion of the slick.

Sky conditions were partly clear and winds were from the east-northeast at 5 to 10 knots at the time of the image.
