MARINE POLLUTION SURVEILLANCE REPORT

Analysis Provided by: The National Oceanic and
Atmospheric Administration/National Environmental
Satellite, Data and Information Service (NOAA/NESDIS)

REPORT DATE: JUNE 18, 2013
REPORT TIME: 2140Z (1640 CDT)
ANALYST: TURK

DATA SOURCE: AQUA MODIS
MODE: Multispectral
RESOLUTION: 250 meter
IMAGE DATE/TIME: 6/18/2013 1905Z (1405 CDT)

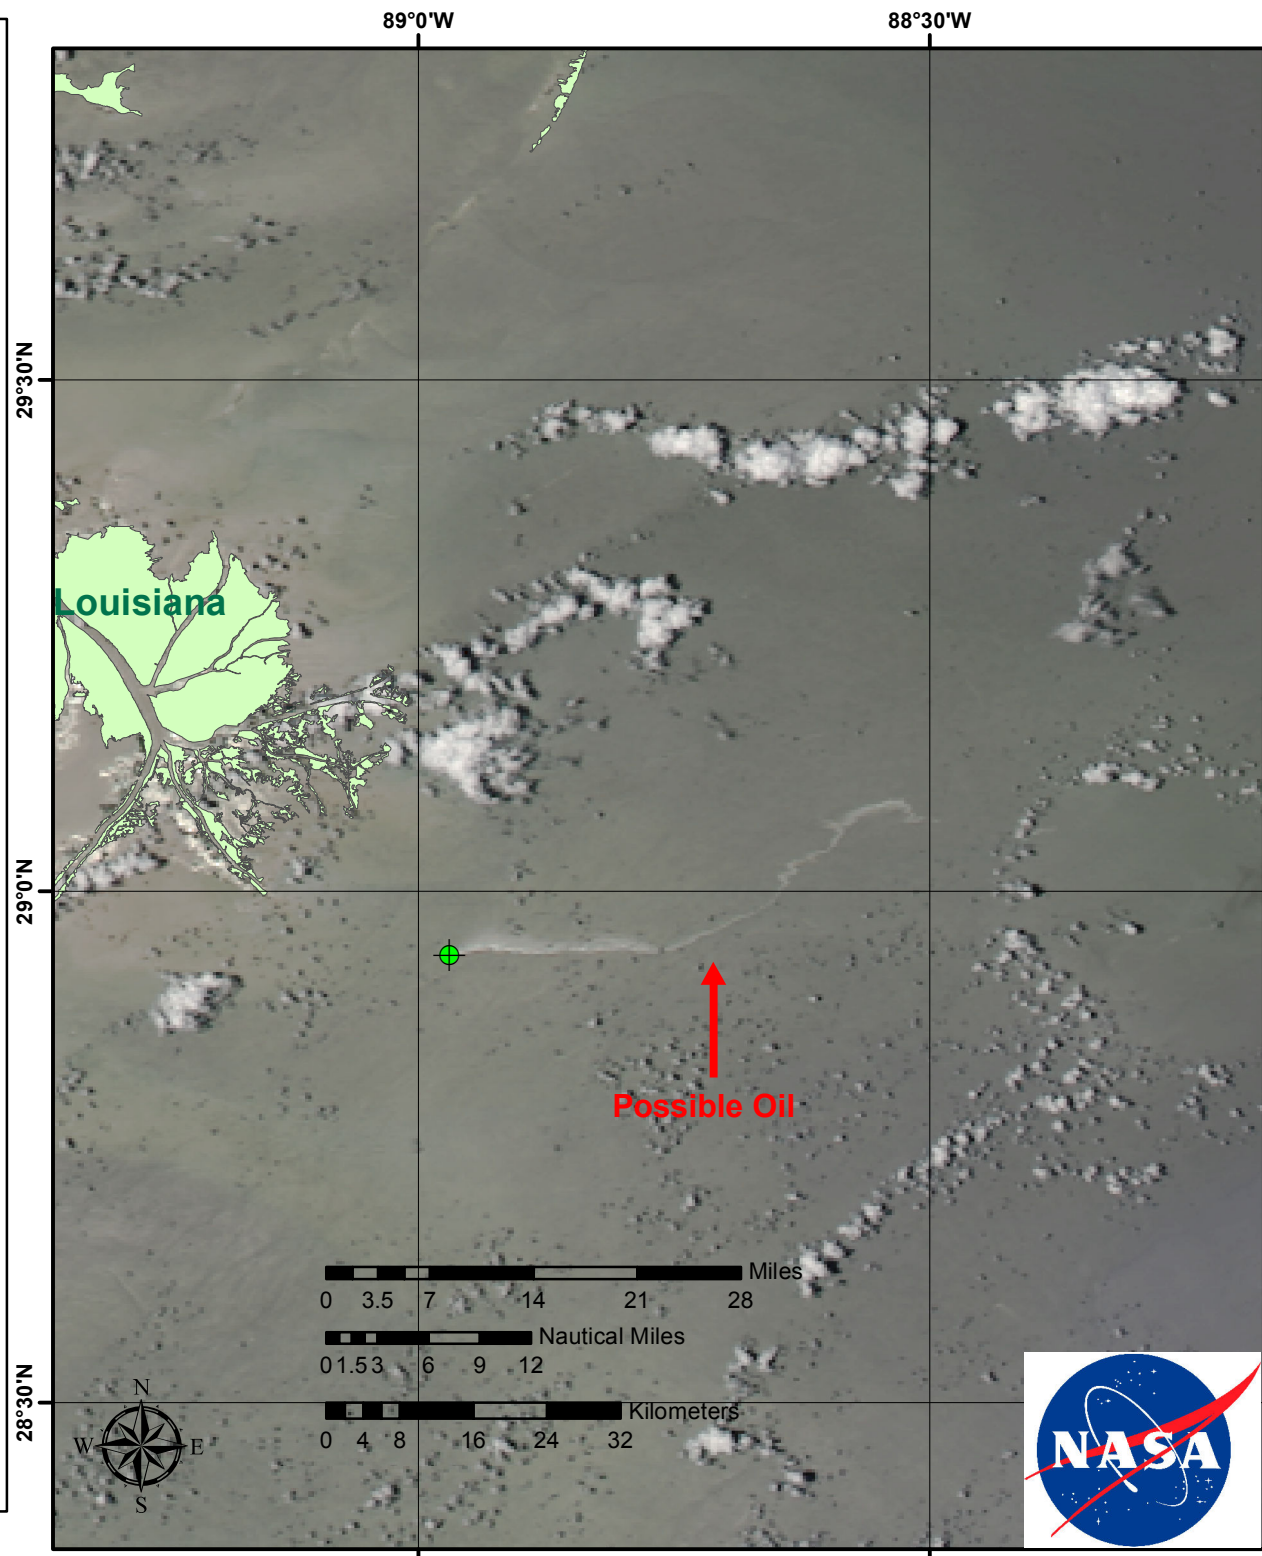
Destroyed Taylor Platform :
[28°56'9" N / 88°58'12" W]

109 km² Area of Possible Oil

An oil slick extended 49 km to the east-northeast of the
destroyed Taylor platform. The slick was up to 3.5 km
wide.

Sky conditions were mostly clear and the winds were
from the west-southwest at 10 knots at the time of the
image.
