MARINE POLLUTION SURVEILLANCE REPORT

Analysis Provided by: The National Oceanic and
Atmospheric Administration/National Environmental
Satellite, Data and Information Service (NOAA/NESDIS)

REPORT DATE: JUNE 18, 2013
REPORT TIME: 2315Z (1815 CDT)
ANALYST: TURK

DATA SOURCE: LANDSAT-8 OLI
MODE: Multispectral
RESOLUTION: 30 meter (multispectral)
IMAGE DATE/TIME: 6/18/2013 1628Z (1128 CDT)

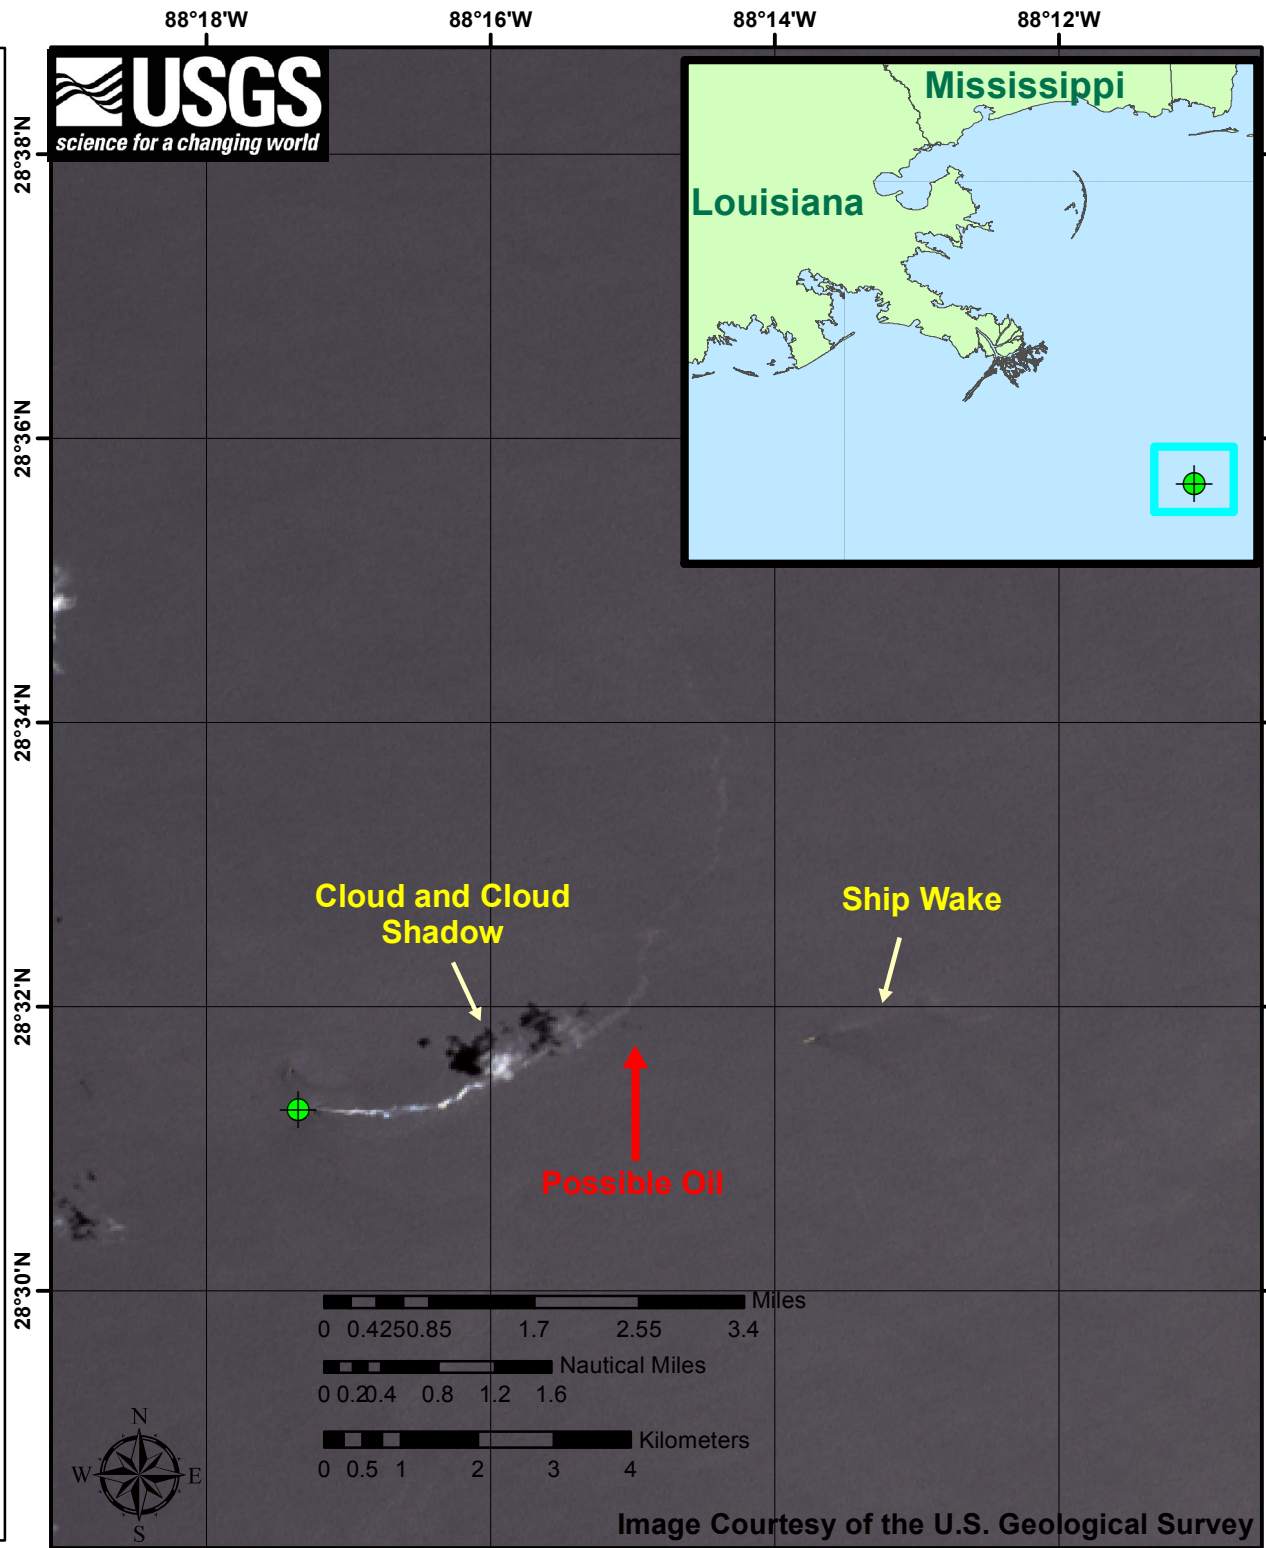
Suspected Point Source:
[28°31'16" N / 88°17'20" W]

2 km² Area of Possible Oil

A possible oil slick extended 8 km from a suspected point source and was up to 0.4 km wide.

Sky conditions were mostly clear and winds were from the west-southwest at 10 knots at the time of the image.
