MARINE POLLUTION SURVEILLANCE REPORT

Analysis Provided by: The National Oceanic and
Atmospheric Administration/National Environmental
Satellite, Data and Information Service (NOAA/NESDIS)

REPORT DATE: JUNE 20, 2013
REPORT TIME: 2230Z (1730 CDT)
ANALYST: SHEFFLER

DATA SOURCE: AQUA MODIS
MODE: Multispectral
RESOLUTION: 250 meter
IMAGE DATE/TIME: 6/20/2013 1850Z (1350 CDT)

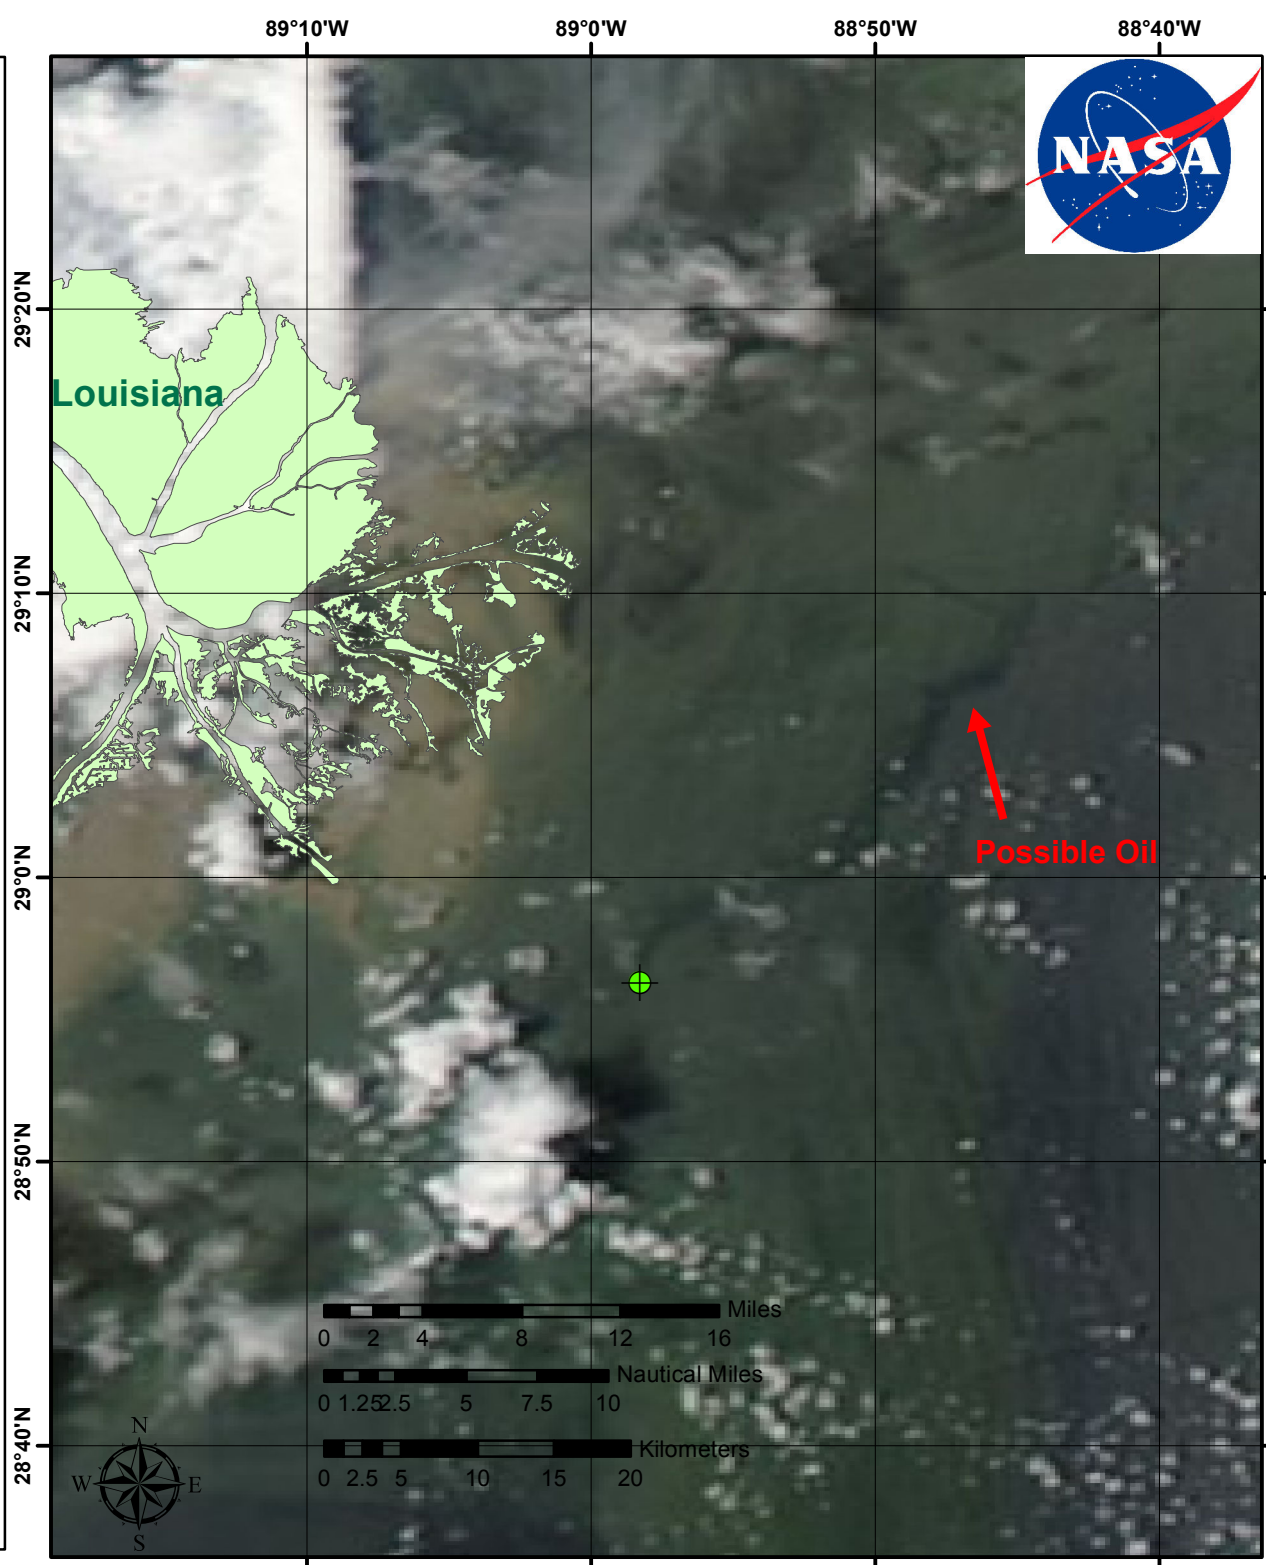
Destroyed Taylor Platform :
[28°56'9" N / 88°58'12" W]

64.8 km²

Area of Possible Oil

A slick could be seen in this MODIS image extending approximately 40 km northeastward from the destroyed Taylor platform. This slick was about 2.5 km wide at the widest point. Sky conditions were partly cloudy over the site though few clouds were actually obscuring the slick. Winds were generally weak/variable at the time of the image with ocean currents from the southeast.
