MARINE POLLUTION SURVEILLANCE REPORT

Analysis Provided by: The National Oceanic and
Atmospheric Administration/National Environmental
Satellite, Data and Information Service (NOAA/NESDIS)

REPORT DATE: MAY 09, 2013
REPORT TIME: 2304Z (1804 CDT)
ANALYST: RAMIREZ

Destroyed Taylor Platform :
[28°56'9" N / 88°58'12" W]

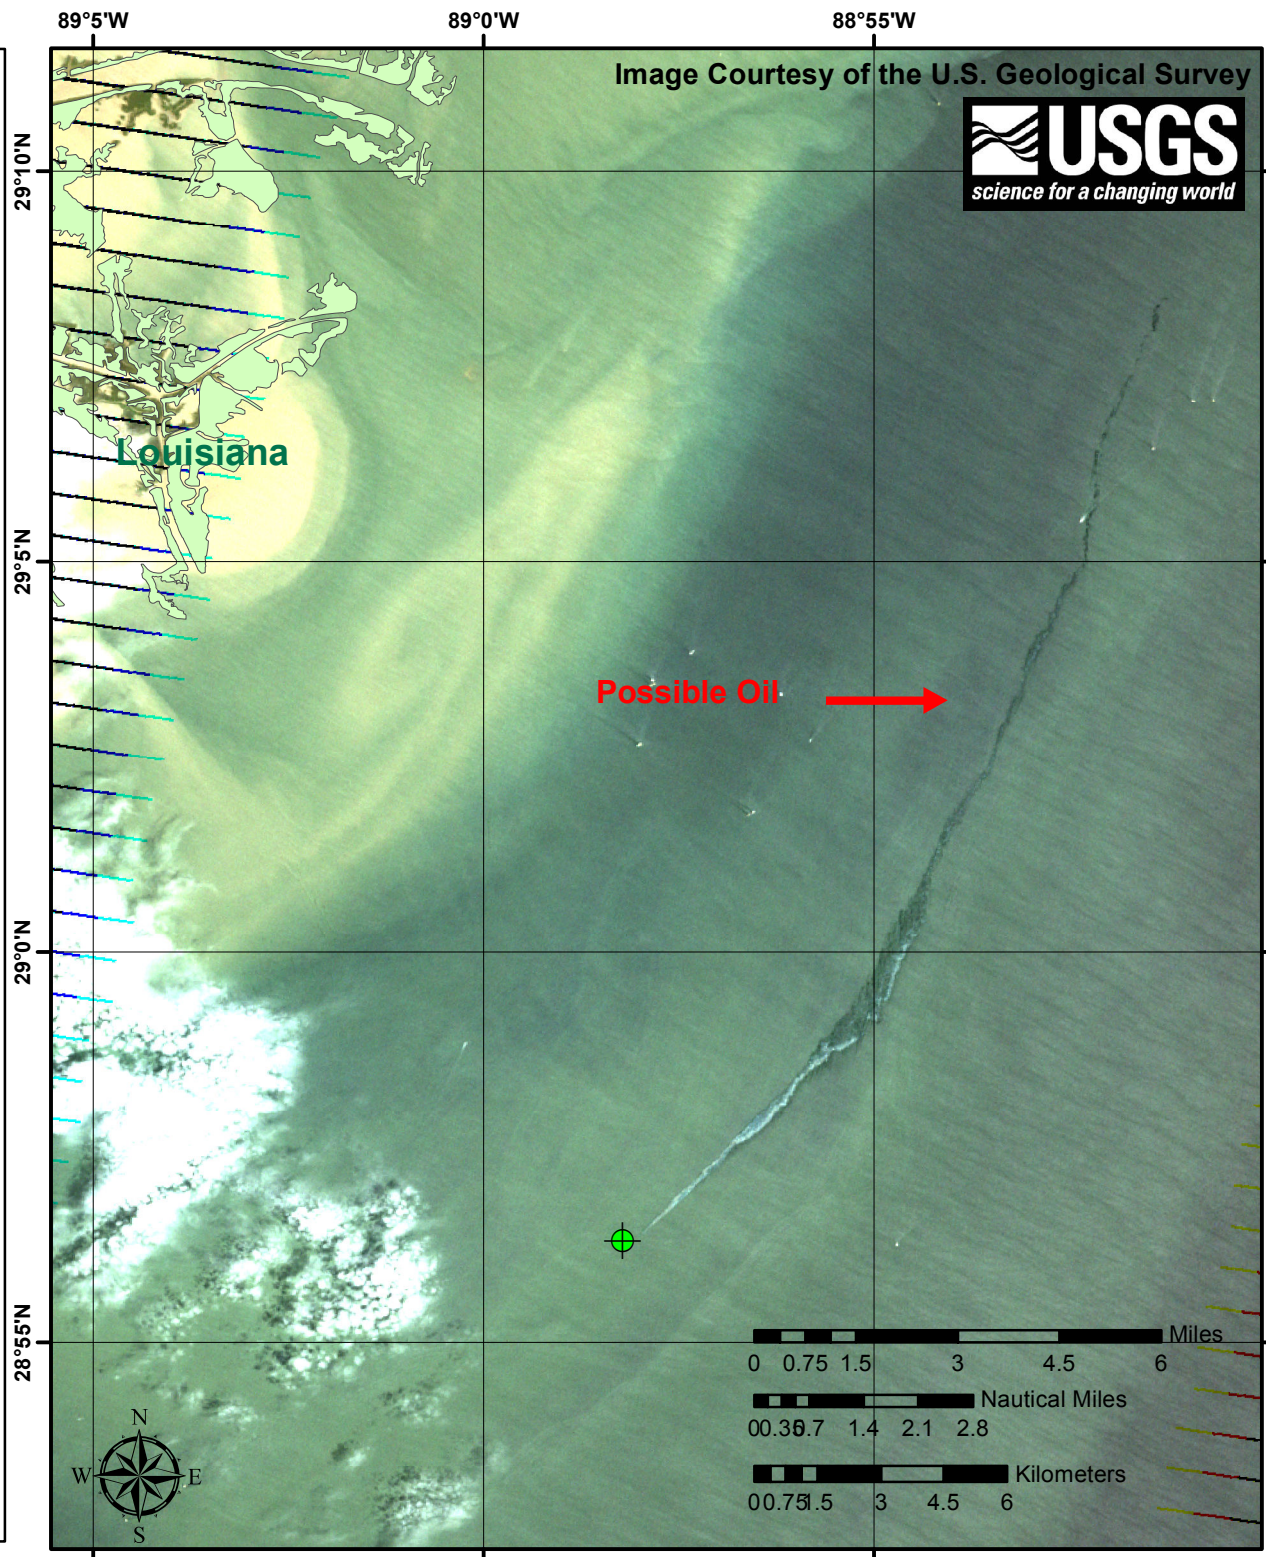
10 km² Area of Possible Oil

Suspected oil is emanating from the destroyed Taylor Energy platform in the northeast direction for 25 km. The width of the slick is approximately 0.2 km except for between the length of 5 and 9 km where the slick reaches 0.6 km in width. Surface winds are southeasterly at 10-15 kts. There are no uncertainties. Confidence is high.
