MARINE POLLUTION SURVEILLANCE REPORT

REPORT DATE: MAY 24, 2013
REPORT TIME: 2300Z (1800 CDT)
ANALYST: VOGT

DATA SOURCE: AQUA MODIS
MODE: Multispectral
RESOLUTION: 250 meter
IMAGE DATE/TIME: 5/24/2013 1735Z (1235 CDT)

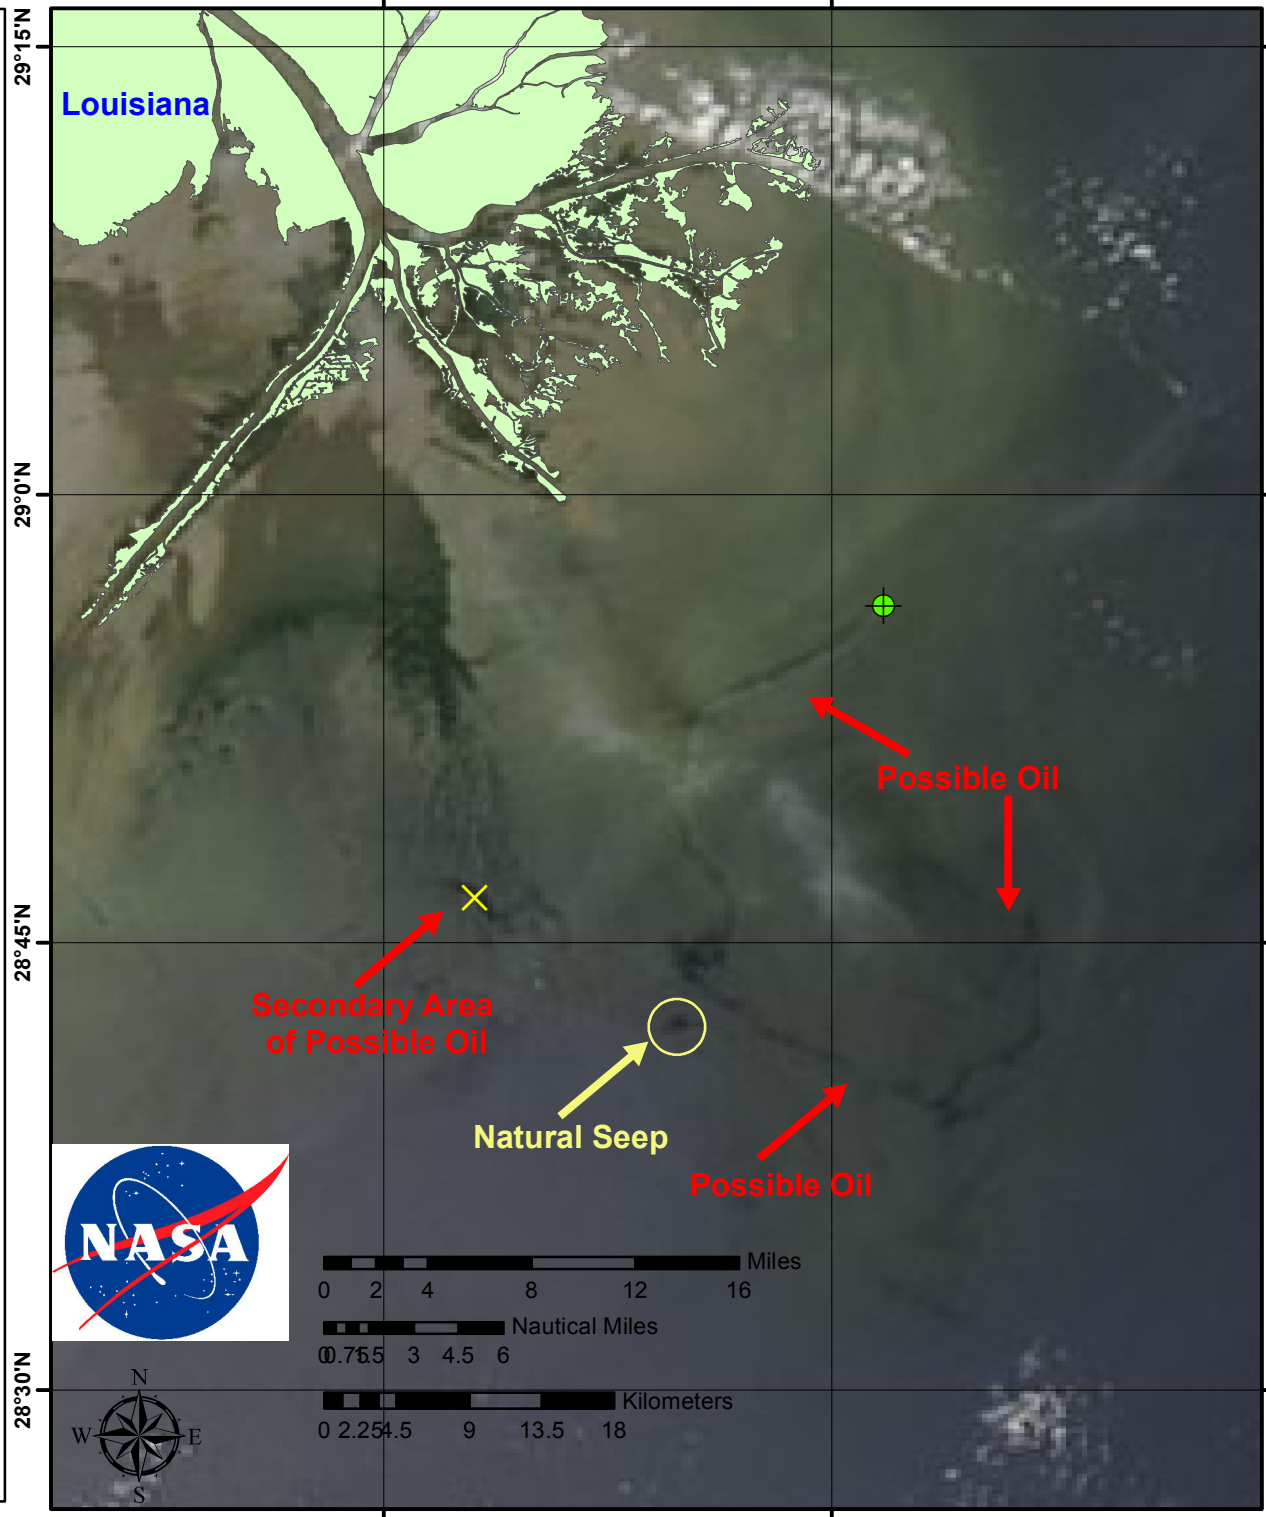
69.8 km² Area of Possible Oil

REMARKS: A large area of suspected oil can be seen originating from the Destroyed Taylor Platform. This suspected slick extends in a counter-clockwise fashion with an areal extent of almost 70 square kilometers. The portion of the slick closest to the platform exhibits a shimmery appearance as it is located on the eastern edge of the sun glint. The surface winds and ocean currents are consistent with the southwestern direction of the slick extending from the platform. This area of oil has a high confidence.

There is another small area of possible oil, annotated by the yellow x on the map. This area could be part of the slick from Taylor that has broken off from the main slick but was not analyzed due to its distance from the platform. Also, there were a few other platforms relatively close in proximity but none were directly connected to the slick itself.
