MARINE POLLUTION SURVEILLANCE REPORT

Analysis Provided by: The National Oceanic and
Atmospheric Administration/National Environmental
Satellite, Data and Information Service (NOAA/NESDIS)

REPORT DATE: MAY 25, 2013
REPORT TIME: 1954Z (1454 CDT)
ANALYST: TURK

DATA SOURCE: LANDSAT-7
MODE: Multispectral
RESOLUTION: 30 meter
IMAGE DATE/TIME: 5/25/2013 1622Z (1122 CDT)

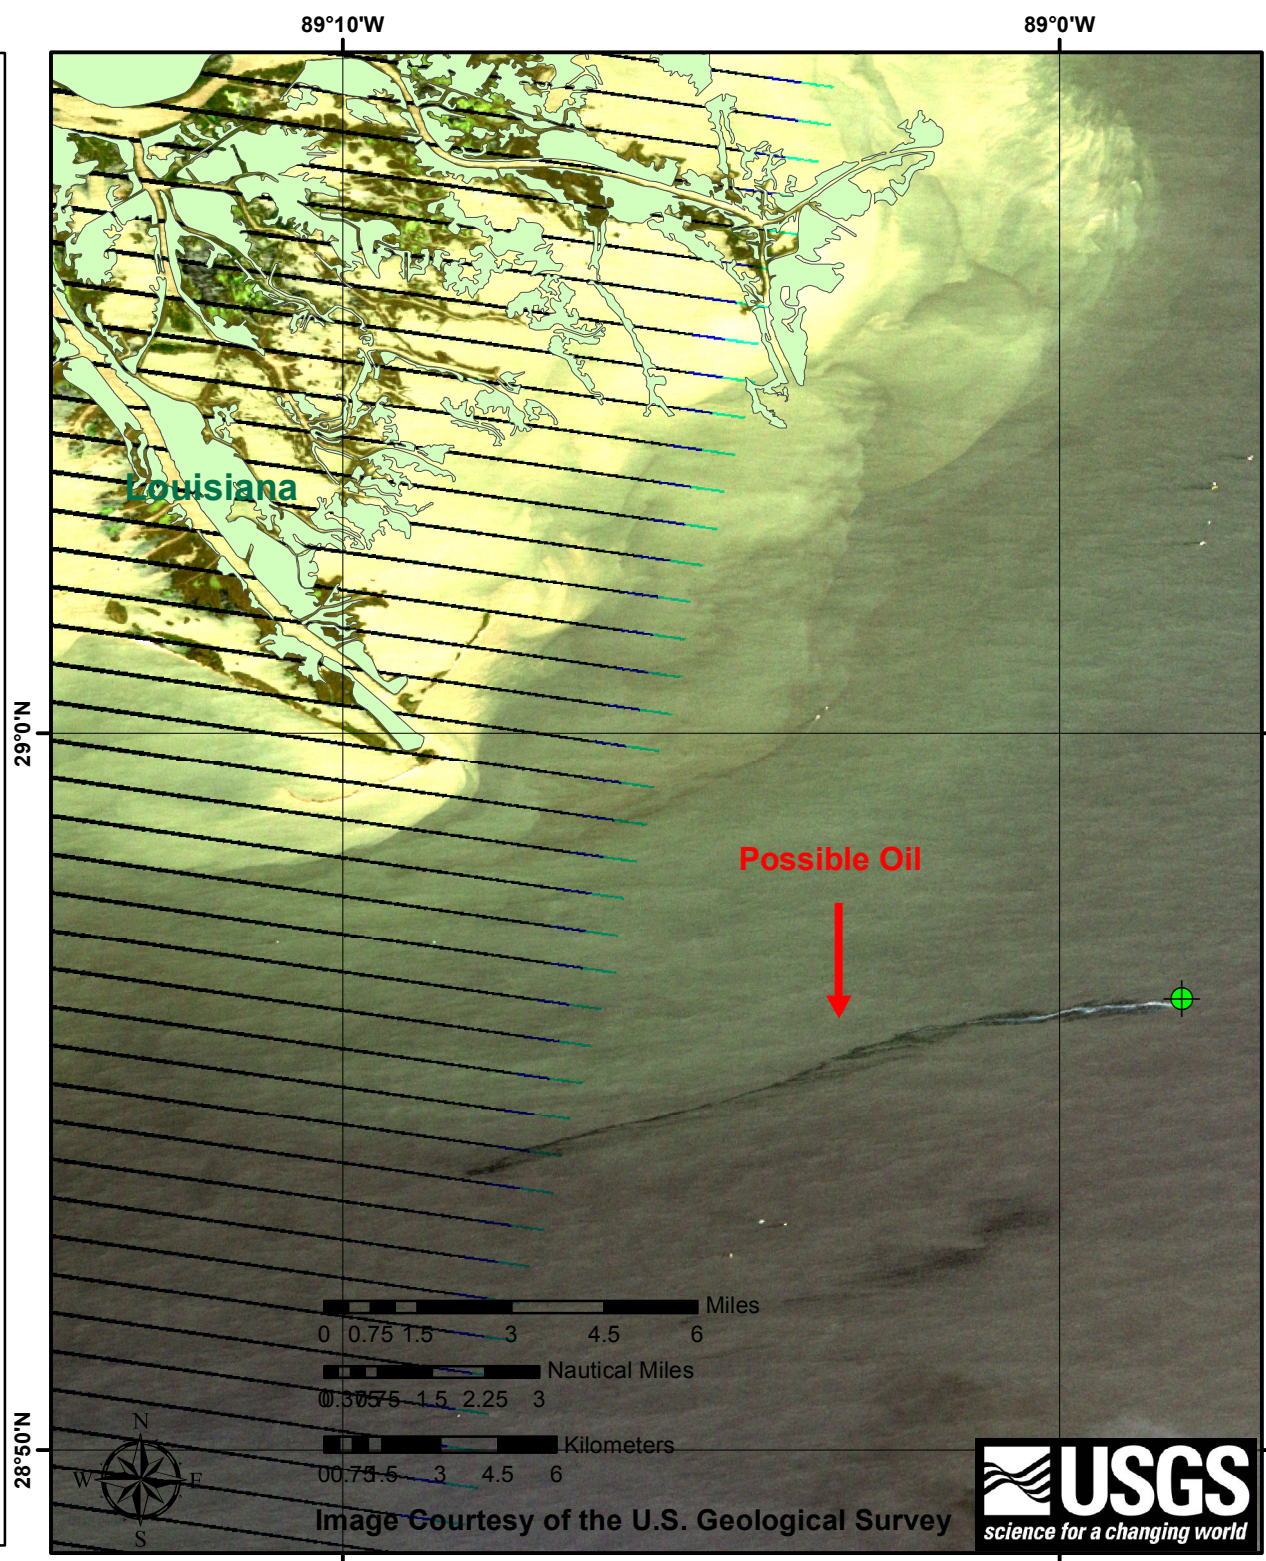
Destroyed Taylor Platform :
[28°56'9" N / 88°58'12" W]

8.9 km² Area of Possible Oil

An oil slick extended 17 km to the west of the destroyed Taylor platform and was up to 0.75 km wide. Skies were clear at the time of the image and winds were 15 knots from the east. The orientation of the slick was consistent with the surface winds and the model forecast ocean currents.
