MARINE POLLUTION SURVEILLANCE REPORT

Analysis Provided by: The National Oceanic and
Atmospheric Administration/National Environmental
Satellite, Data and Information Service (NOAA/NESDIS)

REPORT DATE: NOVEMBER 09, 2013
REPORT TIME: 2300Z (1700 CST)
ANALYST: TURK

DATA SOURCE: LANDSAT-8 OLI
MODE: Multispectral
RESOLUTION: 30 meter
IMAGE DATE/TIME: 11/9/2013 1628Z (1028 CST)

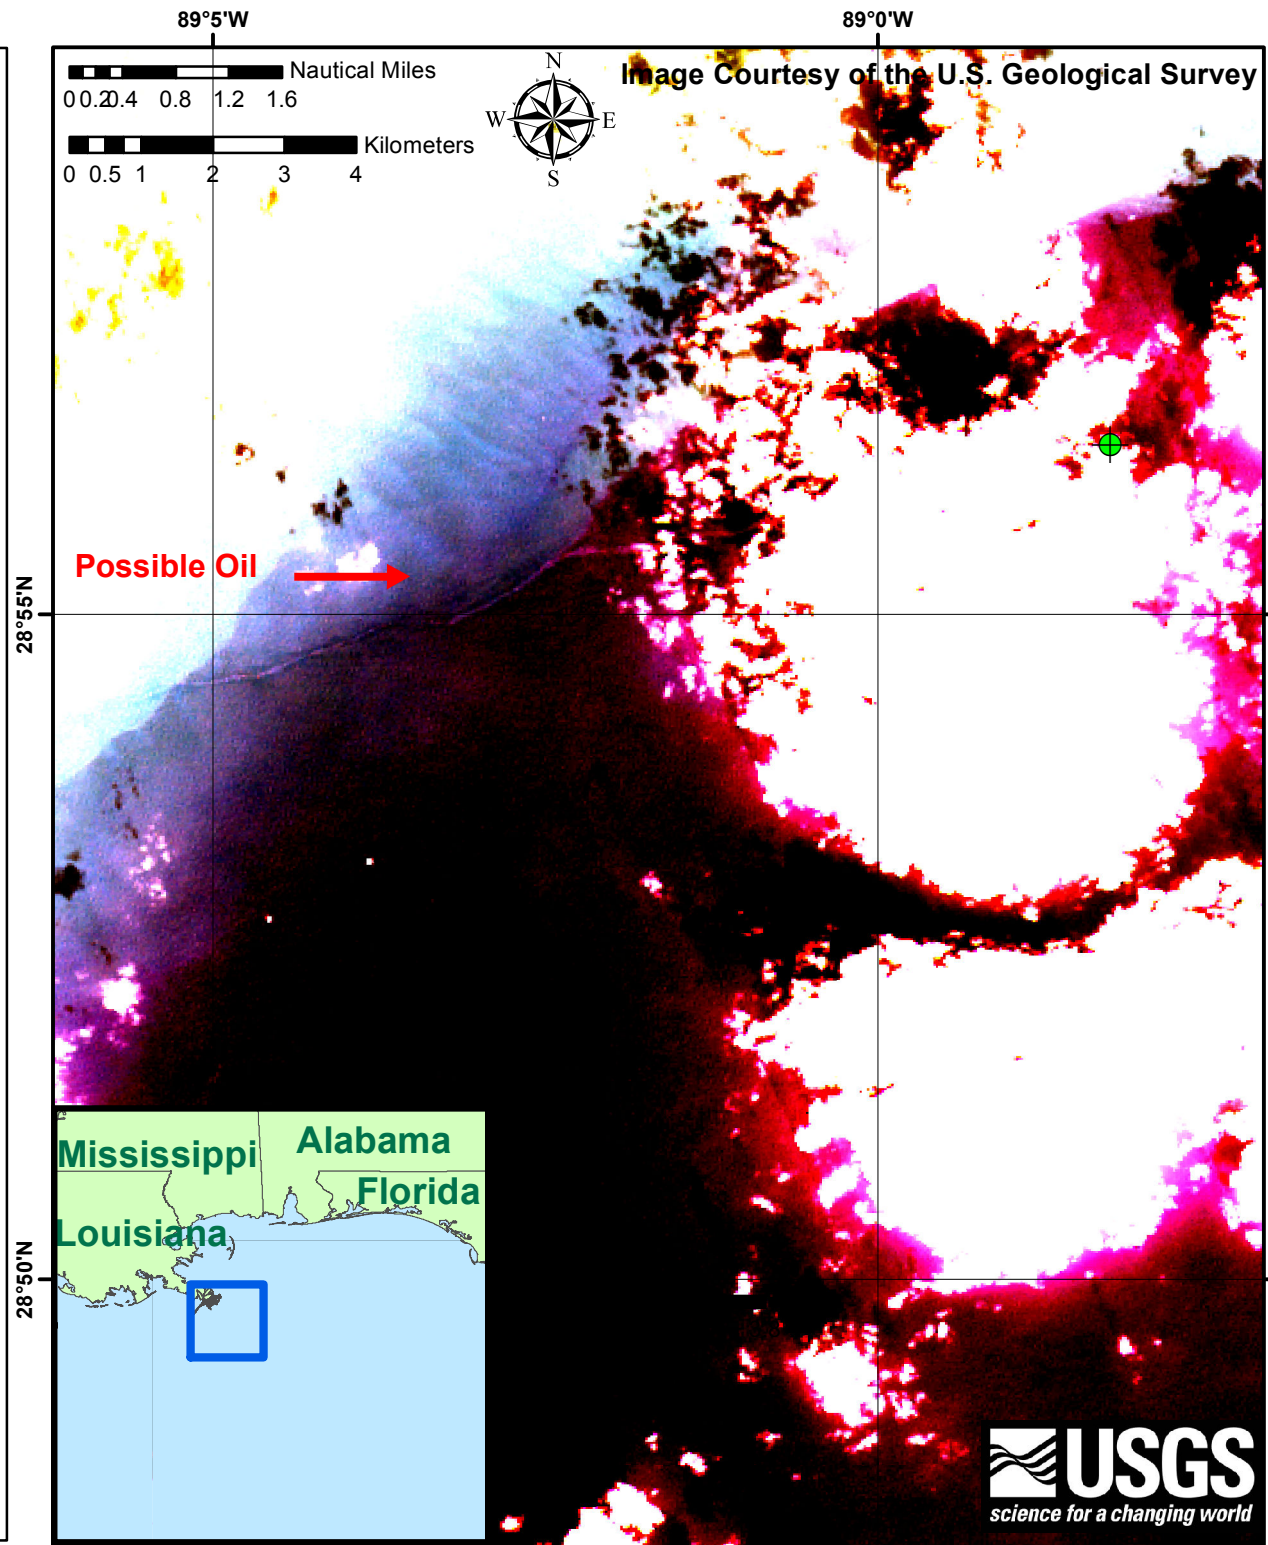
Destroyed Taylor Platform :
[28°56'9" N / 88°58'12" W]

1.3 km² Area of Possible Oil

This enhanced satellite image shows a possible narrow oil slick extending for approximately 3.3 nmi from east-northeast to west-southwest. Based on an analysis of surface winds and ocean currents, the point source is believed to be the destroyed Taylor platform which is located an additional 3.2 nmi to the east-northeast of the eastern edge of the suspected oil slick.

Sky conditions were partly cloudy at the time of the image and winds were blowing from the east-northeast at 5-10 knots.
