# MARINE POLLUTION SURVEILLANCE REPORT

Analysis Provided by: The National Oceanic and  
Atmospheric Administration/National Environmental  
Satellite, Data and Information Service (NOAA/NESDIS)

REPORT DATE: OCTOBER 07, 2013  
REPORT TIME: 1855Z (1355 CDT)  
ANALYST: JANKOT

Destroyed Taylor Platform :  
[ 28°56'9" N / 88°58'12" W ]

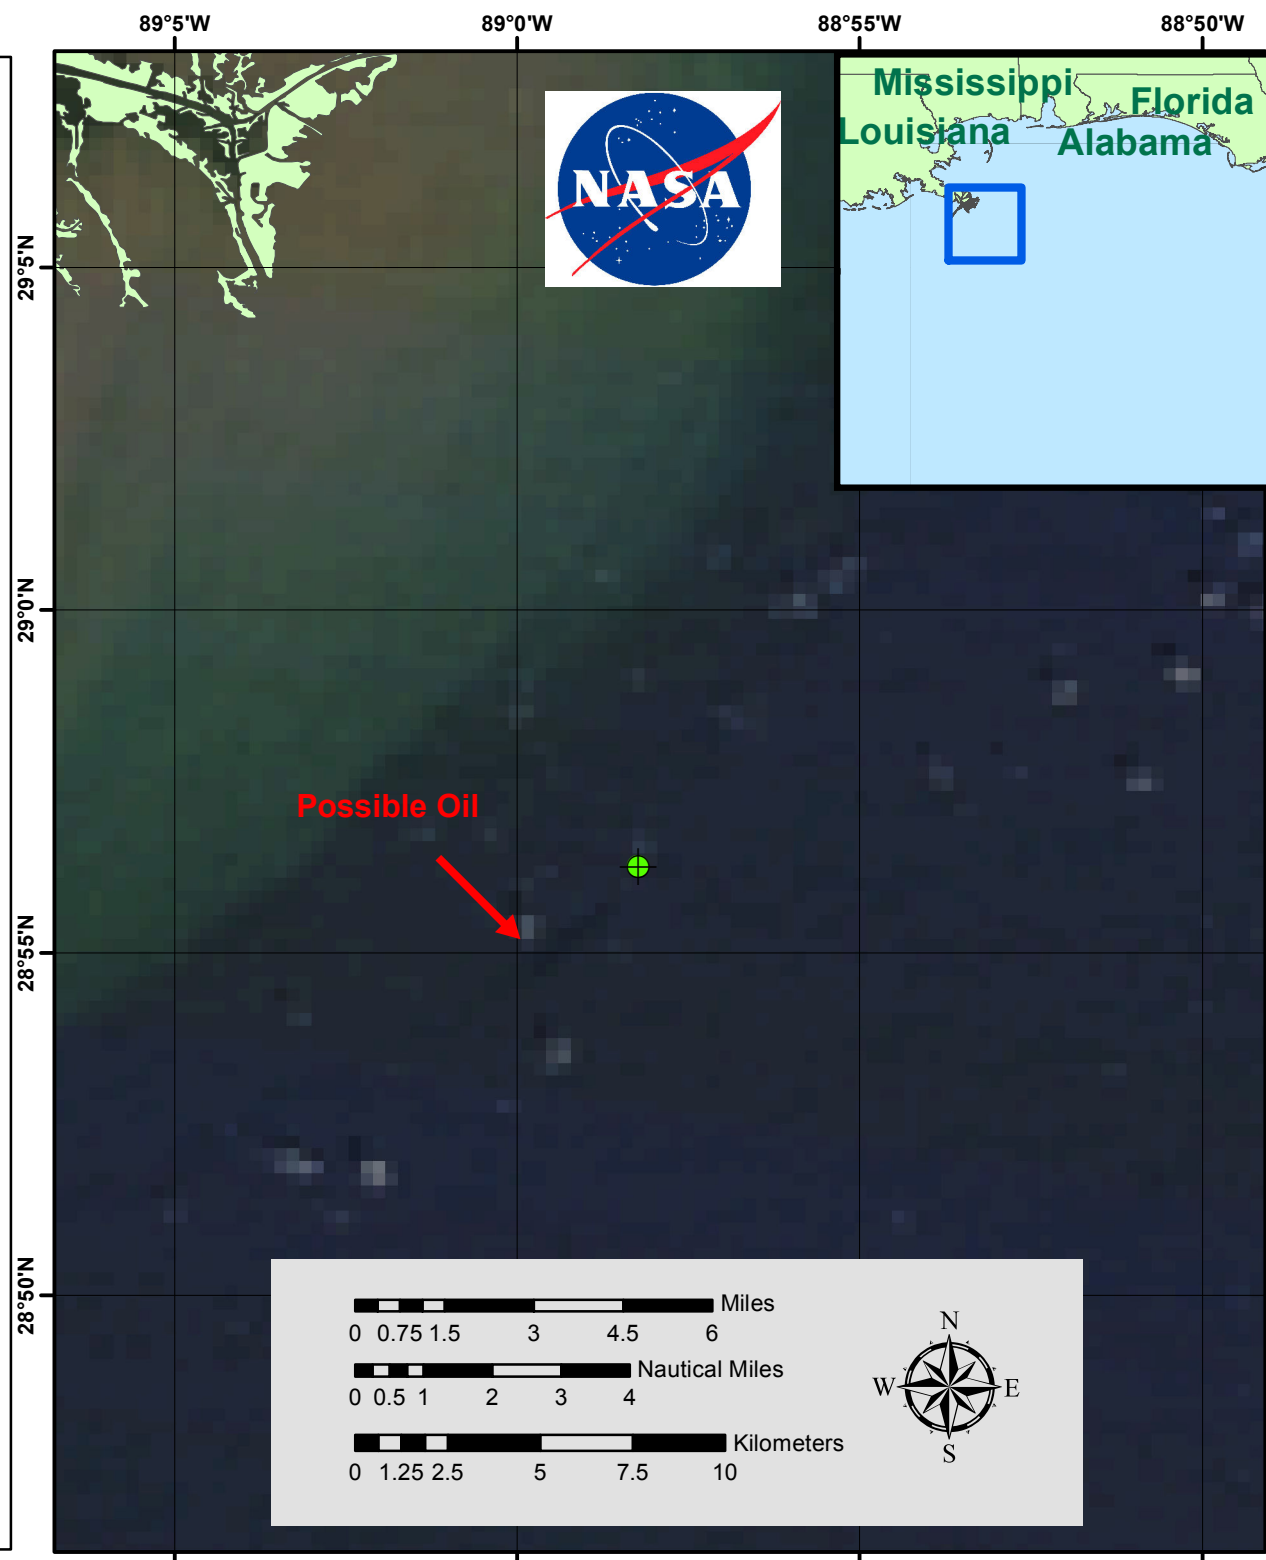
2.46 km<sup>2</sup> Area of Possible Oil

REMARKS: Suspected oil slick is seen extending southwest of the destroyed Taylor Platform for approximately 3.5 miles. Ocean currents are northeast to southwest following the orientation of the suspected slick with surface winds out of the north to north-northeast at 10-15 knots. The slick may extend further to the southwest but lack of sunglint and scattered clouds obscured the view beyond what was outlined.
