MARINE POLLUTION SURVEILLANCE REPORT

Analysis Provided by: The National Oceanic and
Atmospheric Administration/National Environmental
Satellite, Data and Information Service (NOAA/NESDIS)

REPORT DATE: SEPTEMBER 14, 2013
REPORT TIME: 2022Z (1522 CDT)
ANALYST: OEGERLE

Destroyed Taylor Platform :
[28°56'9" N / 88°58'12" W]

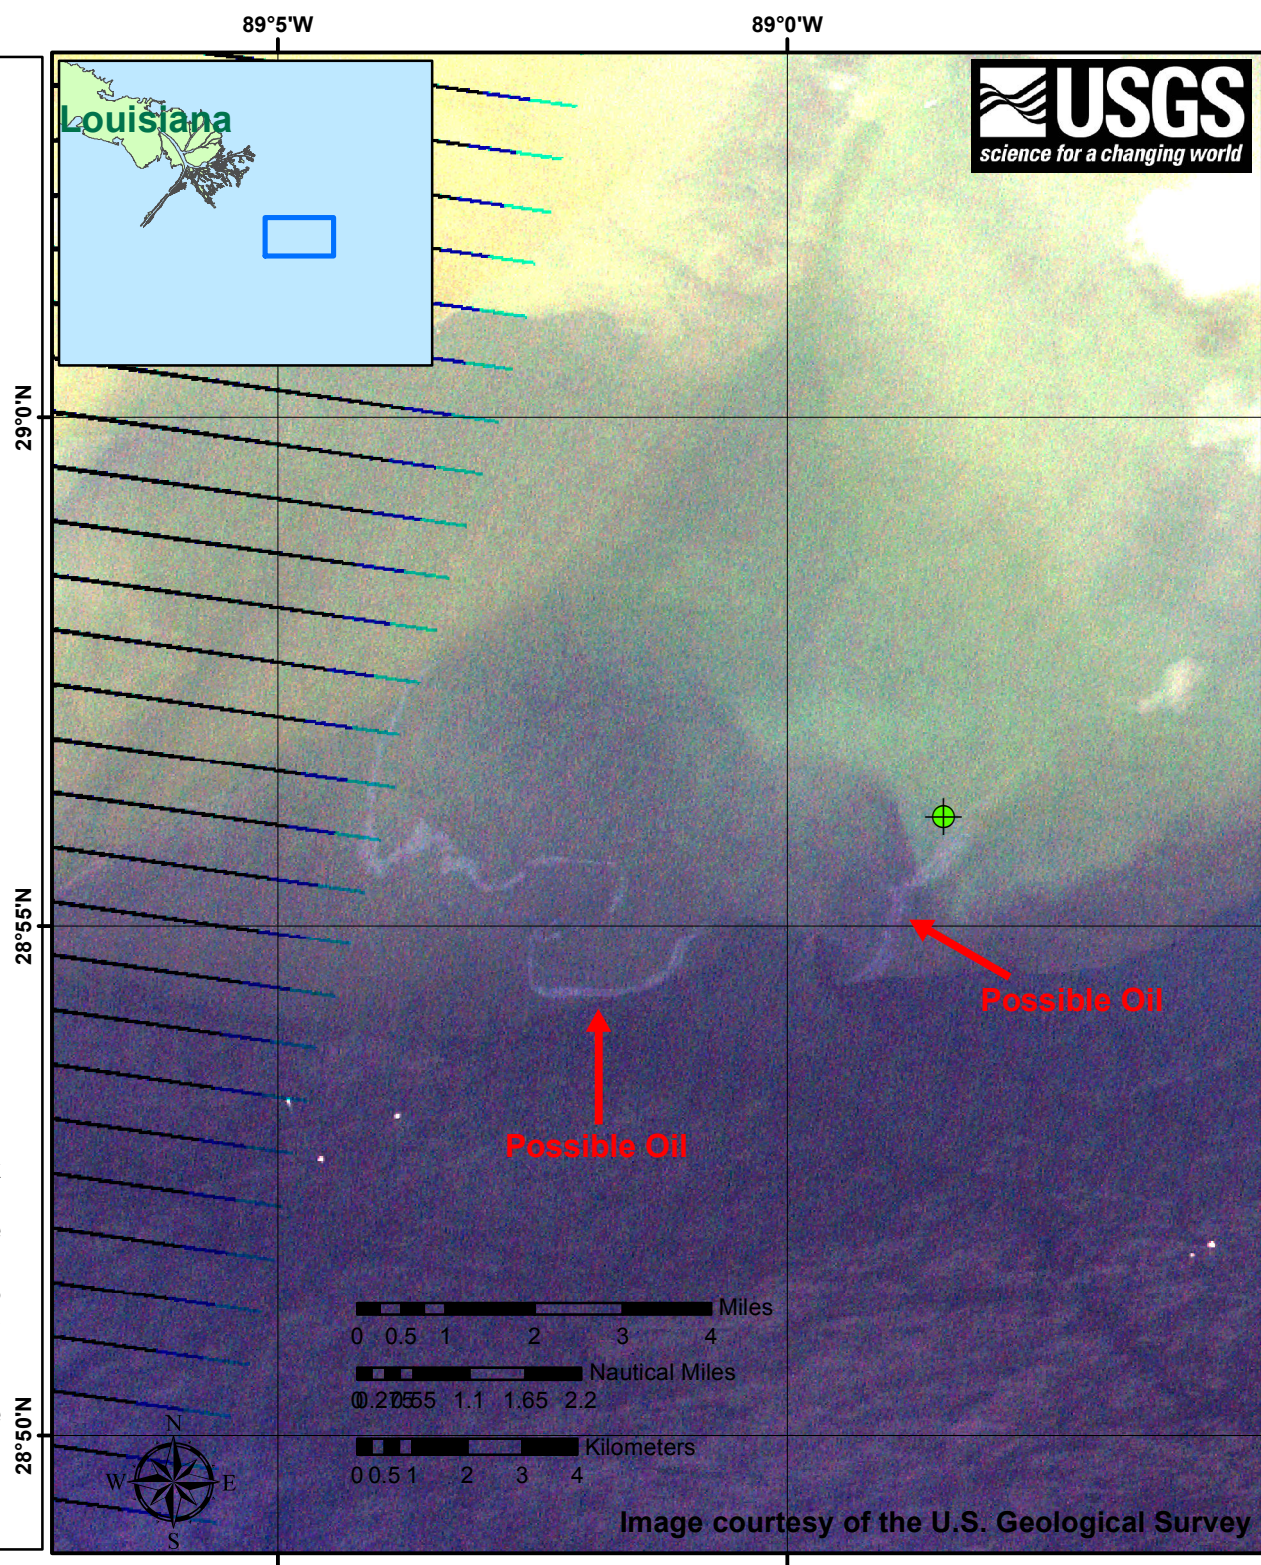
4.4 km² Area of Possible Oil

Suspected oil originates from a known repeat leak source located off of Bird's Foot, Louisiana. The sheen is broken up into two segments; one extending south of the site and one extending west. The first segment extends 6.17 miles south and the second segment extends 10.03 miles west. The wind speed and direction are agreeable to the direction of the suspected sheen. Model forecasting ocean currents in the area mirror the same direction as the winds. Sky conditions at the time of the satellite image are mostly clear.
