MARINE POLLUTION SURVEILLANCE REPORT

Analysis Provided by: The National Oceanic and
Atmospheric Administration/National Environmental
Satellite, Data and Information Service (NOAA/NESDIS)

REPORT DATE: AUGUST 16, 2014
REPORT TIME: 2000Z (1500 CDT)
ANALYST: VELASCO

DATA SOURCE: LANDSAT-7 ETM+
MODE: Multispectral
RESOLUTION: 30 meter
IMAGE DATE/TIME: 8/16/2014 1624Z (1124 CDT)

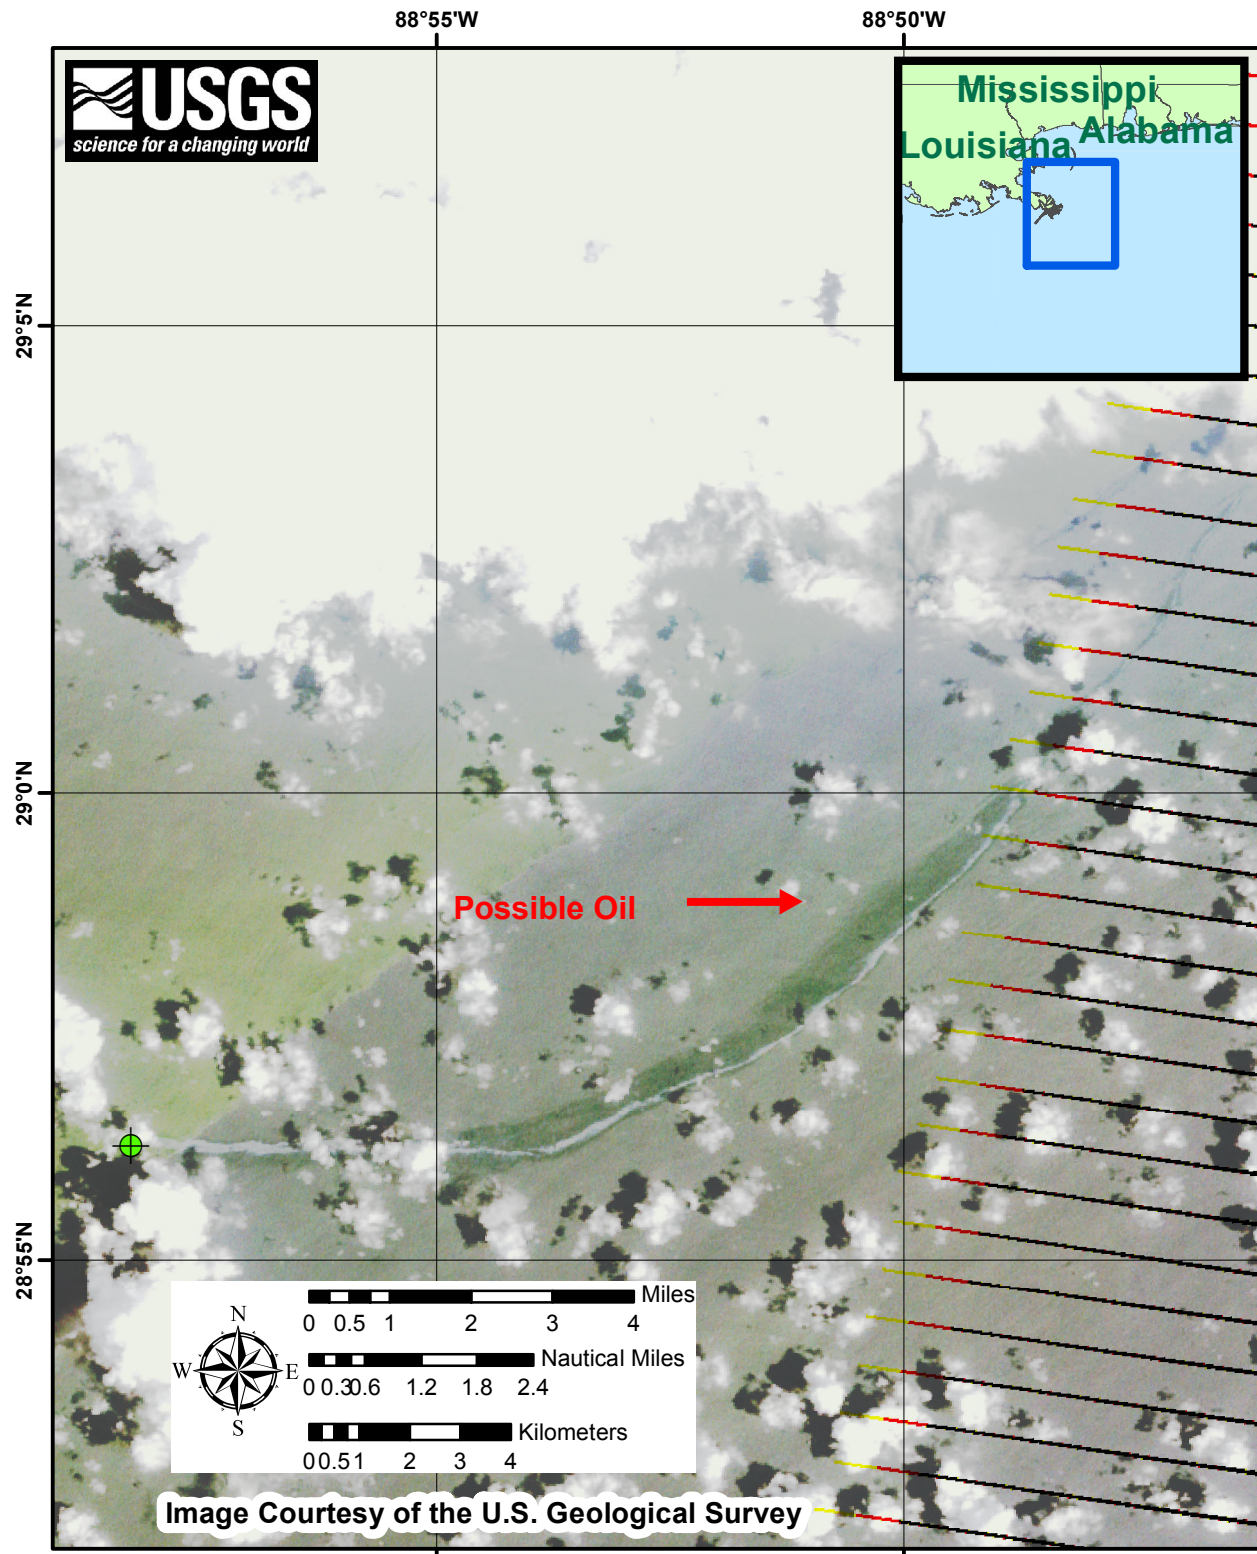
Destroyed Taylor Platform :
[28°56'9" N / 88°58'12" W]

16.6 km² Area of Possible Oil

Suspected oil slick 15.6 miles long and up to 0.6 miles wide seen extending east from the destroyed Taylor platform. Anomaly appears silvery and black. East-northeastward orientation agrees with observed surface winds and NRC Notification #1092509. Sky conditions were partly cloudy and winds were from the West and Southwest at 10 knots.
