MARINE POLLUTION SURVEILLANCE REPORT

REPORT DATE: JULY 08, 2014

Destroyed Taylor Platform :
[28°56'9" N / 88°58'12" W]

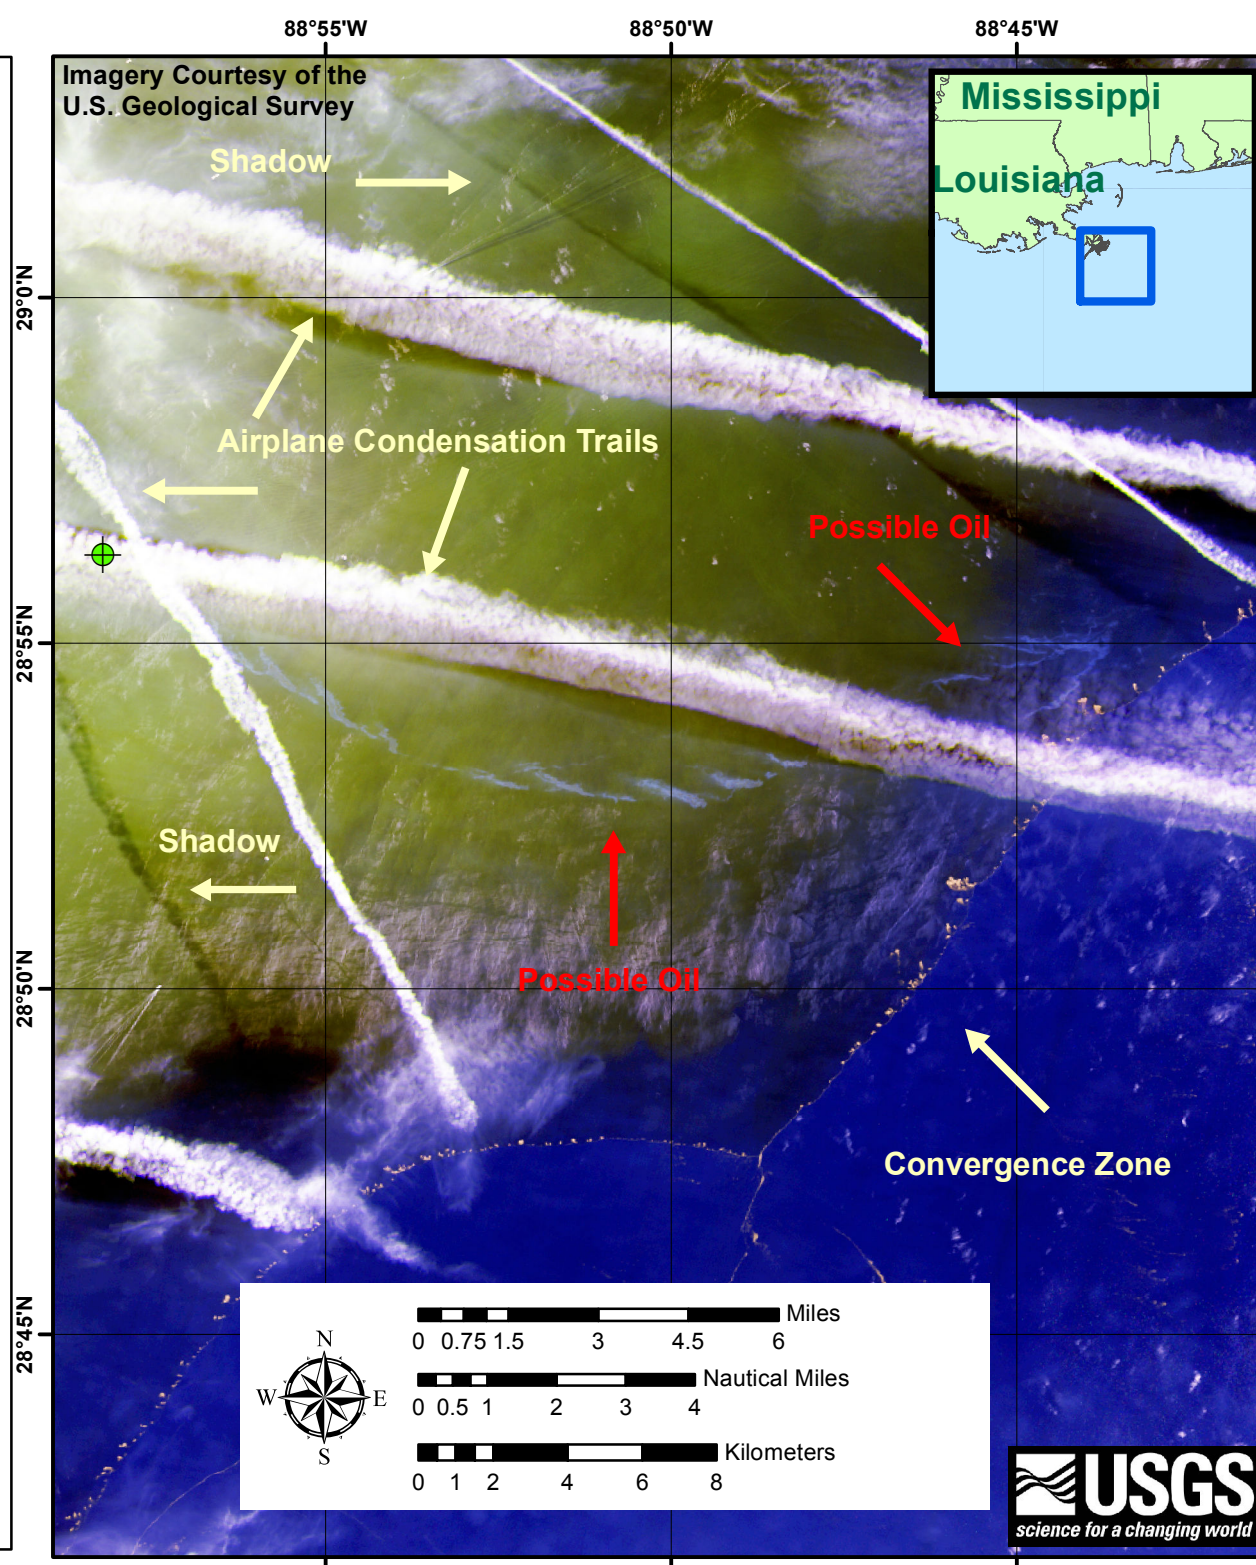
7.9 km² Area of Possible Oil

A segmented 16 mile long oil slick was seen emanating from the destroyed Taylor platform. Airplane condensation trails prevented positively identifying the slick in the immediate vicinity of the destroyed platform. In addition to these contrails, other false positives seen in the image include an extensive convergence zone and the shadows of the contrails.

Sky conditions were partly cloudy at the time and winds were 5 knots or less from the west and west-northwest.
