# MARINE POLLUTION SURVEILLANCE REPORT

Analysis Provided by: The National Oceanic and  
Atmospheric Administration/National Environmental  
Satellite, Data and Information Service (NOAA/NESDIS)

REPORT DATE: JULY 16, 2014  
REPORT TIME: 2230Z (1730 CDT)  
ANALYST: TURK

DATA SOURCE: AQUA MODIS  
MODE: Multispectral  
RESOLUTION: 250 meter  
IMAGE DATE/TIME: 7/16/2014 1900Z (1400 CDT)

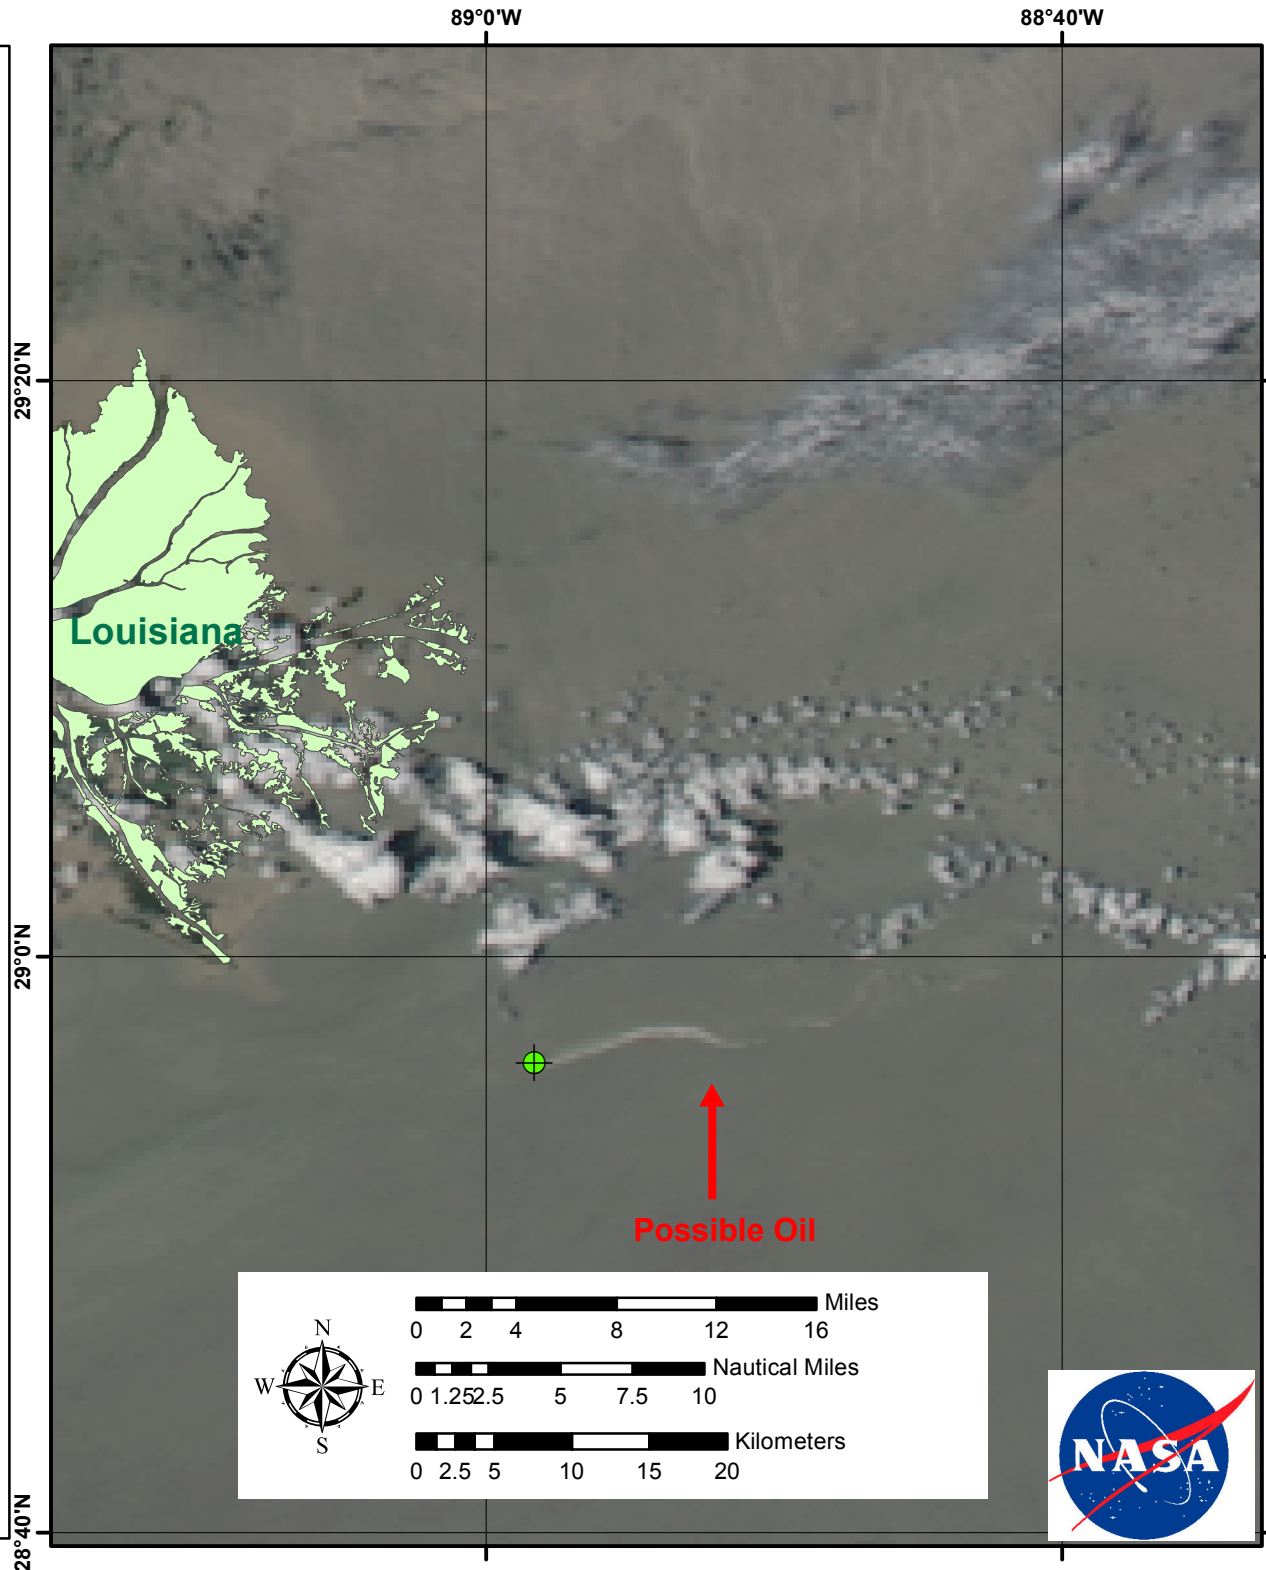
Destroyed Taylor Platform :  
[ 28°56'9" N / 88°58'12" W ]

18.4 km<sup>2</sup> Area of Possible Oil

A lengthy but disjointed slick extended eastward at least  
10 mi from the destroyed Taylor platform.

Sky conditions were partly cloudy and winds were from  
the west at 10 knots at the time of the image.
