MARINE POLLUTION SURVEILLANCE REPORT

Analysis Provided by: The National Oceanic and
Atmospheric Administration/National Environmental
Satellite, Data and Information Service (NOAA/NESDIS)

REPORT DATE: JULY 25, 2014
REPORT TIME: 2215Z (1715 CDT)
ANALYST: RAMIREZ

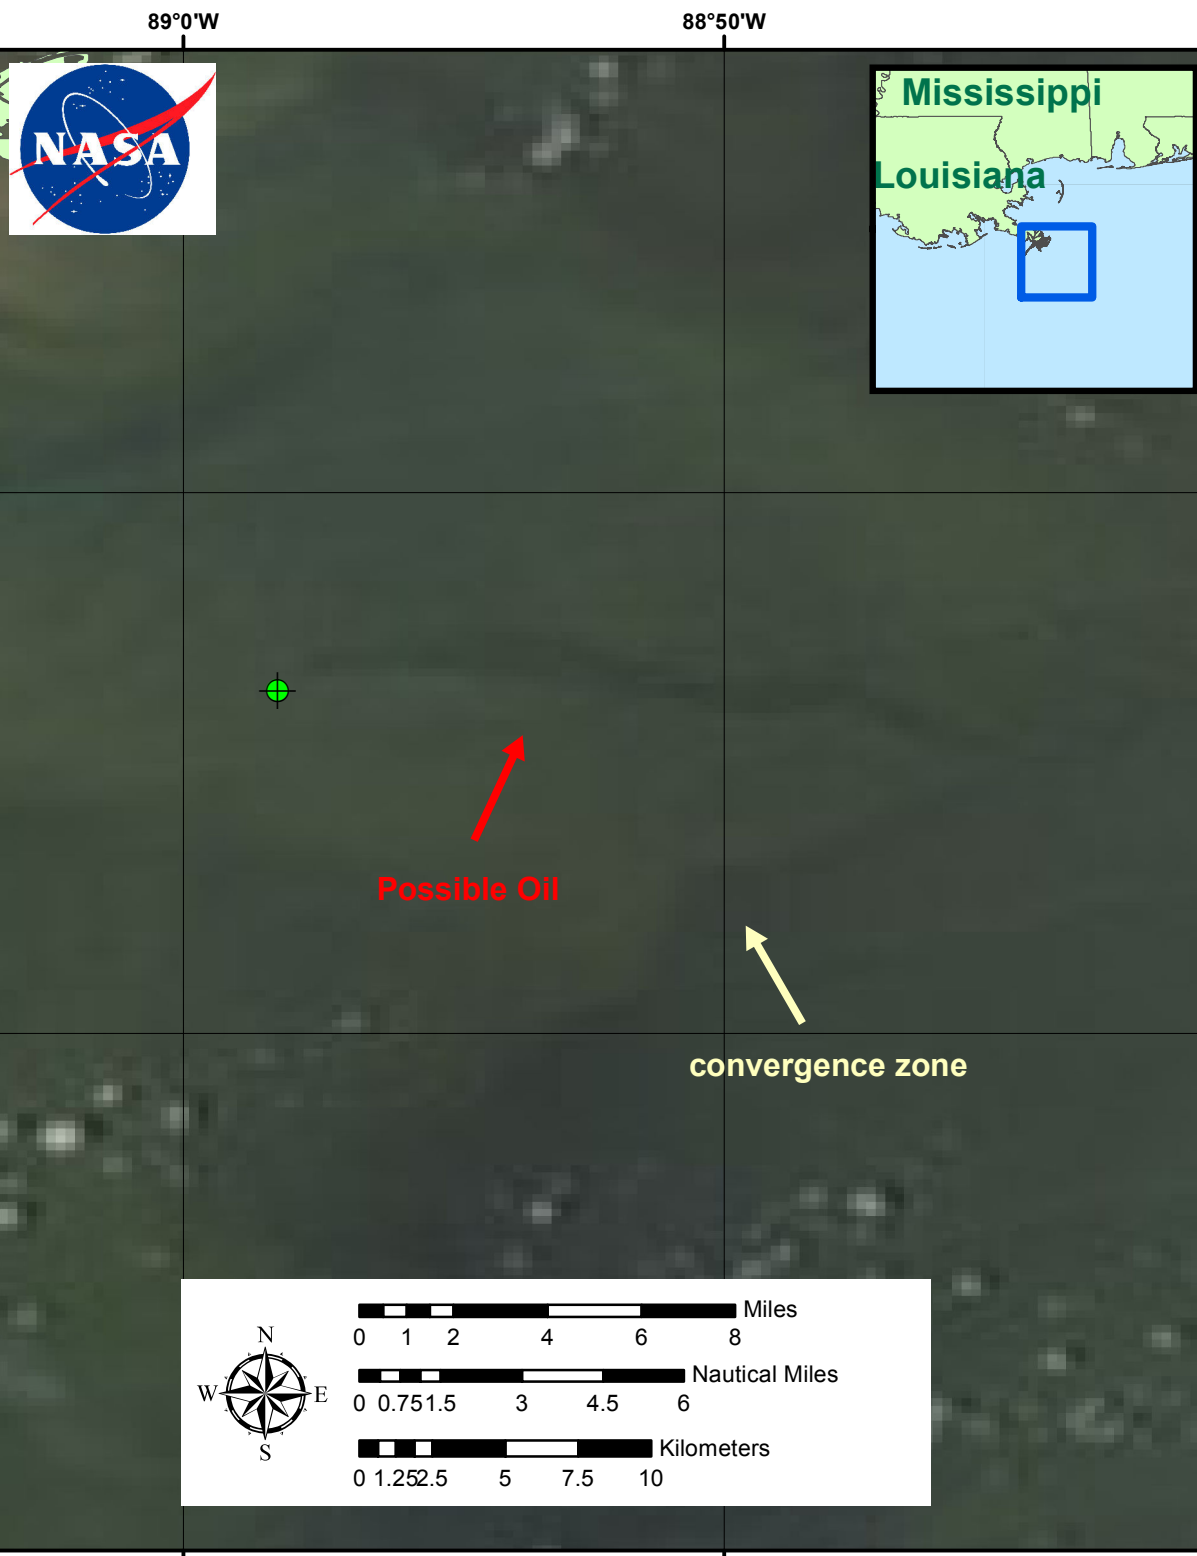
Destroyed Taylor Platform :
[28°56'9" N / 88°58'12" W]

27 km² Area of Possible Oil

Suspected oil anomaly originates from the destroyed Taylor Energy platform and extends for 15 miles due east. The width of the slick varies from 0.5 to 1 mile wide. Sky conditions are mostly clear and the slick appears dark in the absence of sunglint.
