MARINE POLLUTION SURVEILLANCE REPORT

Analysis Provided by: The National Oceanic and
Atmospheric Administration/National Environmental
Satellite, Data and Information Service (NOAA/NESDIS)

REPORT DATE: JULY 28, 2014
REPORT TIME: 2317Z (1817 CDT)
ANALYST: OEGERLE

DATA SOURCE: LANDSAT-8 OLI
MODE: Multispectral
RESOLUTION: 30 meter
IMAGE DATE/TIME: 7/28/2014 1645Z (1145 CDT)

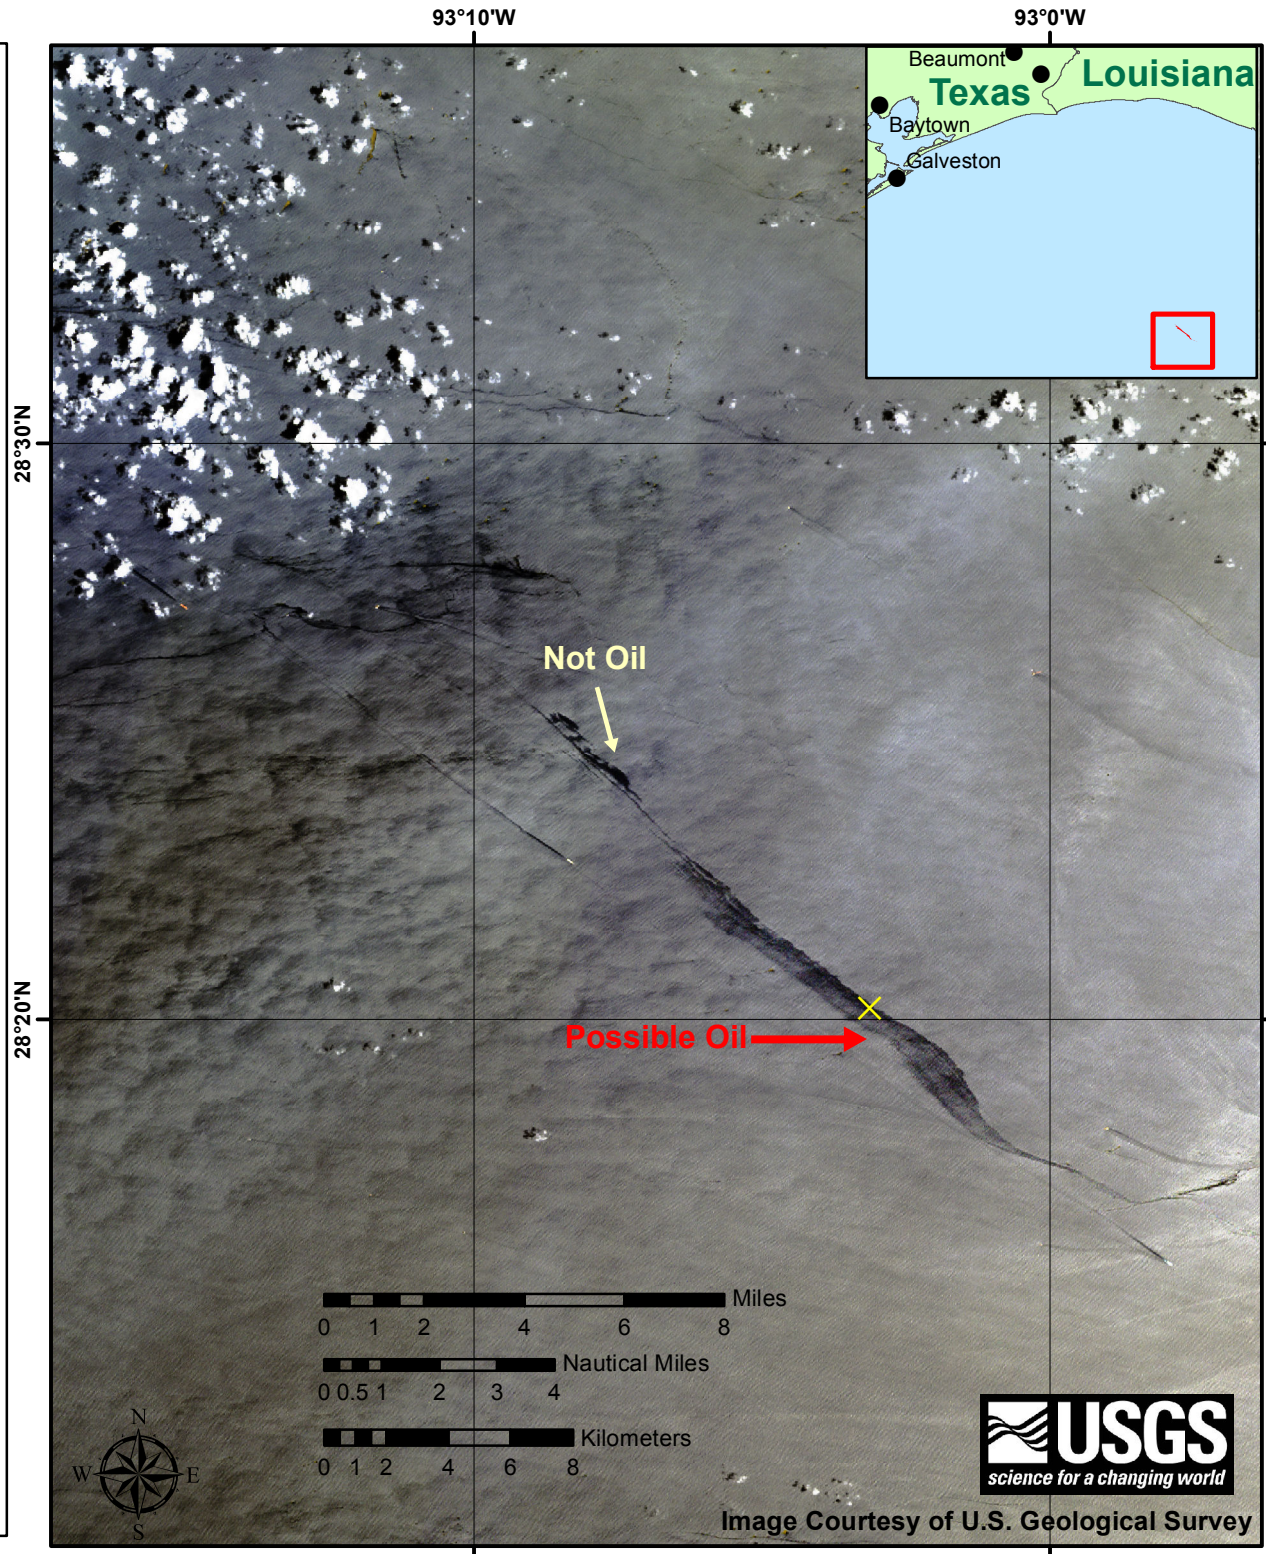
Center Point of Oil Slick:
[28°20'12" N / 93°03'11" W]

11.8 km² Area of Possible Oil

Suspected slick is located in the NW Gulf of Mexico, 131.2 miles SE of Galveston, Texas. Slick has an unknown point source, however there is a moving ship just SE of slick, as well as multiple rigs located in the scene. Length of slick is 11.8 miles long and 1 mile wide. The slick appears black in color, irregular, and tested negative for vegetation in false positive imagery. Direction of slick is congruent with surface wind in the area with favorable speed. The slick is also visible in the 1920Z AQUA image of the area in sunglint, where the anomaly appears silver in color which is agreeable with oil.
