MARINE POLLUTION SURVEILLANCE REPORT

REPORT DATE: JULY 31, 2014
REPORT TIME: 1920Z (1420 CDT)
ANALYST: JANKOT

DATA SOURCE: LANDSAT-7 ETM+
MODE: Multispectral
RESOLUTION: 30 meter
IMAGE DATE/TIME: 7/31/2014 1623Z (1123 CDT)

Destroyed Taylor Platform :
[28°56'9" N / 88°58'12" W]

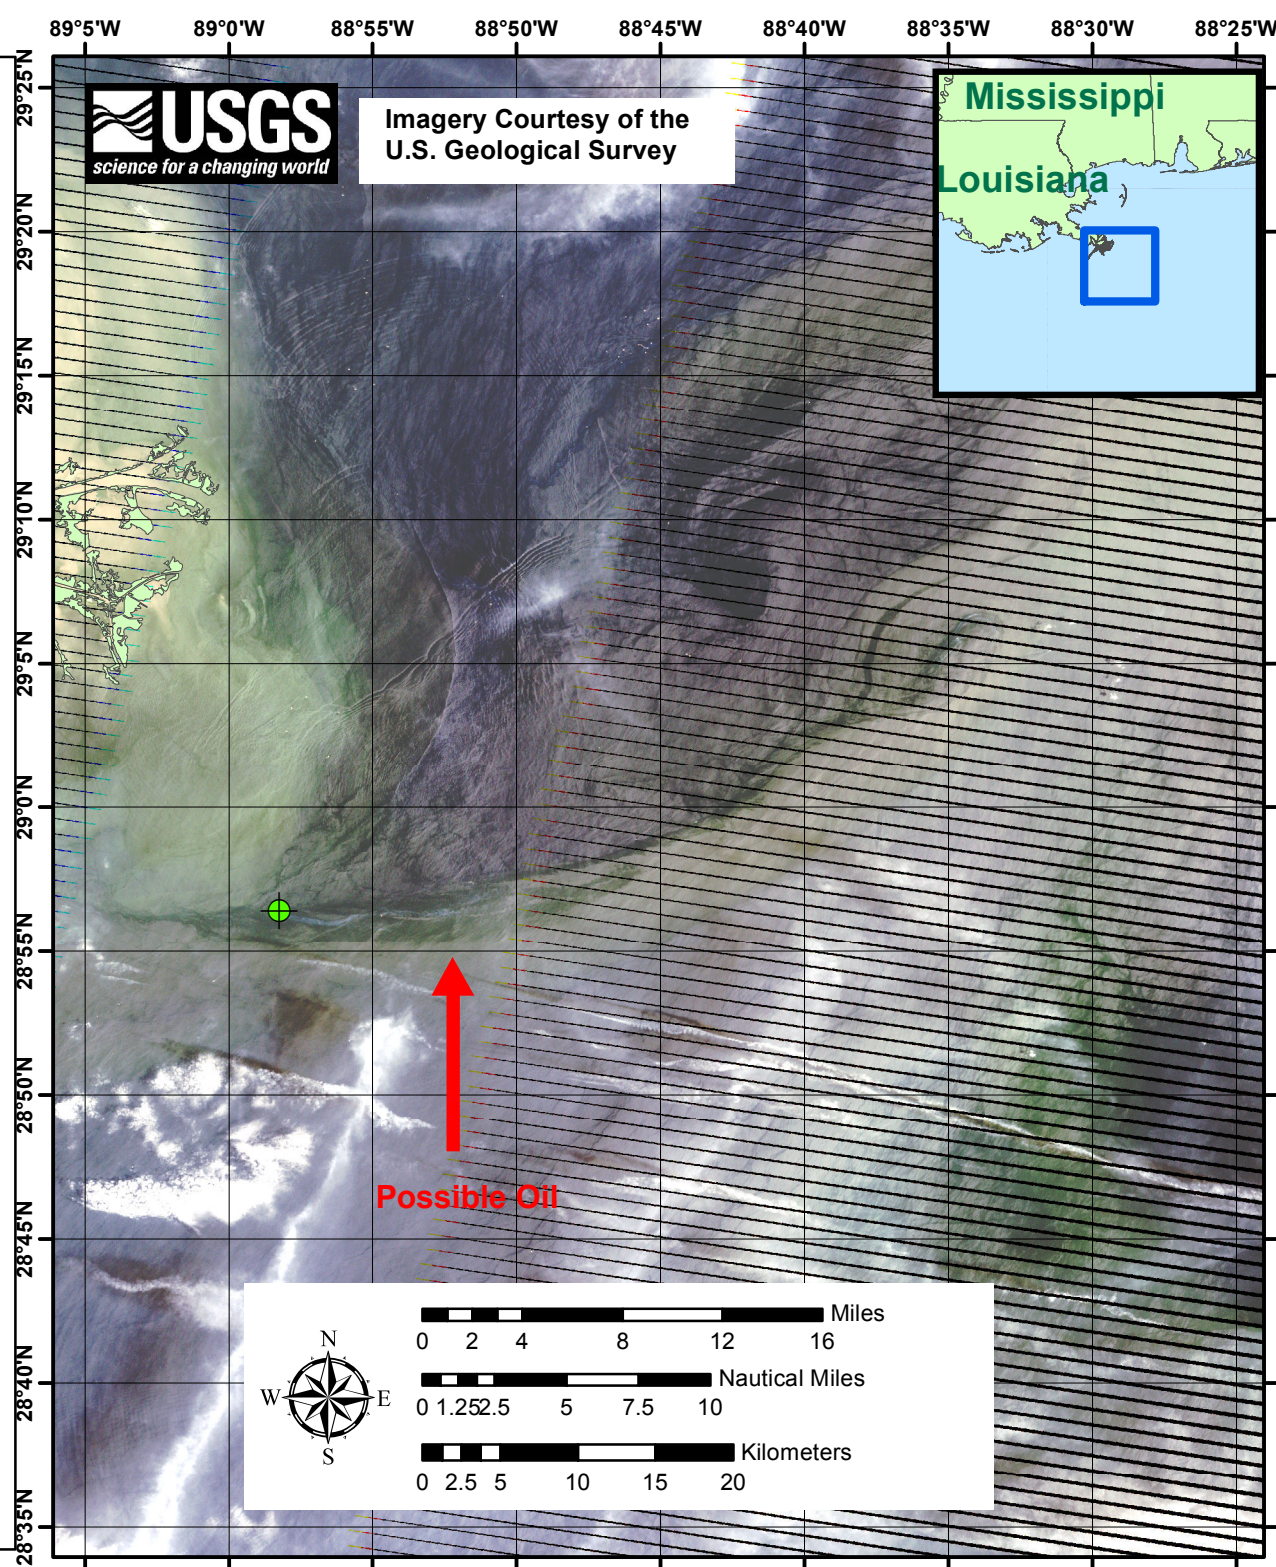
162.6km² Area of Possible Oil

Possible oil is connected to the Destroyed Taylor Platform, a repeat leak source. Please note a similar anomaly and orientation was also seen in yesterdays MODIS 1905Z AQUA pass, increasing confidence. The anomaly extends for approximately 34 miles and is as wide as 3 miles. The anomaly appears both black and silver in color and in clear contrast with its surroundings. In addition the shape of the anomaly is irregular with a feathering signature.

Sky conditions were partly cloudy at time of image (yet not obscuring the view of the anomaly). Surface winds were generally weak at time of image at up to 5 knots and modeled ocean currents were also weak out of the northeast.
