MARINE POLLUTION SURVEILLANCE REPORT

Analysis Provided by: The National Oceanic and
Atmospheric Administration/National Environmental
Satellite, Data and Information Service (NOAA/NESDIS)

REPORT DATE: JUNE 21, 2014
REPORT TIME: 0530Z (0030 CDT)
ANALYST: JANKOT/RAMIREZ

DATA SOURCE: EO-1 Advanced Land Imager
MODE: Multispectral
RESOLUTION: 30 meter
IMAGE DATE/TIME: 6/19/2014 1540Z (6/19/2014 1040 CDT)

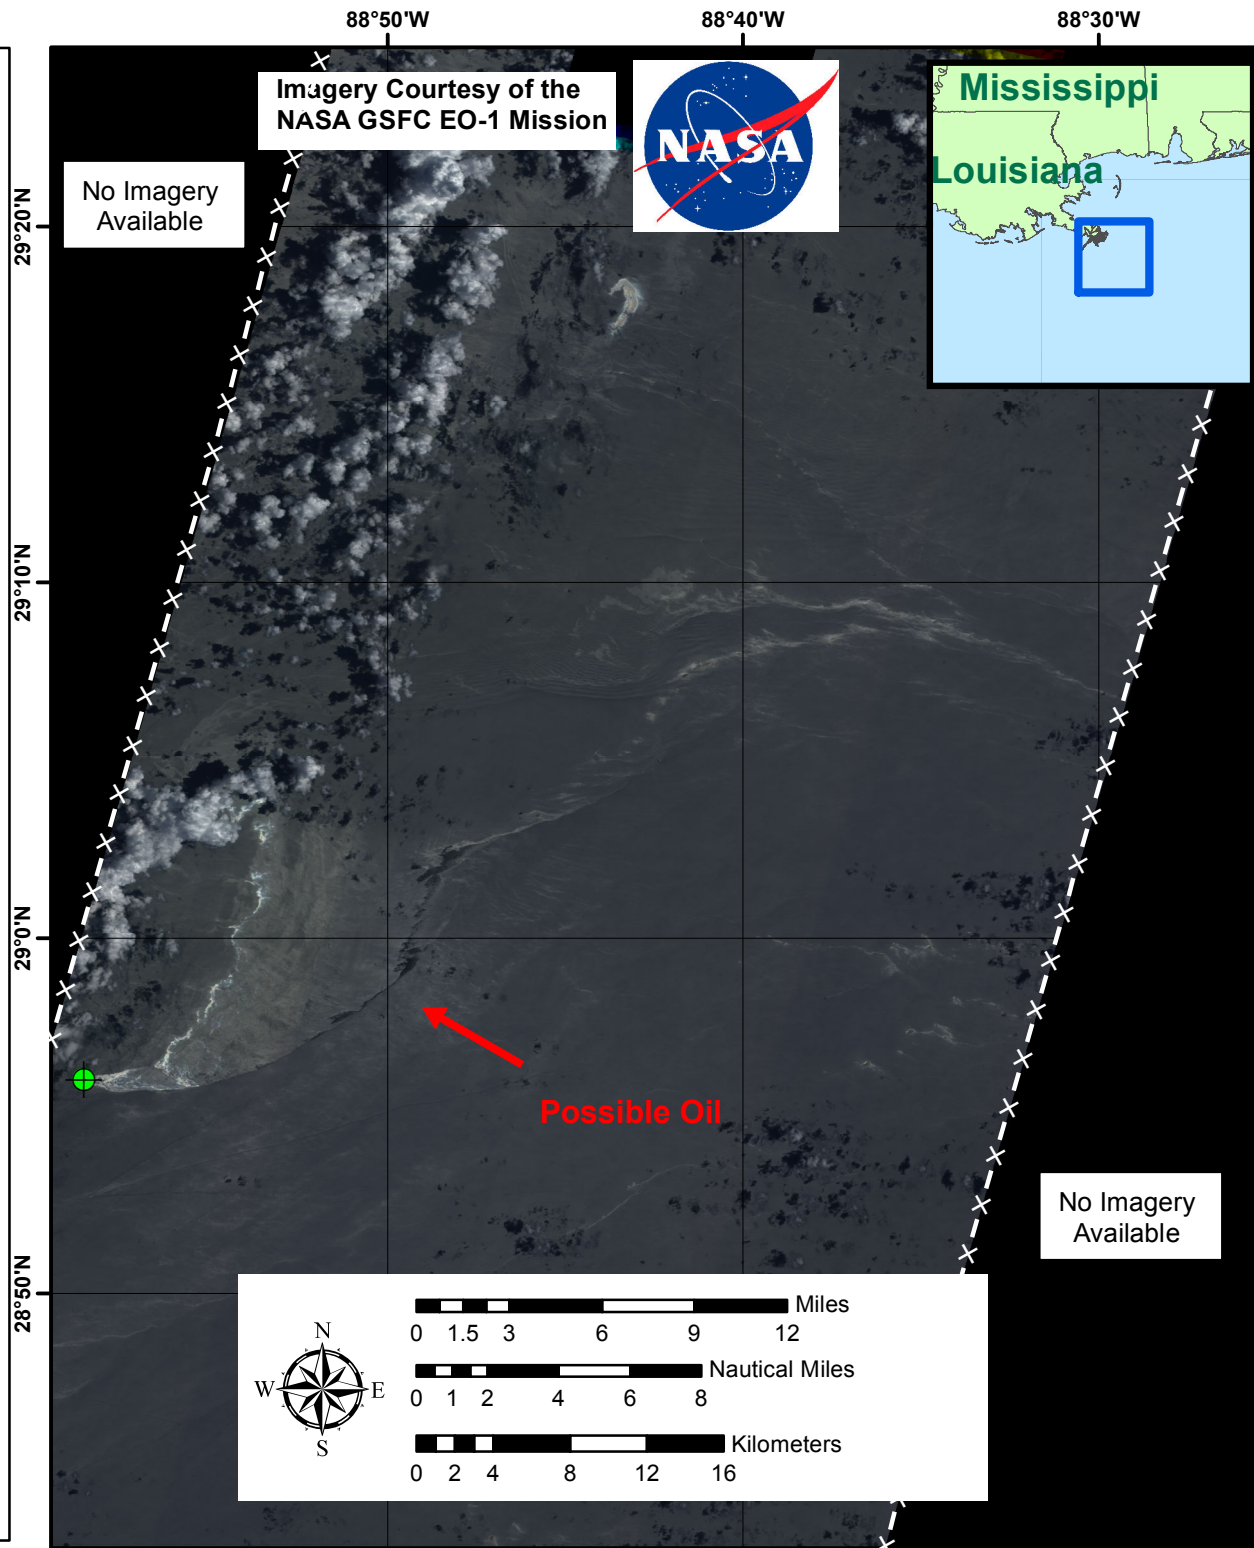
Destroyed Taylor Platform :
[28°56'9" N / 88°58'12" W]

200km² Area of Possible Oil

REMARKS: Please note that the image was taken on June 19th at 1540Z. Possible oil slick winds for approximately 30 miles in the northeast direction. The origin is the Destroyed Taylor Platform, a repeat leak source. Boundaries of the suspected slick are well defined close to source, becoming more ambiguous with increasing distance. Confidence is high.
