MARINE POLLUTION SURVEILLANCE REPORT

Analysis Provided by: The National Oceanic and
Atmospheric Administration/National Environmental
Satellite, Data and Information Service (NOAA/NESDIS)

REPORT DATE: JUNE 22, 2014

Destroyed Taylor Platform :
[28°56'9" N / 88°58'12" W]

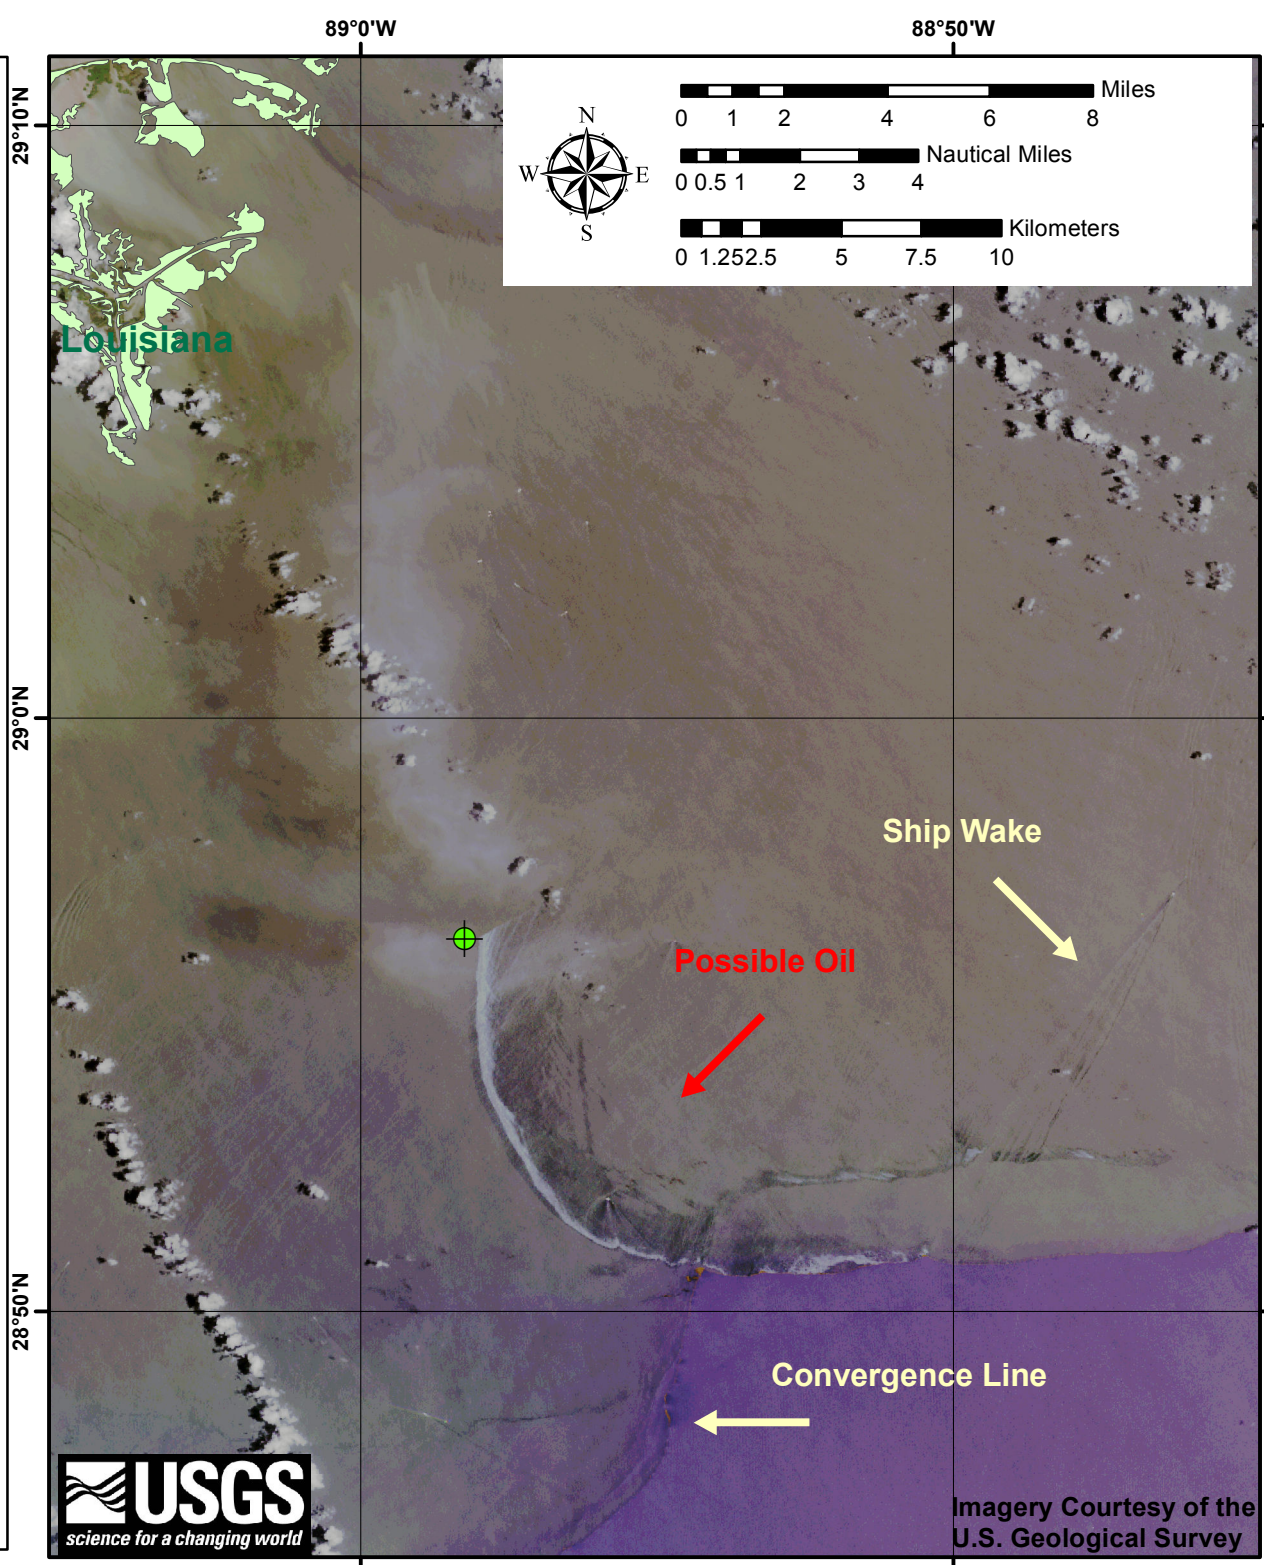
47.5 km² Area of Possible Oil

An oil slick extended a total of 13.5 nmi from the destroyed Taylor platform. The slick extended south for approximately 5 nmi before turning to the east and extending up to an additional 8.5 nmi. Sky conditions were mostly clear at the time of the image and winds were out of the north-northwest at 5-10 knots. The eastern portion of the slick was broken by a ship wake; and just east of the bend a convergence line extended to the south of the slick. Biogenic material was detected in the convergence line and along the southern extent of the slick.
