# MARINE POLLUTION SURVEILLANCE REPORT

Analysis Provided by: The National Oceanic and  
Atmospheric Administration/National Environmental  
Satellite, Data and Information Service (NOAA/NESDIS)

REPORT DATE: JUNE 22, 2014  
REPORT TIME: 0830Z (0330 CDT)  
ANALYST: RAMIREZ

DATA SOURCE: LANDSAT-8 OLI  
MODE: Multispectral  
RESOLUTION: 30 meter  
IMAGE DATE/TIME: 6/21/2014 1626Z (1126 CDT)

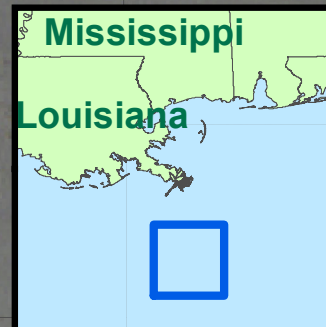
Center Point of Oil Slick:  
[ 28°7'48" N / 89°5'35" W ]

High confidence that oil is present due to the silvery color. Tests for vegetation were negative. Uncertain on the origin of the anomaly because both active rigs and natural seeps are in the immediate vicinity, therefore no specific point source is given. Anomaly extends approximately 2mi away from the marked center location in any given direction.

Possible Oil
