# MARINE POLLUTION SURVEILLANCE REPORT

REPORT DATE: MARCH 01, 2014  
REPORT TIME: 2345Z (1745 CST)  
ANALYST: JANKOT

Destroyed Taylor Platform :  
[ 28°56'9" N / 88°58'12" W ]

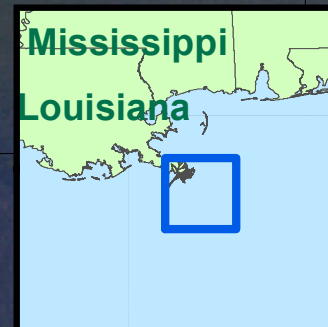
2.3 km<sup>2</sup> Area of Possible Oil

REMARKS: Possible anomaly extends to east north east  
for approximately 3.25 miles from the Destroyed Taylor  
Platform, a repeat leak source. The orientation of the  
slick relative to the point source is consistent with NRC  
Incident Report # 1075472.

Sky conditions were generally clear at the time of the  
image with a few clouds to the southeast. Surface winds  
were weak out of the south around 10 knots.
