MARINE POLLUTION SURVEILLANCE REPORT

Analysis Provided by: The National Oceanic and
Atmospheric Administration/National Environmental
Satellite, Data and Information Service (NOAA/NESDIS)

REPORT DATE: MAY 05, 2014
REPORT TIME: 0115Z (5/4/2014 2015 CDT)
ANALYST: JANKOT

DATA SOURCE: LANDSAT-8 OLI
MODE: Multispectral
RESOLUTION: 30 meter
IMAGE DATE/TIME: 5/4/2014 162601Z (1126 CDT)

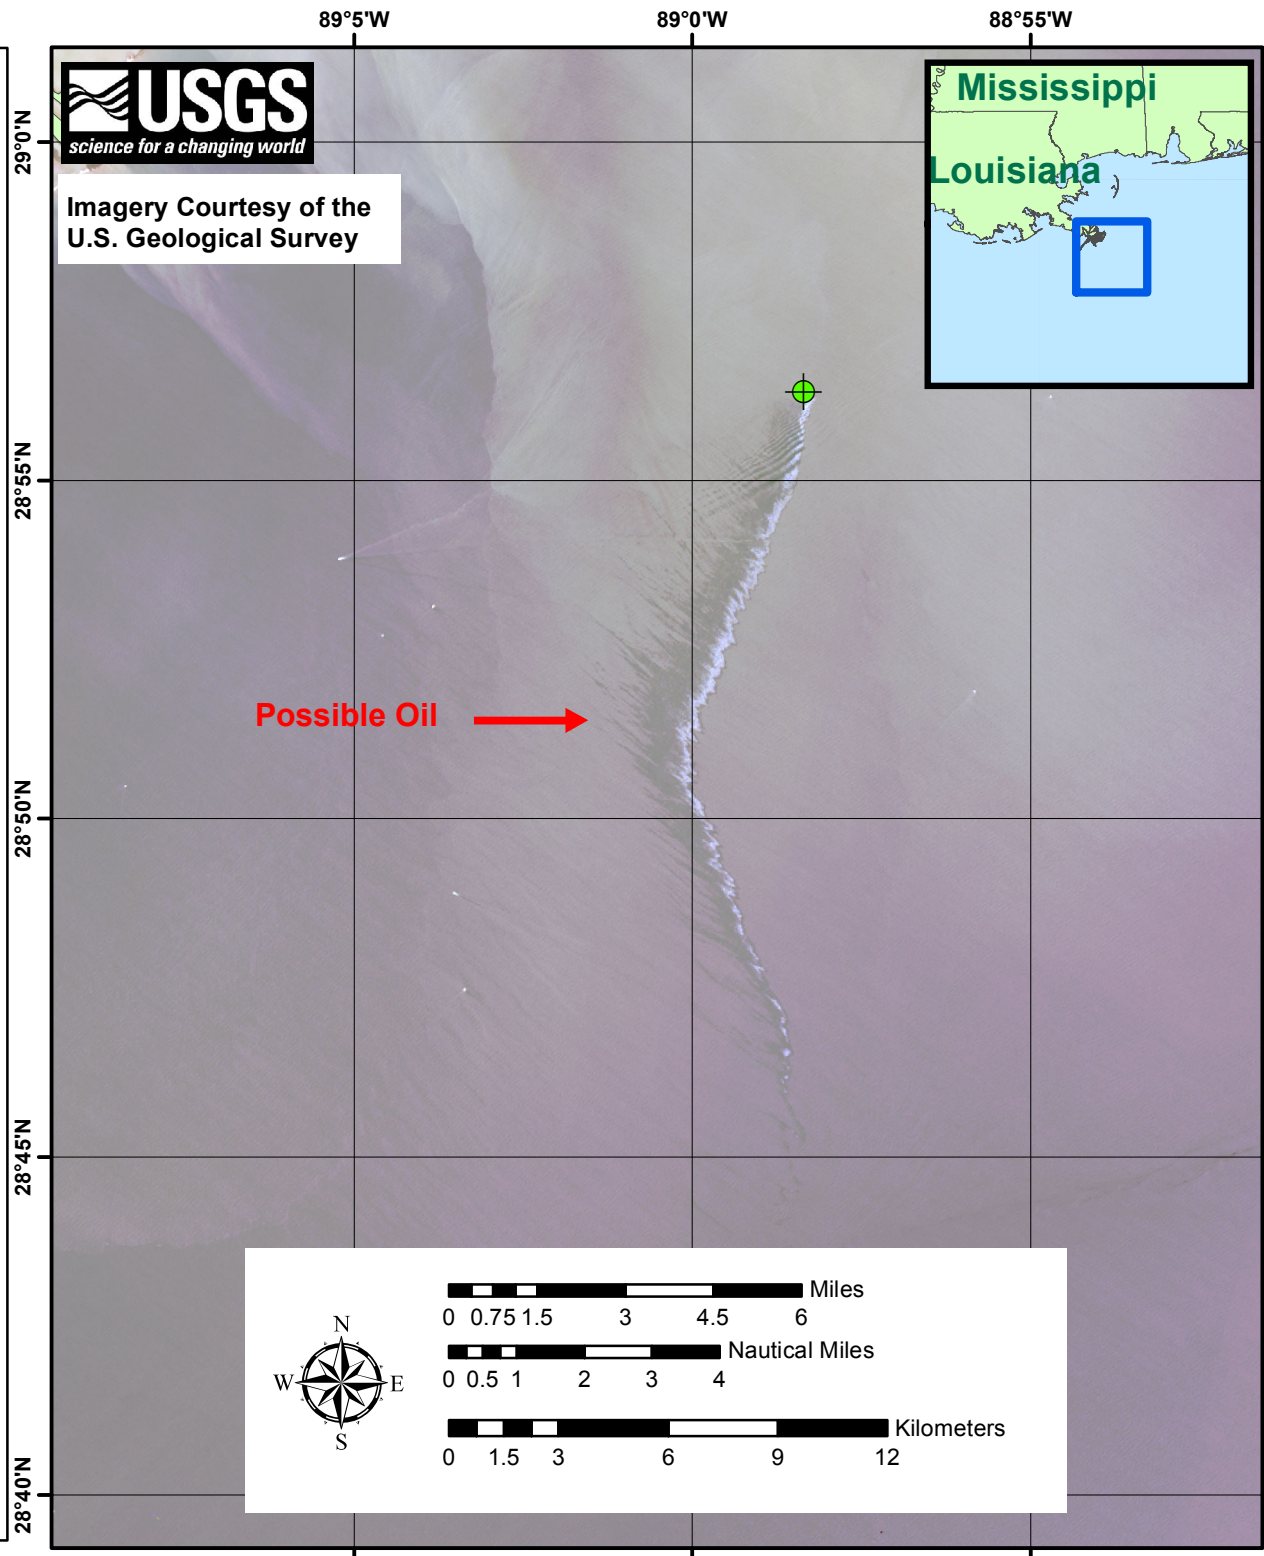
Destroyed Taylor Platform :
[28°56'9" N / 88°58'12" W]

26.0 km² Area of Possible Oil

Suspected oil slick originating from the Destroyed Taylor Platform, a repeat leak source. The anomaly measured 15 miles long and as wide as 1.8 miles. Ocean currents agree with the orientation of the slick with modeled currents out of the north-northeast. However surface winds were 5-10 knots out of the west north-west. High confidences in this anomaly as it was also seen in today's 1900Z Aqua pass, in addition to yesterday's Terra pass.
