MARINE POLLUTION SURVEILLANCE REPORT

Analysis Provided by: The National Oceanic and
Atmospheric Administration/National Environmental
Satellite, Data and Information Service (NOAA/NESDIS)

REPORT DATE: MAY 13, 2014
REPORT TIME: 2306Z (1806 CDT)
ANALYST: JANKOT

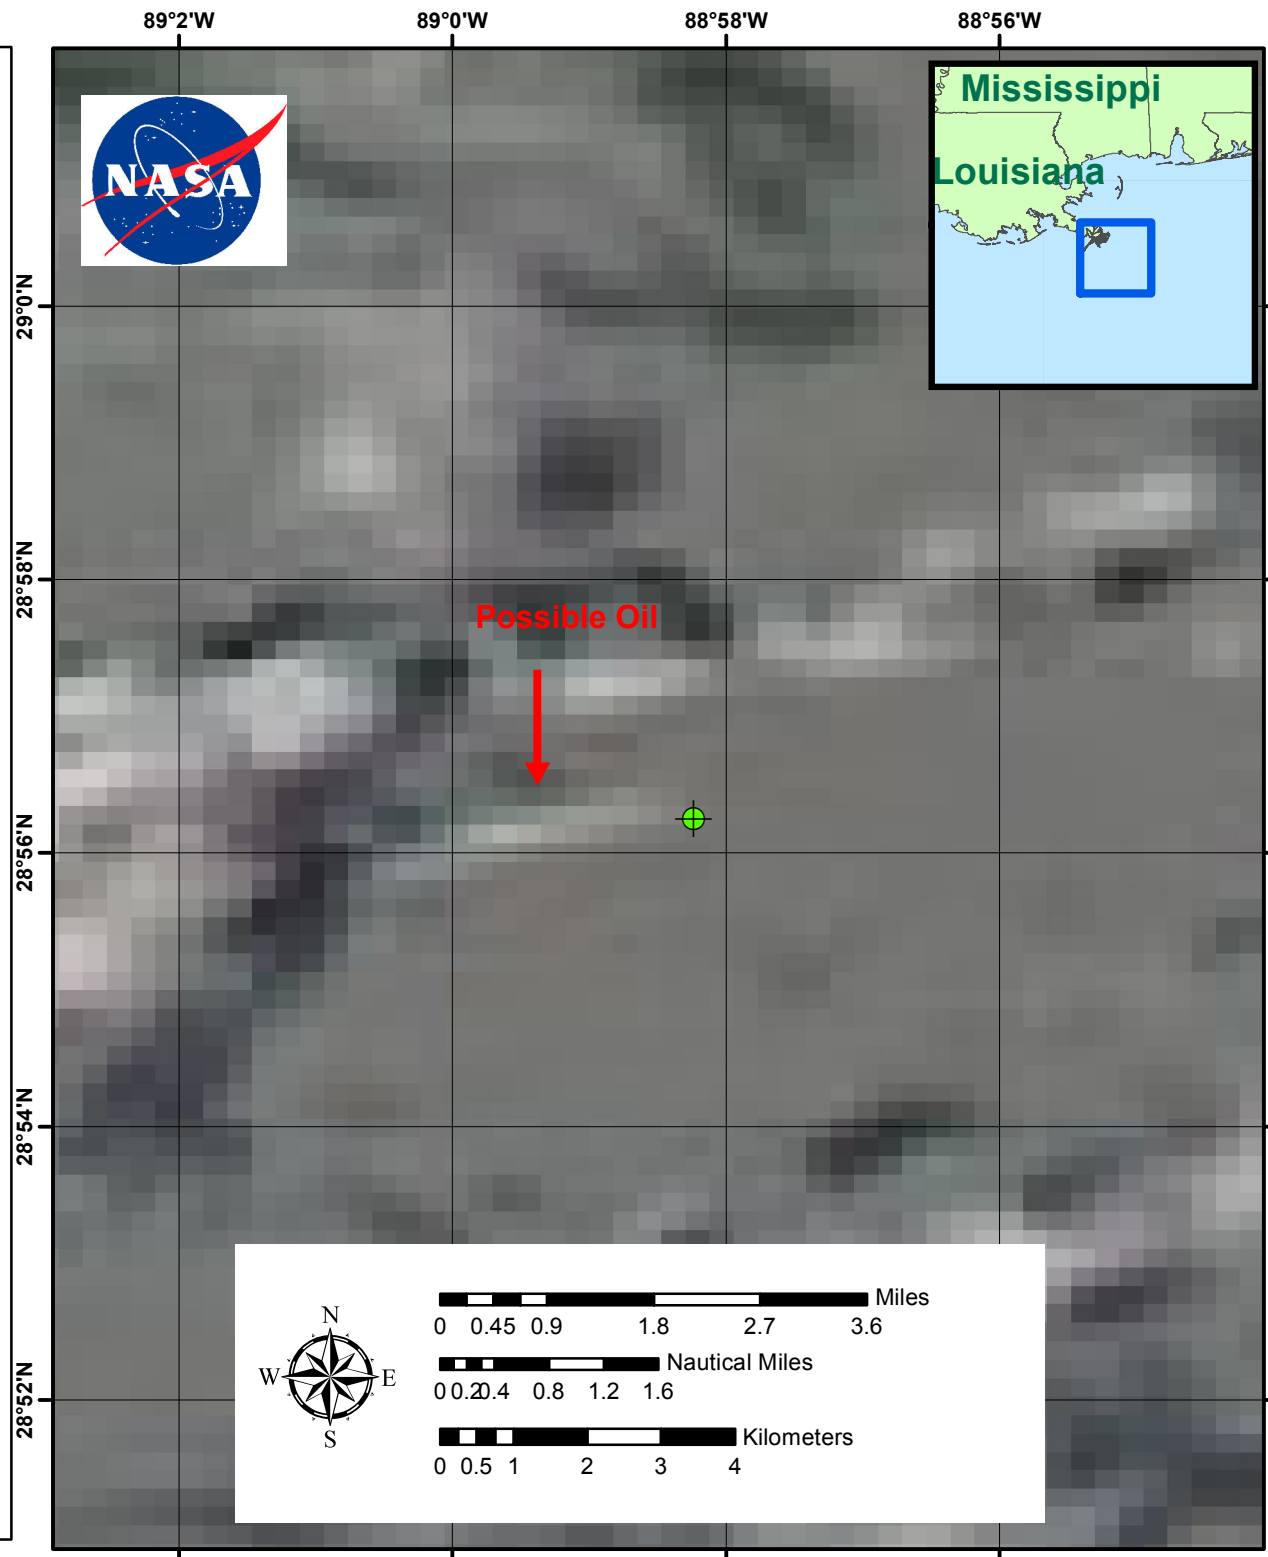
Destroyed Taylor Platform :
[28°56'9" N / 88°58'12" W]

1.7 km² Area of Possible Oil

Suspected oil located from repeat leak source, the Destroyed Taylor Platform off Birds Foot of Louisiana. Slick extends for approximately 1.9 miles to the west south-west of suspected point source. Surface winds support the orientation of the slick out of the east at 5-10 knots at time of the image. In addition, modeled ocean currents were out of the east north-east which also supports the orientation of the slick. Anomaly is just to the east of cloud cover which increases uncertainty but yesterday's Landsat-7 image also showed a similar anomaly with a similar orientation with respect to the Destroyed Taylor Platform.
