MARINE POLLUTION SURVEILLANCE REPORT

Analysis Provided by: The National Oceanic and
Atmospheric Administration/National Environmental
Satellite, Data and Information Service (NOAA/NESDIS)

REPORT DATE: OCTOBER 26, 2014

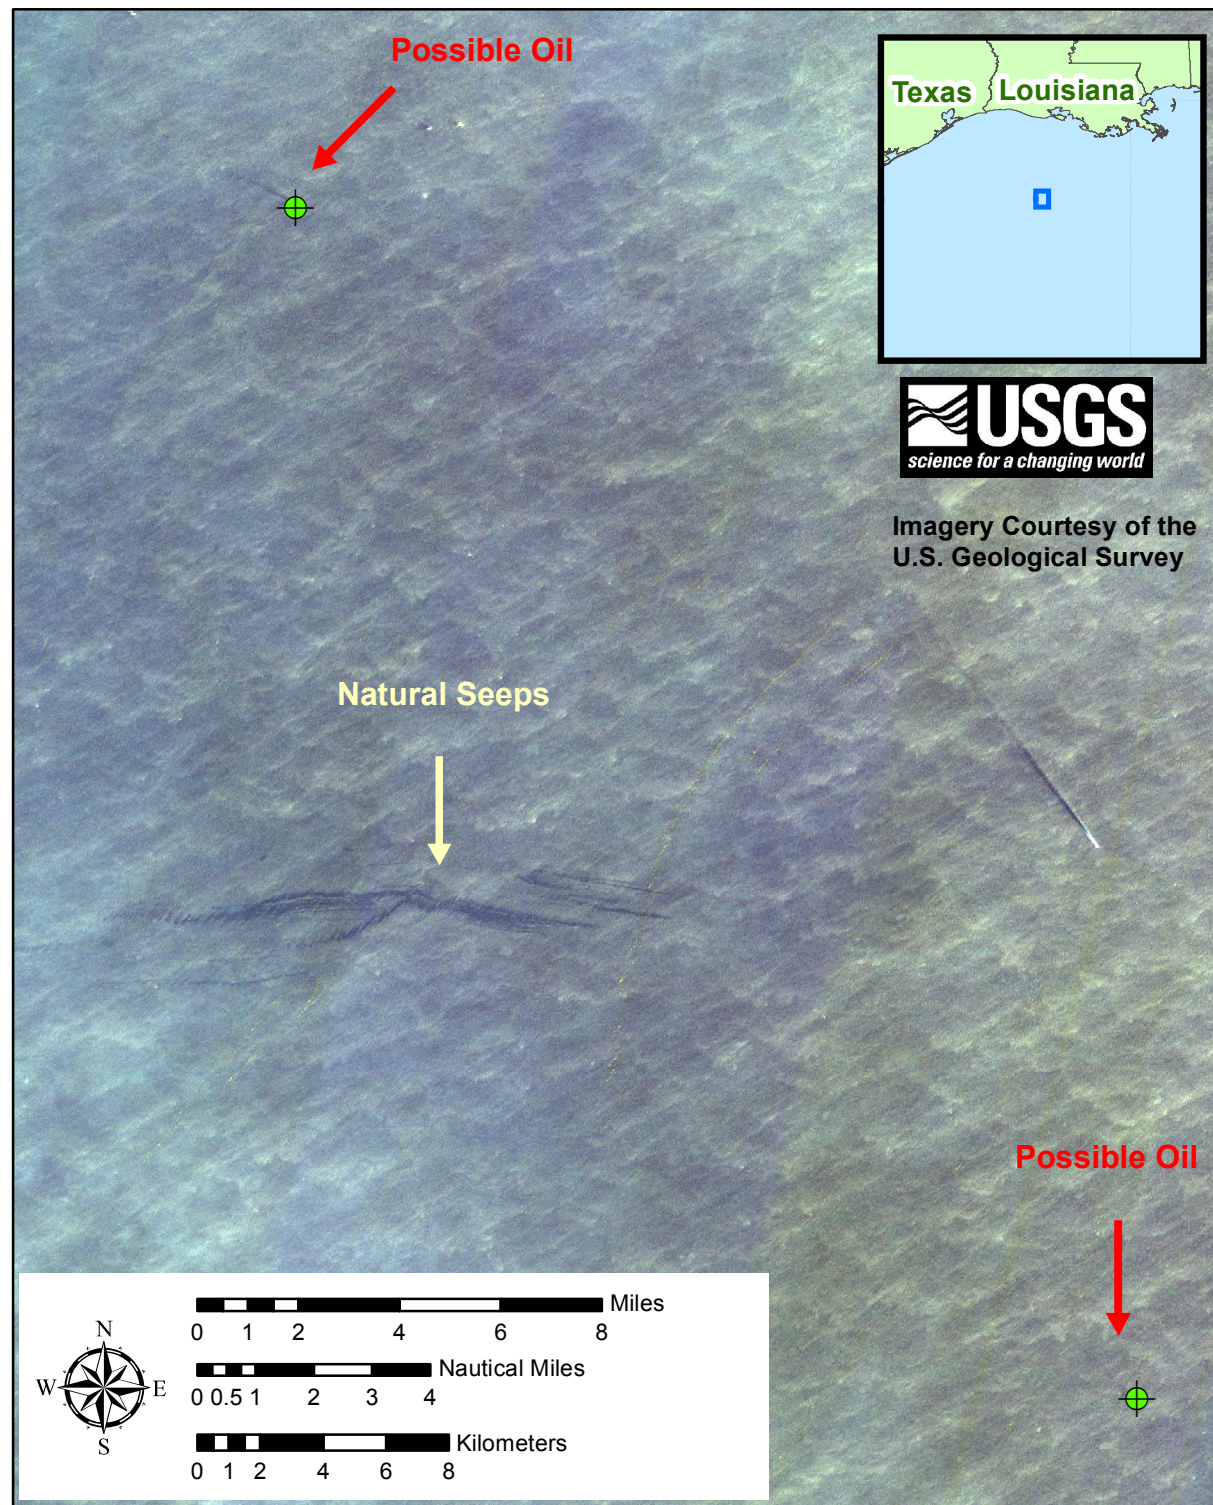
Area of Possible Oil

Confidence: Low

Two small anomalies have been detected in association with rigs in the Garden Banks area. One is in Block 426; the other in Block 783.

Both anomalies extend a short distance to the NW of the rig. This orientation was inconsistent with the surface winds which were blowing from the ENE at 10 knots at the time of the image. It is unknown whether the orientation of the anomaly was consistent with currents because model forecast ocean currents were not available. For these reasons confidence that the anomalies are oil is low.
