# MARINE POLLUTION SURVEILLANCE REPORT

REPORT DATE: OCTOBER 28, 2014

Destroyed Taylor Platform :  
[ 28°56'9" N / 88°58'12" W ]

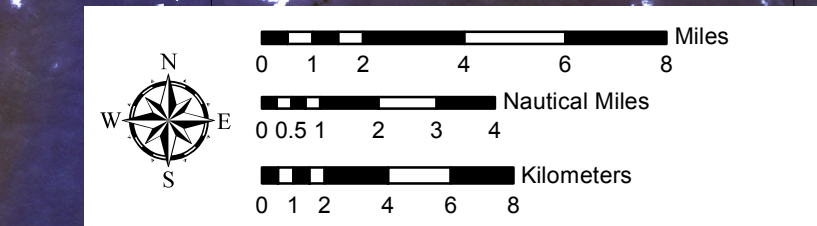
23.9 km<sup>2</sup>

Area of Possible Oil

Possible oil slick originating from the destroyed Taylor platform. The slick extends from east-northeast to west-southwest for 21.5 miles, an orientation that is supported by surface winds in the area at the time the satellite image was taken. The oil slick is 2.7 miles wide at its widest point and 0.1 miles wide at its narrowest. The oil has a silvery and black appearance, exhibits a feathering signature, and tested negative for vegetation when false color image analysis was conducted.
