MARINE POLLUTION SURVEILLANCE REPORT

Analysis Provided by: The National Oceanic and
Atmospheric Administration/National Environmental
Satellite, Data and Information Service (NOAA/NESDIS)

REPORT DATE: SEPTEMBER 10, 2014
REPORT TIME: 1035Z (0535 CDT)
ANALYST: GALLINA

DATA SOURCE: LANDSAT-8 OLI
MODE: Multispectral
RESOLUTION: 30 meter
IMAGE DATE/TIME: 9/9/2014 1626Z (1126 CDT)

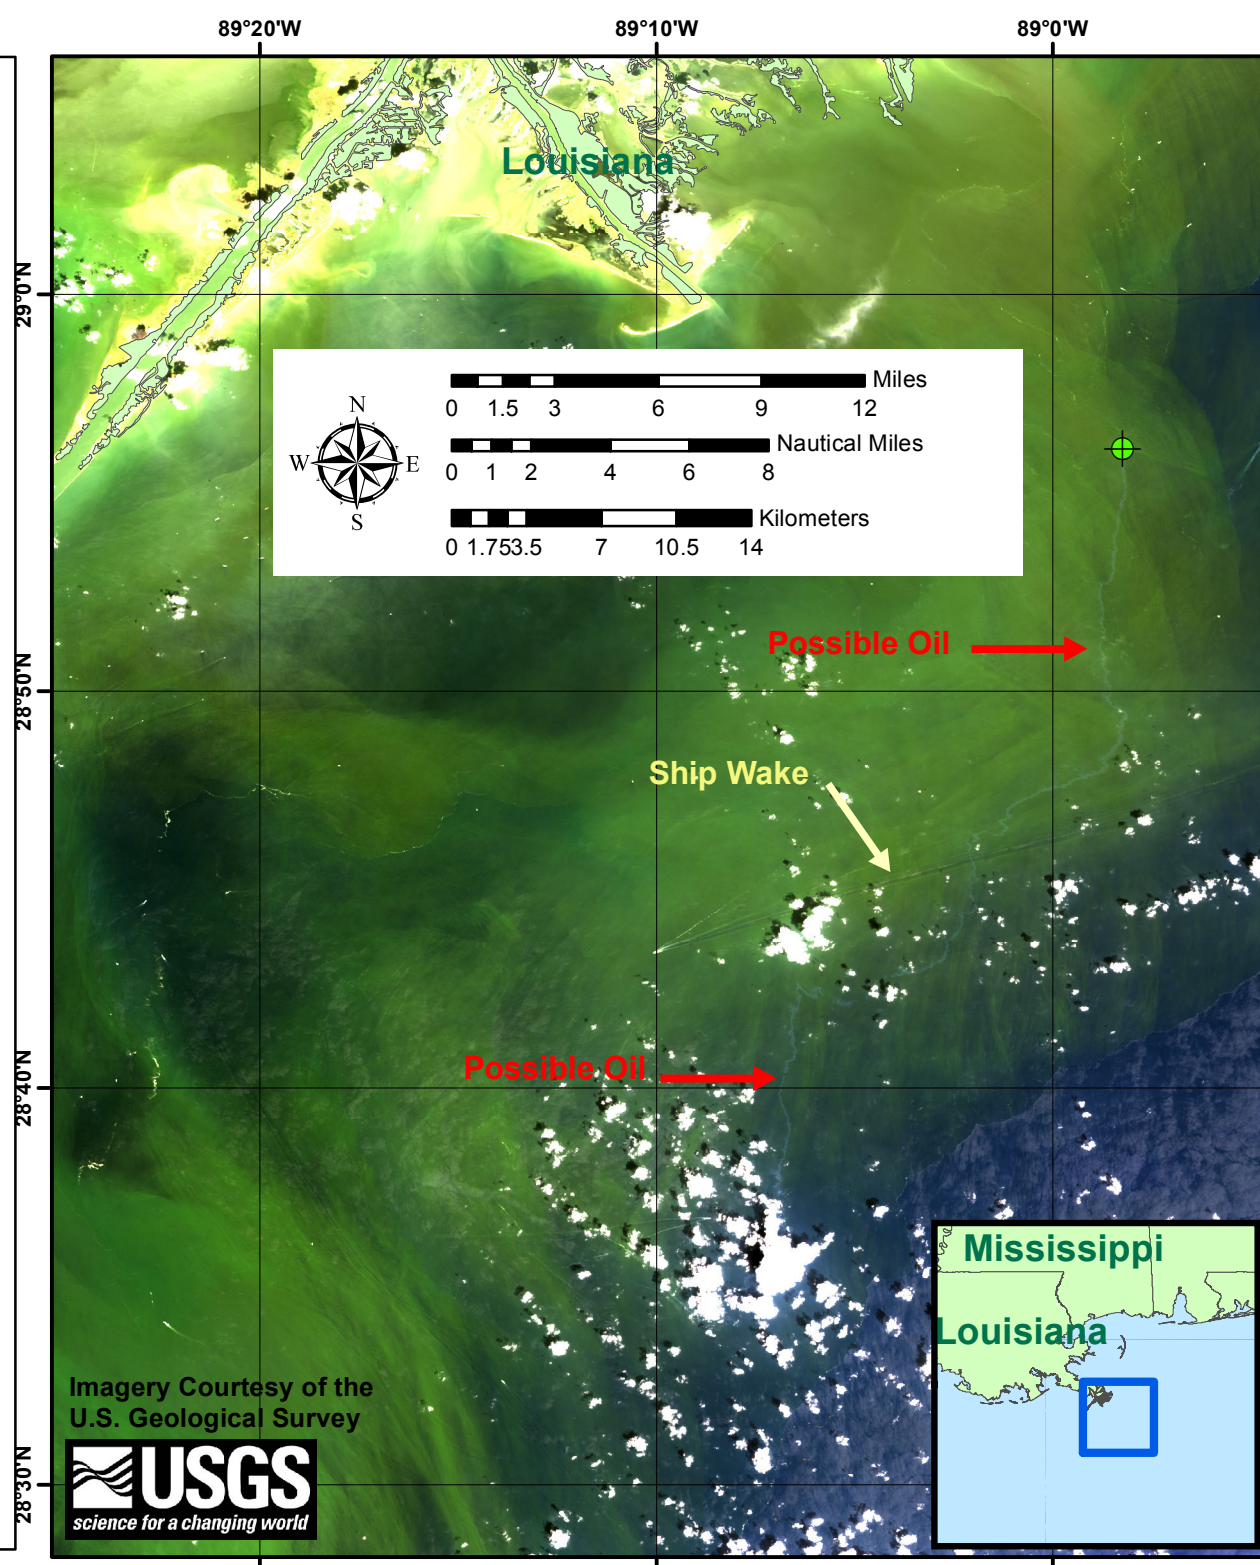
Destroyed Taylor Platform :
[28°56'9" N / 88°58'12" W]
-

6.6 km² Area of Possible Oil

Confidence: High

Oil slick from Destroyed Taylor platform is about 23 miles long but on average .1 miles wide and snakes between 12 miles SE of the South Pass of the Mississippi River (near the source) to 27 miles due S of the South Pass. Lack of dispersal is likely due to very weak winds. Slick appears silvery in color and is distinctive against background color. A false positive dark feature bisects the slick and is related to a passing ship's wake
