MARINE POLLUTION SURVEILLANCE REPORT

Analysis Provided by: The National Oceanic and
Atmospheric Administration/National Environmental
Satellite, Data and Information Service (NOAA/NESDIS)

REPORT DATE: APRIL 04, 2015
REPORT TIME: 2248Z (1748 CDT)
ANALYST: WARREN

DATA SOURCE: WORLDVIEW-1
MODE: Panchromatic
RESOLUTION: 0.46 meter
IMAGE DATE/TIME: 4/2/2015 1751Z (1251 CDT)

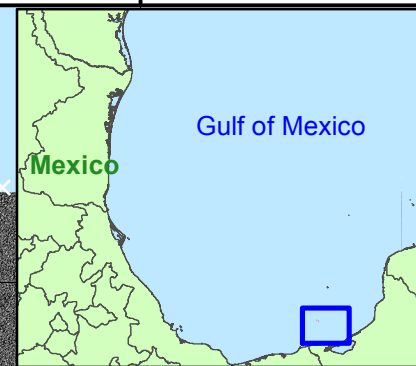
5.6 km² Area of Possible Oil

CONFIDENCE: Medium-High

A small, elongated anomaly has been detected in the vicinity of a reported oil rig explosion in Mexico's eastern Bay of Campeche. The anomaly extends out to the northwest of the rig site 6.4 miles long with a width upwards of 0.4 miles. The western portion of the anomaly may extend farther, due to edge of image. Sky conditions were mostly clear, a few thin high clouds over site location.

The dimensions and orientation of the anomaly analyzed in this report is very similar to the one issued using satellite imagery on April 1.
