MARINE POLLUTION SURVEILLANCE REPORT

Analysis Provided by: The National Oceanic and
Atmospheric Administration/National Environmental
Satellite, Data and Information Service (NOAA/NESDIS)

REPORT DATE: APRIL 06, 2015

Destroyed Taylor Platform :
[28°56'9" N / 88°58'12" W]
-

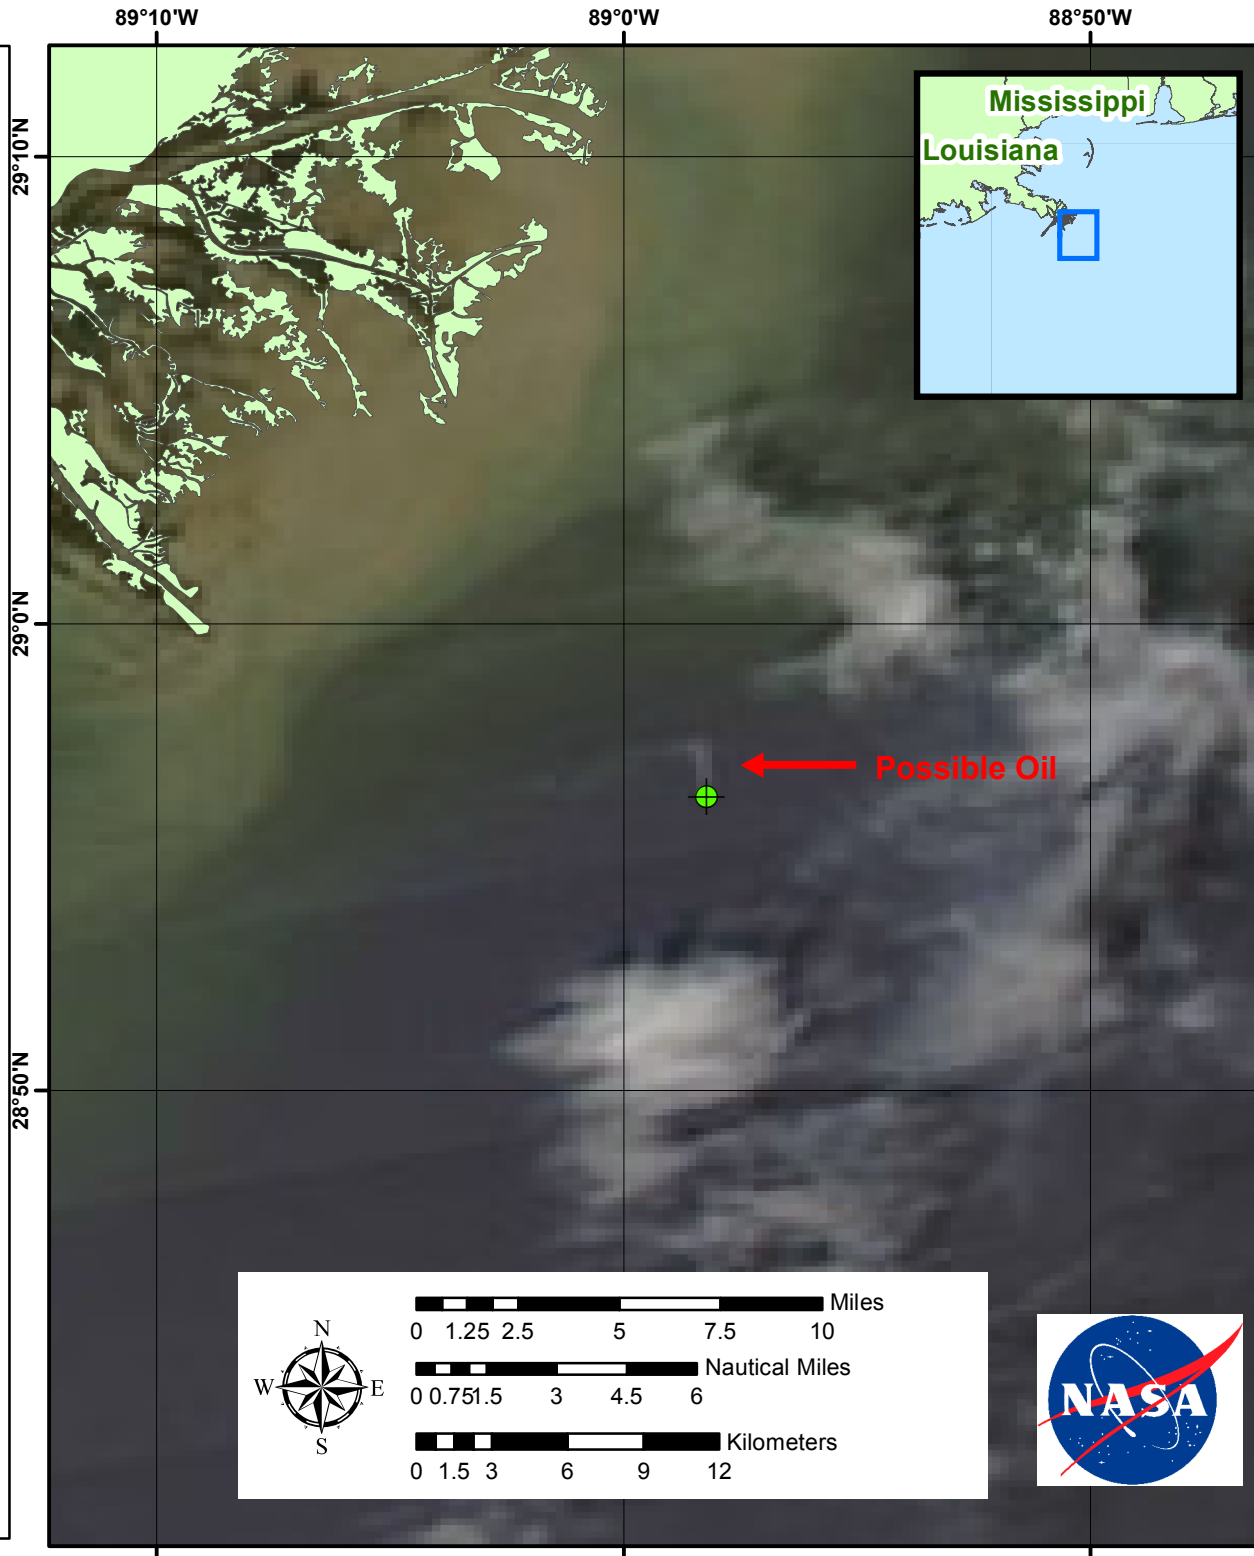
9.2 km² Area of Possible Oil

CONFIDENCE: High

Possible oil slick seen radiating from the location of the destroyed Taylor platform, a source of repeat oil leaks. The slick is silvery in sun glint, is 5 miles long and 1 mile wide. It is located 10.5 miles southeast of the Birdfoot Delta and its orientation is supported by the direction of currents in the area and easterly winds.
