MARINE POLLUTION SURVEILLANCE REPORT

Analysis Provided by: The National Oceanic and
Atmospheric Administration/National Environmental
Satellite, Data and Information Service (NOAA/NESDIS)

REPORT DATE: APRIL 21, 2015
REPORT TIME: 2345Z (1845 CDT)
ANALYST: TURK

DATA SOURCE: AQUA MODIS
MODE: Multispectral
RESOLUTION: 250 meter
IMAGE DATE/TIME: 4/21/2015 1905Z (1405 CDT)

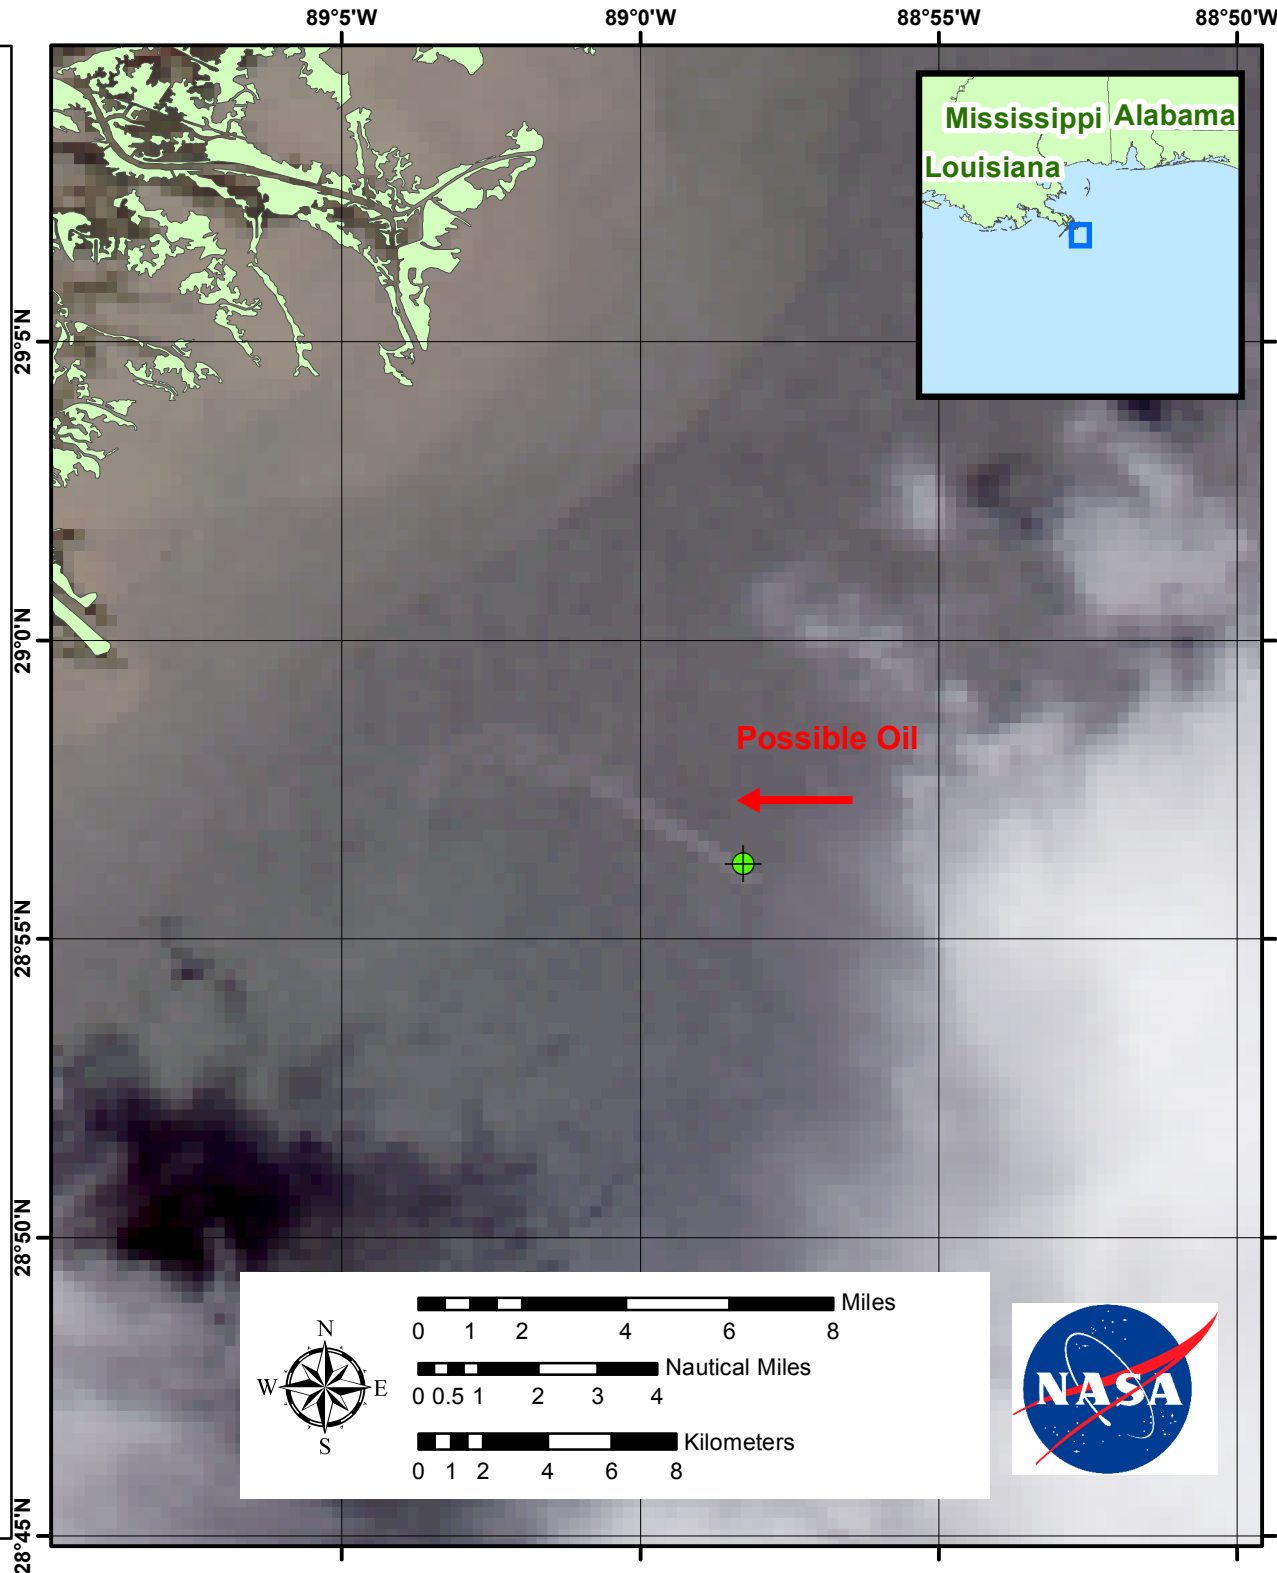
Destroyed Taylor Platform :
[28°56'9" N / 88°58'12" W]
-

3.8 km² Area of Possible Oil

CONFIDENCE: High

An oil slick extended 3 miles to the northwest of the
destroyed Taylor platform. The slick was up to 0.4 miles
wide.

Sky conditions were partly cloudy and winds were from
the east-northeast at 15-20 knots at the time of the
image.
