# MARINE POLLUTION SURVEILLANCE REPORT

Analysis Provided by: The National Oceanic and  
Atmospheric Administration/National Environmental  
Satellite, Data and Information Service (NOAA/NESDIS)

REPORT DATE: APRIL 30, 2015  
REPORT TIME: 2020Z (1520 CDT)  
ANALYST: TURK

DATA SOURCE: AQUA MODIS  
MODE: Multispectral  
RESOLUTION: 250 meter  
IMAGE DATE/TIME: 4/30/2015 1900Z (1400 CDT)

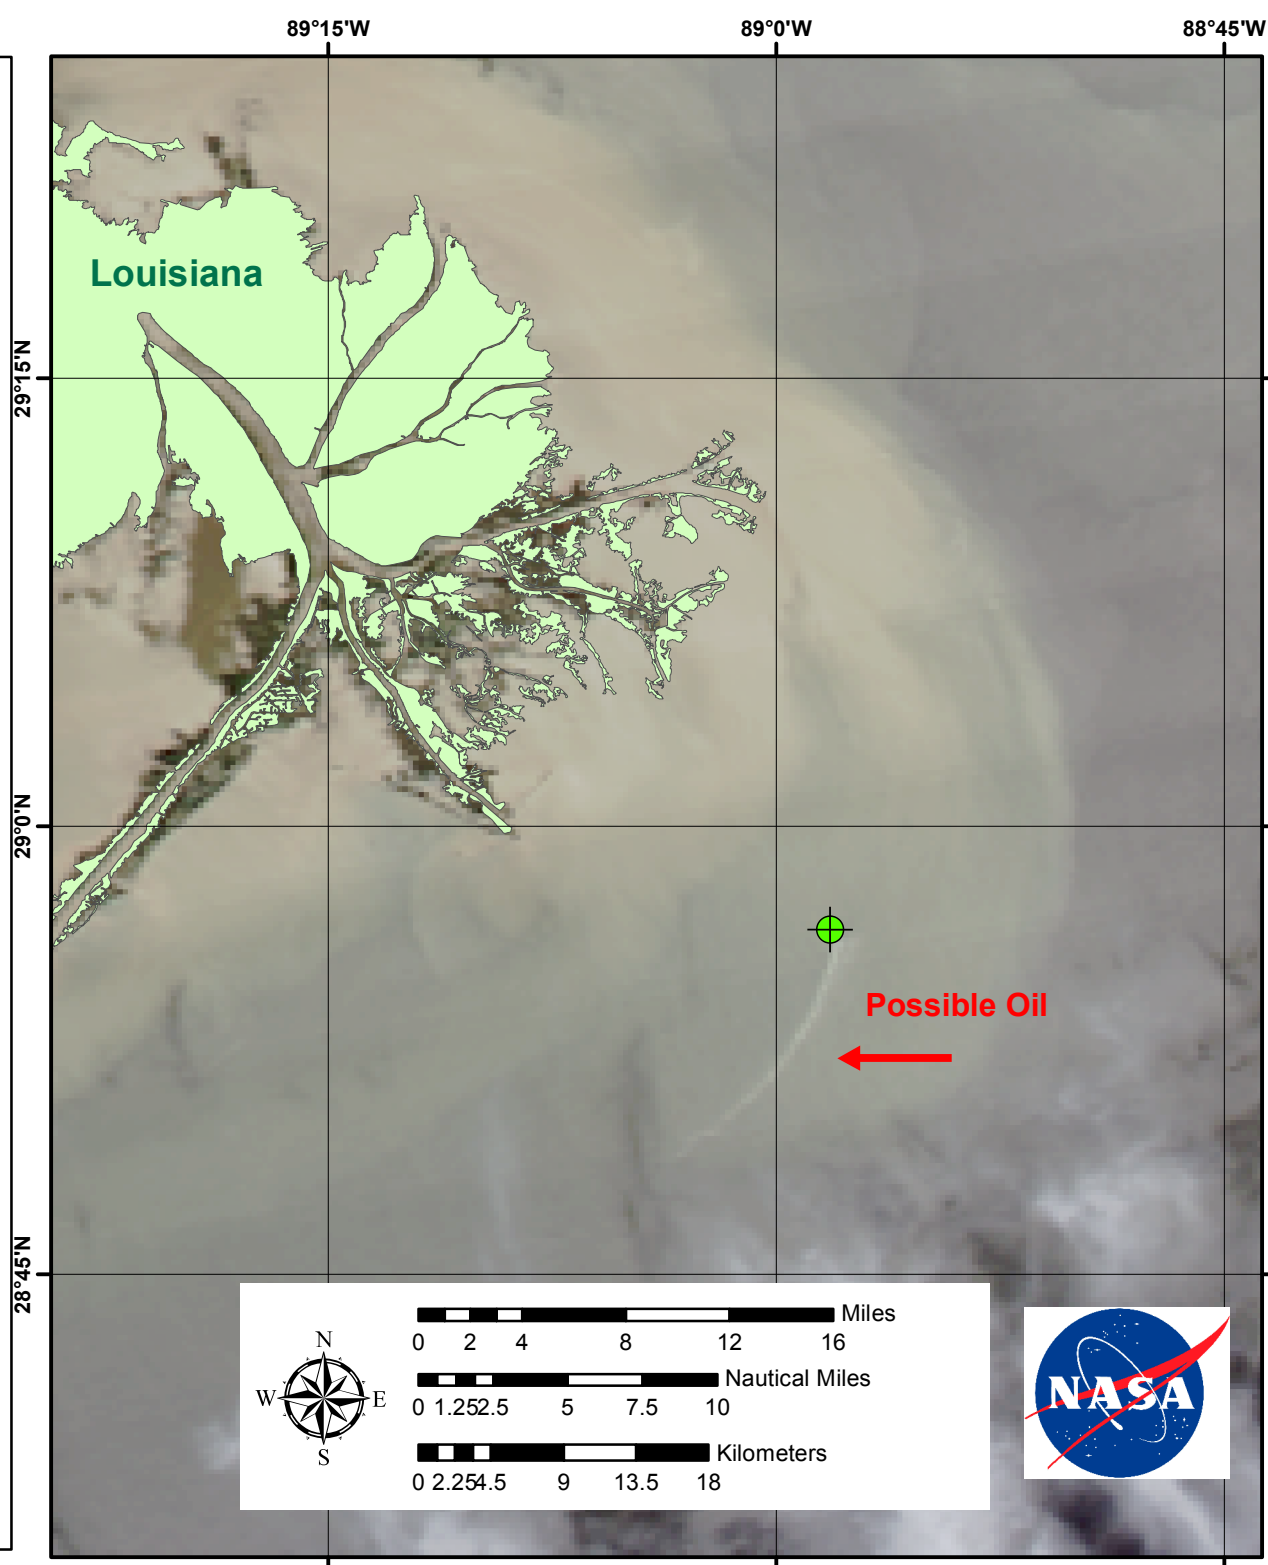
Destroyed Taylor Platform :  
[ 28°56'9" N / 88°58'12" W ]
-

13.6 km<sup>2</sup> Area of Possible Oil

**CONFIDENCE: High**

An oil slick extended 10 miles to the southwest of the  
destroyed Taylor platform. The slick was up to 0.5 mile  
wide.

Sky conditions were mostly clear and winds were from  
the northwest at 10 knots at the time of the image.  
Forecast model ocean currents were from the northeast,  
which is consistent with the orientation of the slick.
