MARINE POLLUTION SURVEILLANCE REPORT

Analysis Provided by: The National Oceanic and
Atmospheric Administration/National Environmental
Satellite, Data and Information Service (NOAA/NESDIS)

REPORT DATE: AUGUST 10, 2015
REPORT TIME: 2015Z (1515 CDT)
ANALYST: KEMAL

Destroyed Taylor Platform :
[28°56'9" N / 88°58'12" W]
-

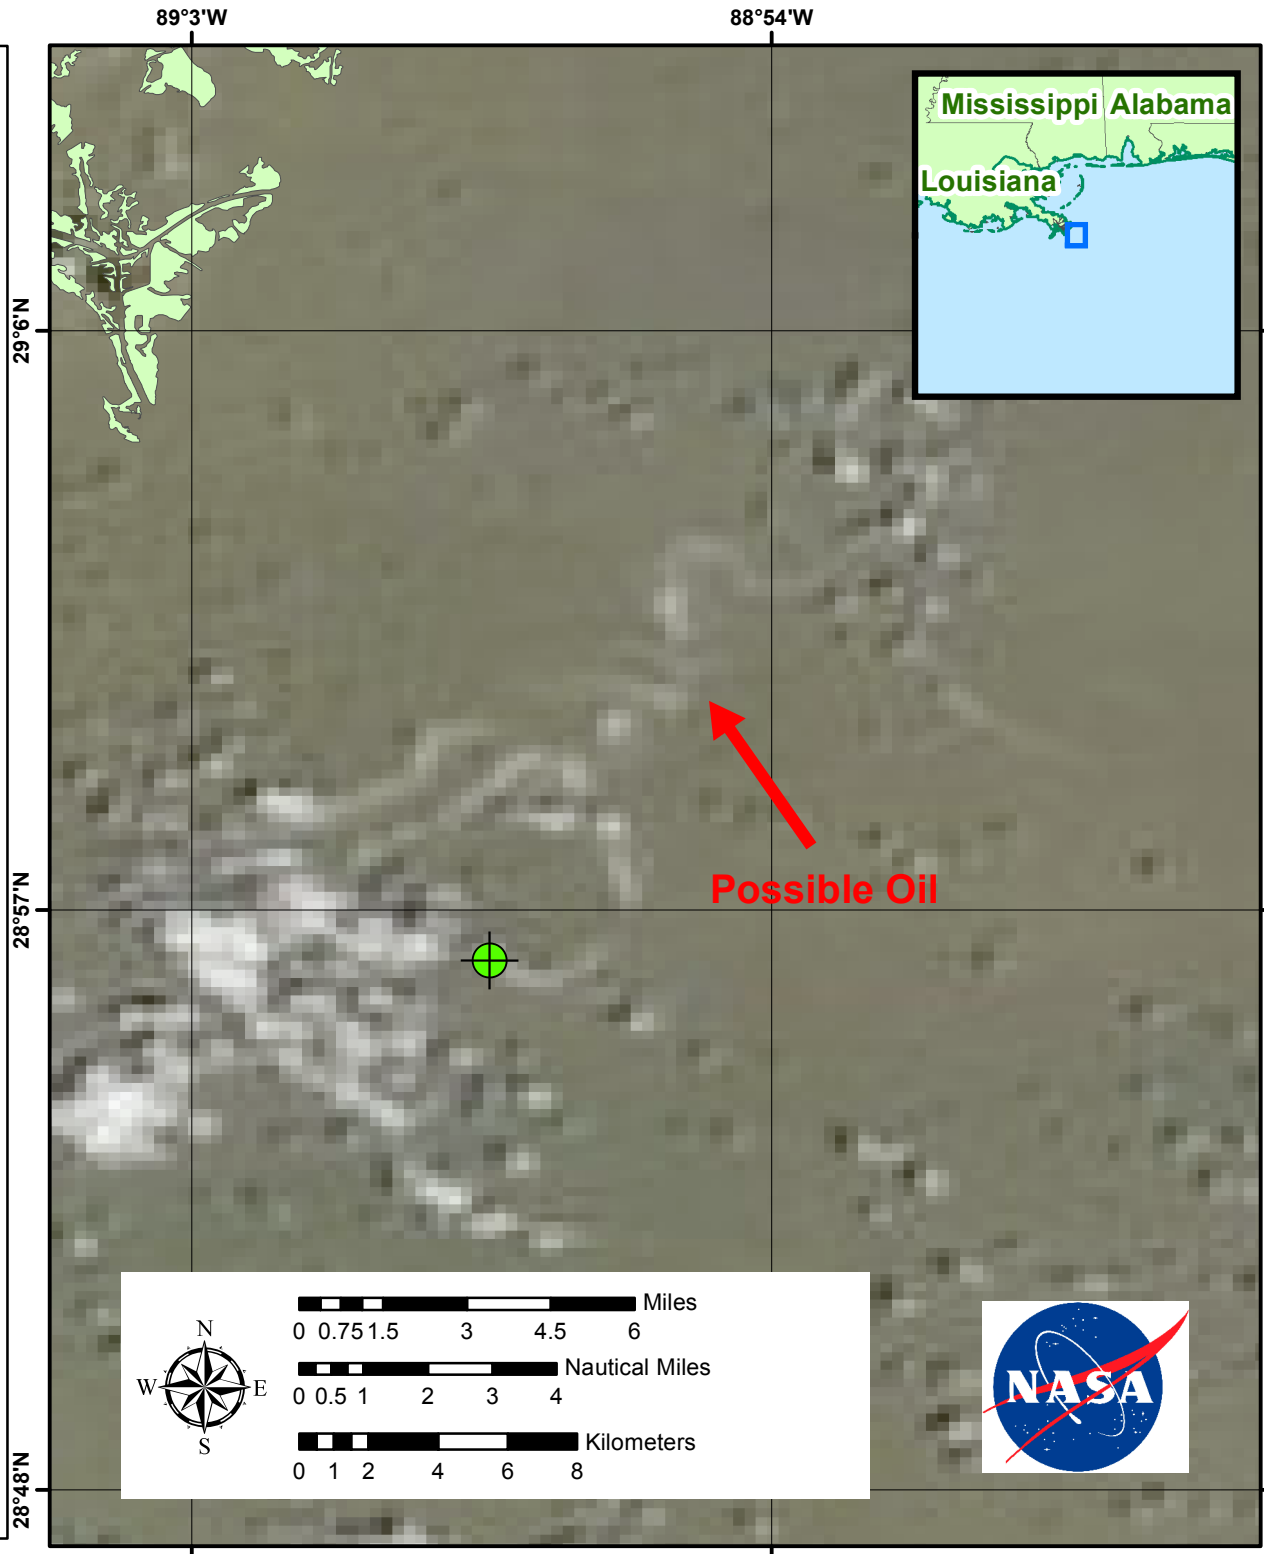
Area of Possible Oil

CONFIDENCE: High

The anomaly seen in the imagery is in sun glint and has a very faint grey feature located near the repeating leak source, the Destroyed Taylor Platform. There was an NRC Notification #1125245 reported about the slick. In the report it indicated the slick was seen moving east of the platform, which our imagery and the wind speed and direction supports. The length of the anomaly identified by the over flight assessment is 16.6 miles with a width of 7.3 miles, but based on our analysis, we were able to see a 22 miles long slick with a maximum width of 1.1 miles.
