MARINE POLLUTION SURVEILLANCE REPORT

REPORT DATE: AUGUST 20, 2015
REPORT TIME: 2315Z (1815 CDT)
ANALYST: TURK

DATA SOURCE: AQUA MODIS
MODE: Multispectral
RESOLUTION: 250 meter
IMAGE DATE/TIME: 8/20/2015 1900Z (1400 CDT)

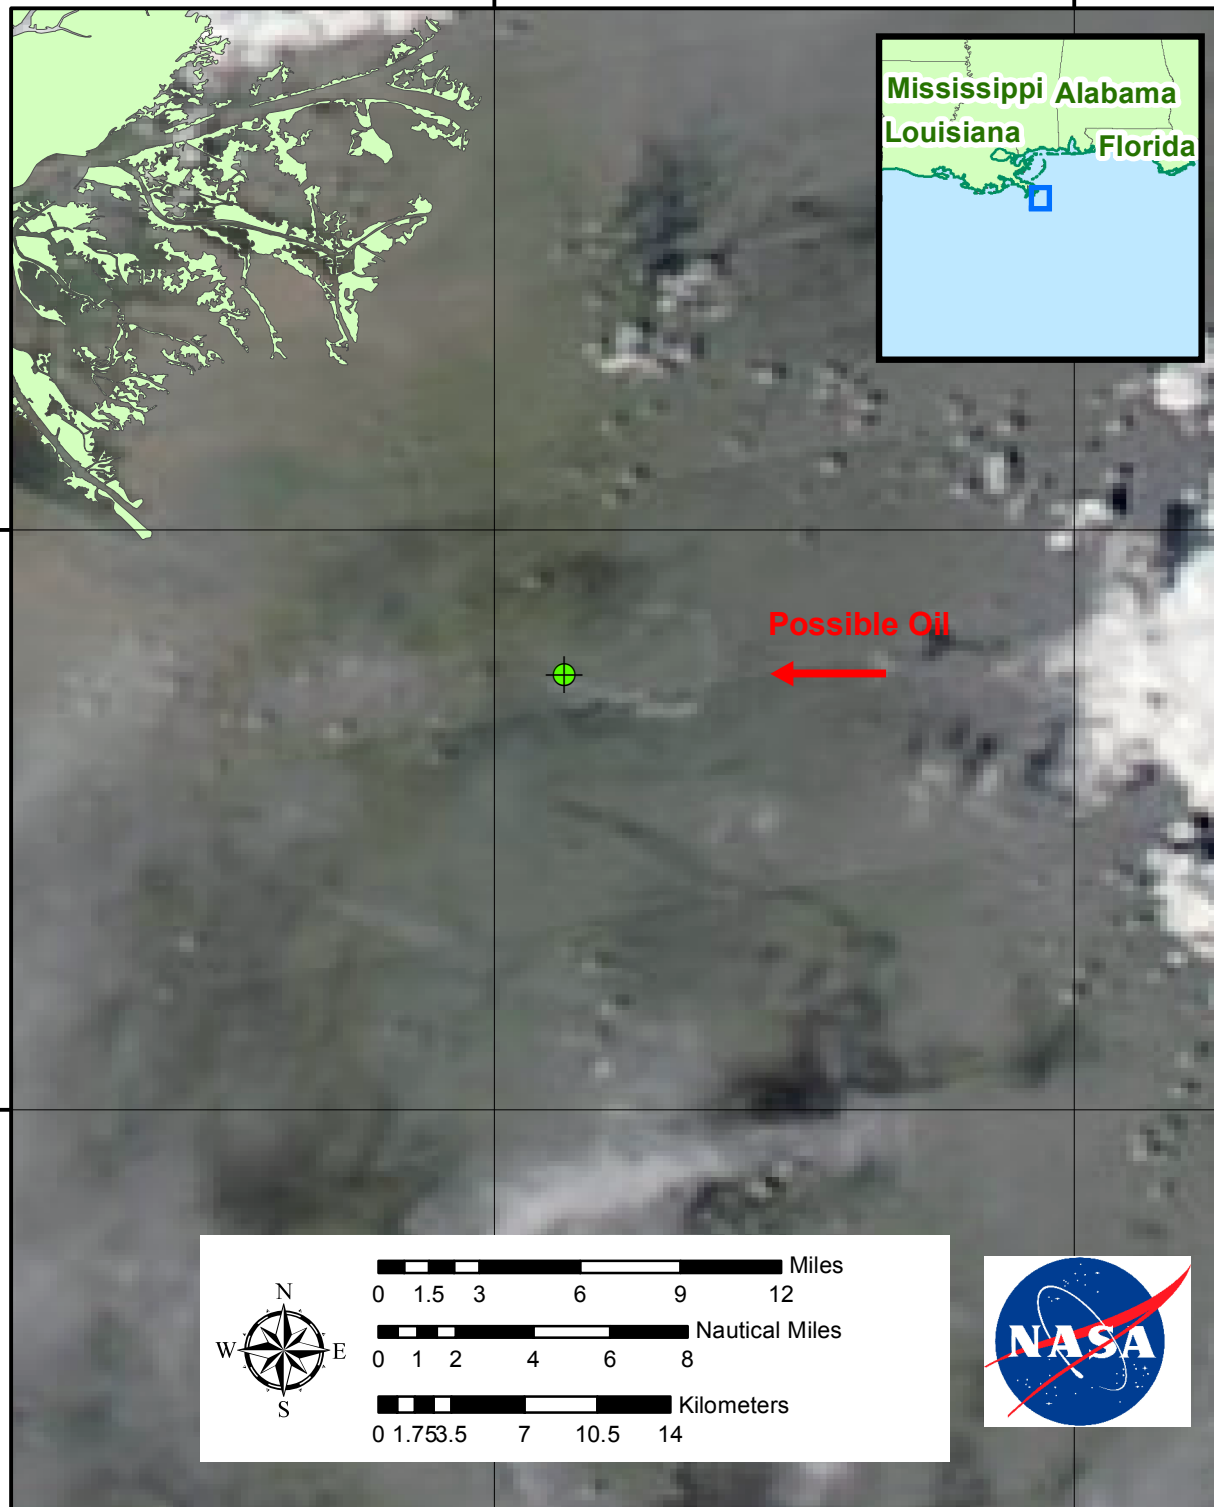
Destroyed Taylor Platform :
[28°56'9" N / 88°58'12" W]
-

Area of Possible Oil

A slick from the destroyed Taylor platform extended 8.8 miles. Skies were partly cloudy and winds were light from the southwest at 5 knots at the time of the image.

Confidence is high given that this is a known repeat leak source and the anomaly appears silvery in sun glint.
