MARINE POLLUTION SURVEILLANCE REPORT

Analysis Provided by: The National Oceanic and
Atmospheric Administration/National Environmental
Satellite, Data and Information Service (NOAA/NESDIS)

REPORT DATE: AUGUST 26, 2015
REPORT TIME: 2134Z (1634 CDT)
ANALYST: JANKOT

DATA SOURCE: TERRA MODIS
MODE: Multispectral
RESOLUTION: 250 meter
IMAGE DATE/TIME: 8/26/2015 1650Z (1150 CDT)

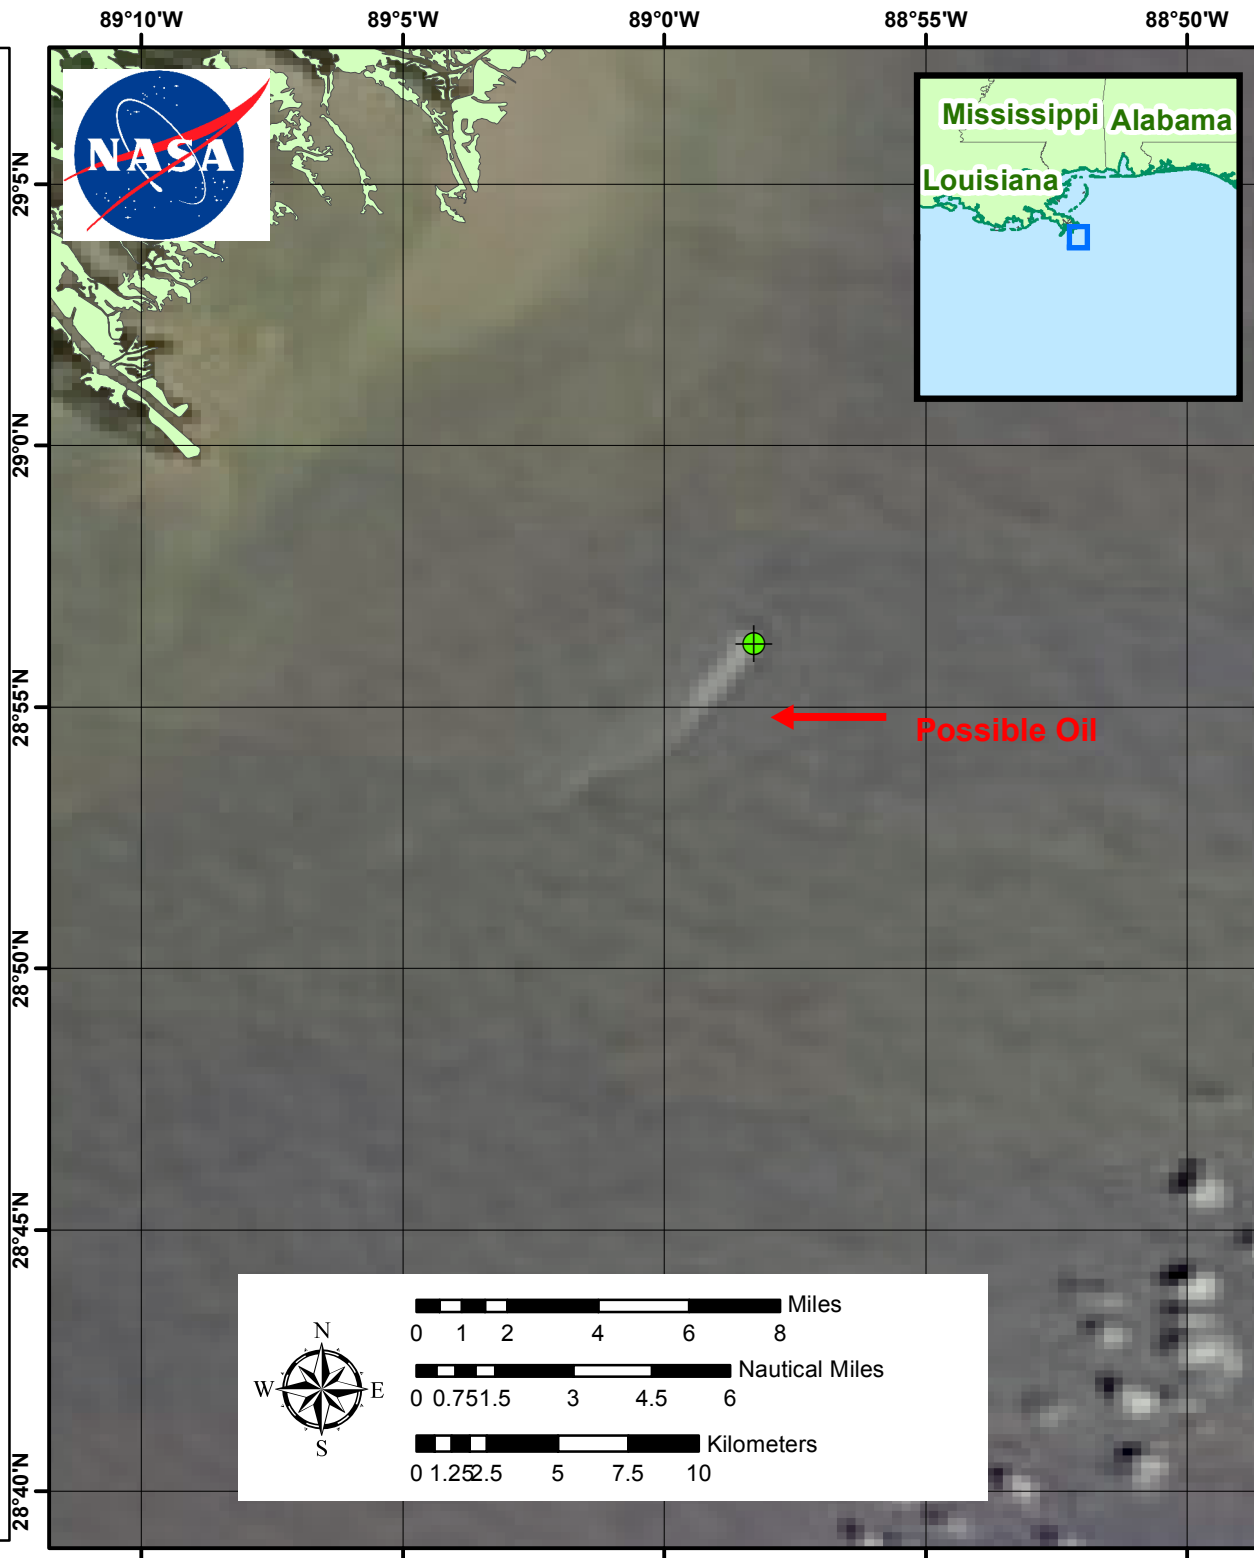
Area of Possible Oil

CONFIDENCE: High

Anomaly is connected to the Destroyed Taylor Platform,
a repeat leak source. Anomaly appears white in color, a
common oil signature in sunglint conditions. Furthermore,
surface winds were north-northeast at 5
knots and modeled ocean currents were east-northeast
at the time of image, both agreeing with the orientation of
the slick.
