# MARINE POLLUTION SURVEILLANCE REPORT

Analysis Provided by: The National Oceanic and  
Atmospheric Administration/National Environmental  
Satellite, Data and Information Service (NOAA/NESDIS)

REPORT DATE: AUGUST 28, 2015  
REPORT TIME: 0115Z (8/27/2015 2015 CDT)  
ANALYST: RAMIREZ

DATA SOURCE: LANDSAT-8 OLI  
MODE: Multispectral  
RESOLUTION: 30 meter  
IMAGE DATE/TIME: 8/27/2015 1626Z (1126 CDT)

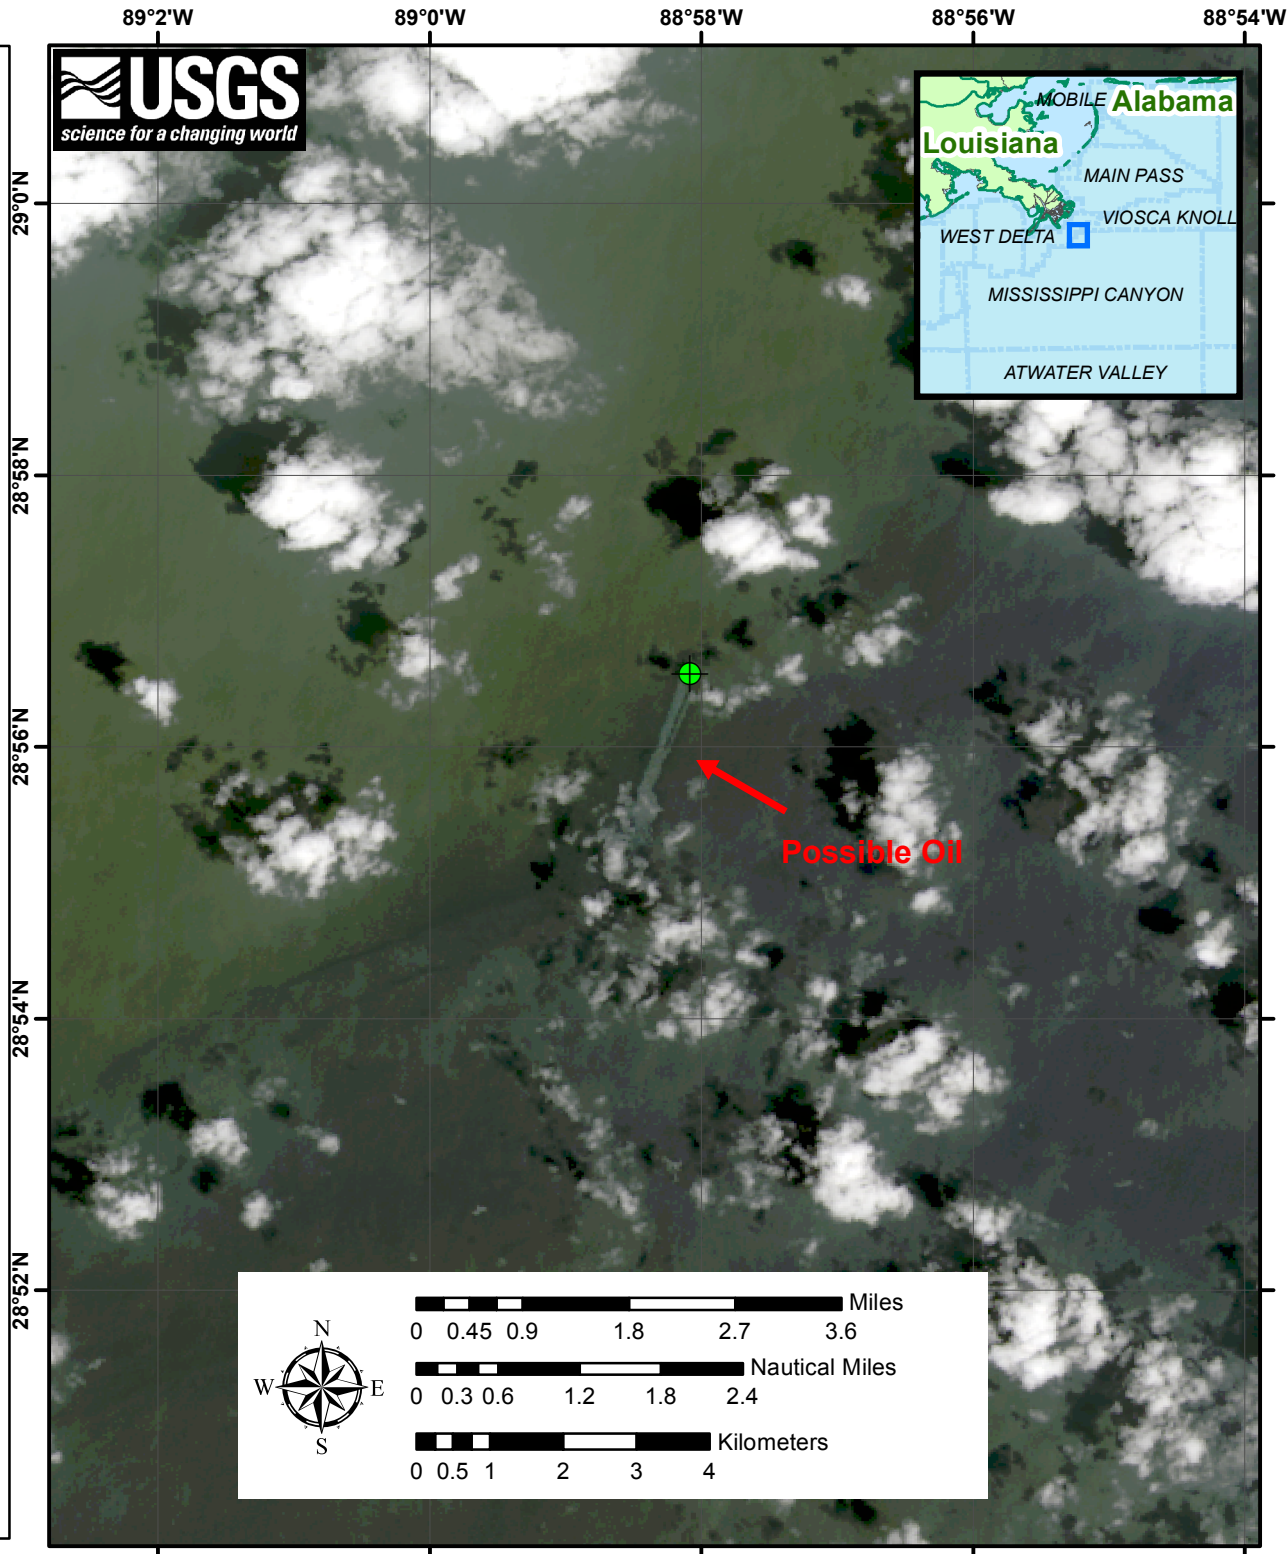
Area of Possible Oil

**CONFIDENCE: High**

Oil slick observed emanating from the destroyed Taylor Platform. Confidence is high as this is a repeat leak source. Slick is measured at 2.7km in length and 0.4km in width, but the entire extent cannot be determined due to the presence of clouds.
