# MARINE POLLUTION SURVEILLANCE REPORT

Analysis Provided by: The National Oceanic and  
Atmospheric Administration/National Environmental  
Satellite, Data and Information Service (NOAA/NESDIS)

REPORT DATE: DECEMBER 03, 2015  
REPORT TIME: 0315Z (12/2/2015 2215 EST)  
ANALYST: BOLL

Coimbra Tanker Shipwreck:  
[ 40°24'20" N / 72°22'17" W ]
-

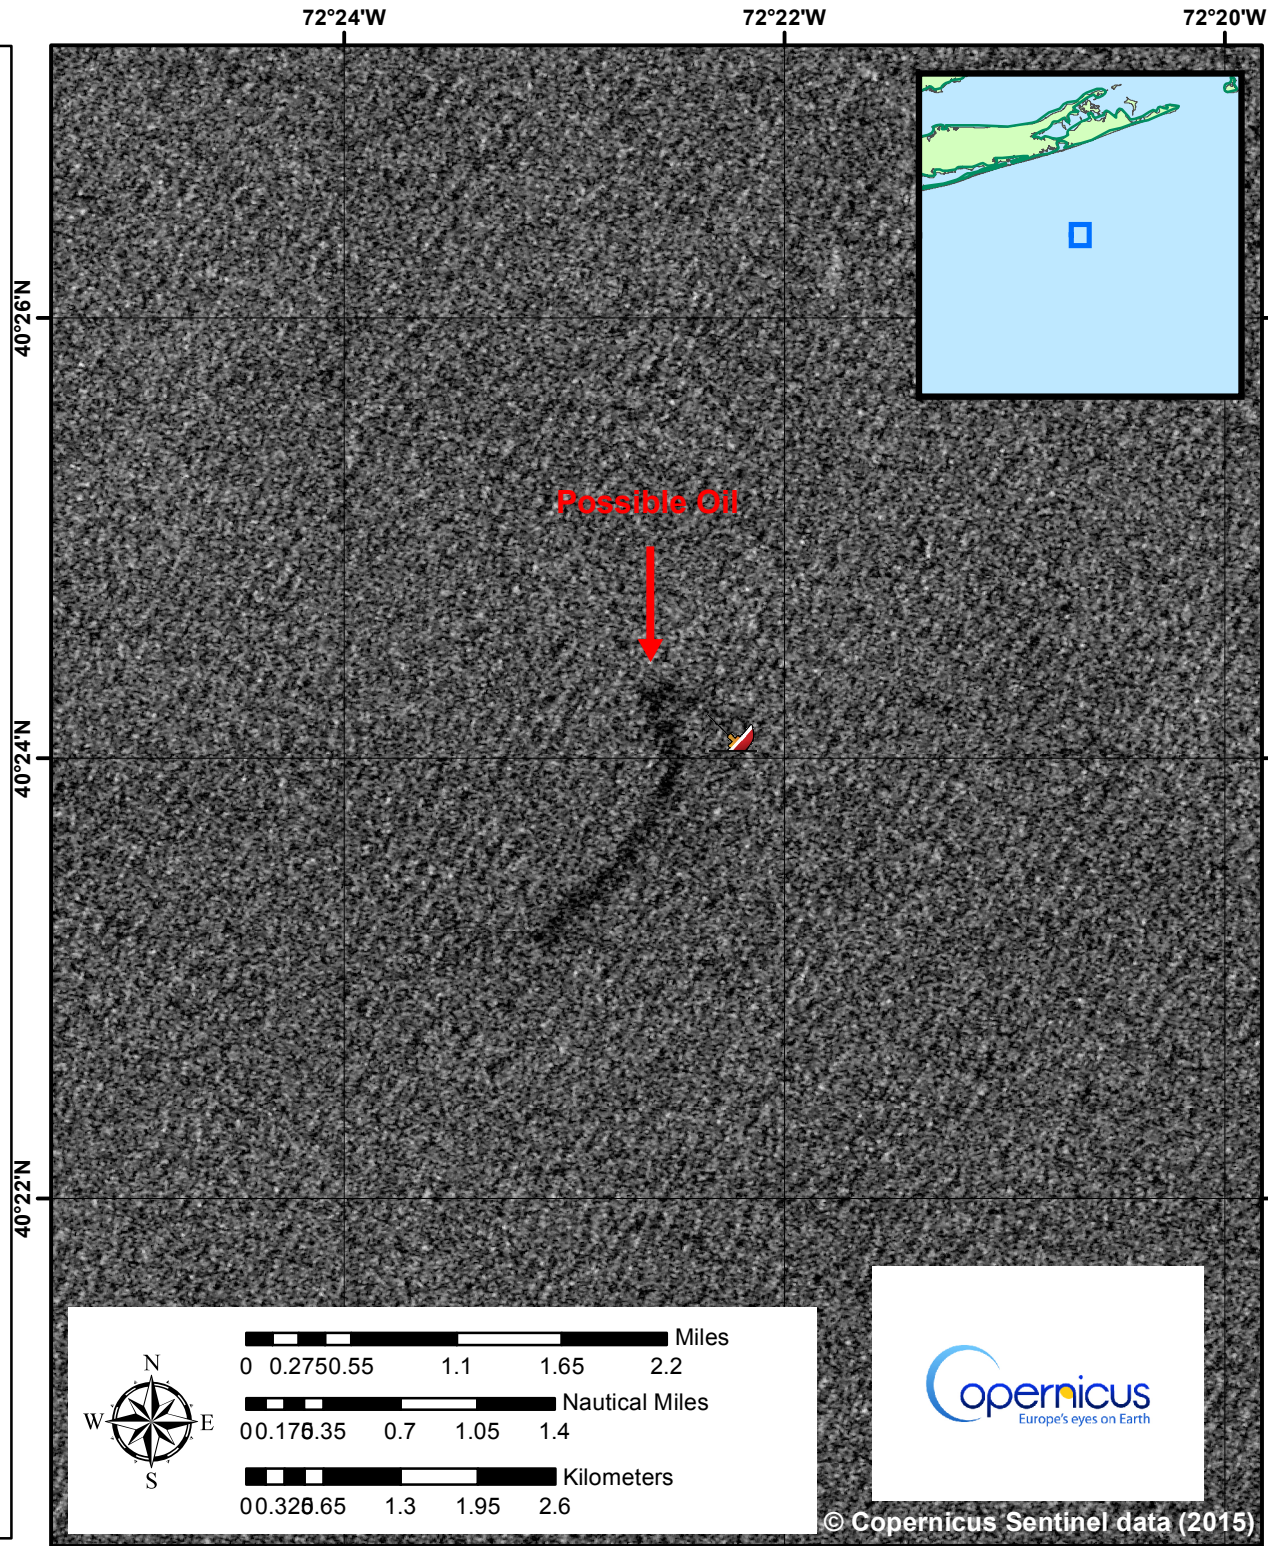
.5 km<sup>2</sup> Area of Possible Oil

A narrow oil slick extended 1.5 NM to the southwest of  
the Coimbra Tanker Shipwreck.

Winds were from the southwest at 10 knots at the time of  
the image. Mild ocean currents under 0.5 knots were  
forecasted for the same time.

Confidence was high given that this is a known leak  
source.
