MARINE POLLUTION SURVEILLANCE REPORT

Analysis Provided by: The National Oceanic and
Atmospheric Administration/National Environmental
Satellite, Data and Information Service (NOAA/NESDIS)

REPORT DATE: DECEMBER 05, 2015
REPORT TIME: 1615Z (1015 CST)
ANALYST: SHEFFLER

DATA SOURCE: RADARSAT-2
MODE: ScanSAR Wide VV
RESOLUTION: 100 meter (wide)
IMAGE DATE/TIME: 12/5/2015 1147Z (0547 CST)

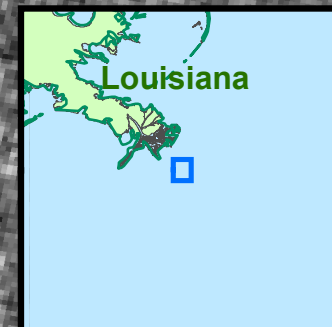
1.9 km² Area of Possible Oil

CONFIDENCE: High

An area of possible oil is seen extending to the SW from the site of the Destroyed Taylor platform, a known repeat leak source. The oil stretches approximately 3 miles from the source point with the width of the sheen varying between 0.25-0.5 mile. Winds were out of the ENE to NE at 16kts at the time of the image which is in agreement with the orientation of the area of possible oil. The medium wind speeds allowed for ideal conditions for oil sheen detection this morning.
