# MARINE POLLUTION SURVEILLANCE REPORT

Analysis Provided by: The National Oceanic and  
Atmospheric Administration/National Environmental  
Satellite, Data and Information Service (NOAA/NESDIS)

REPORT DATE: JULY 03, 2015  
REPORT TIME: 2120Z (1620 CDT)  
ANALYST: TURK

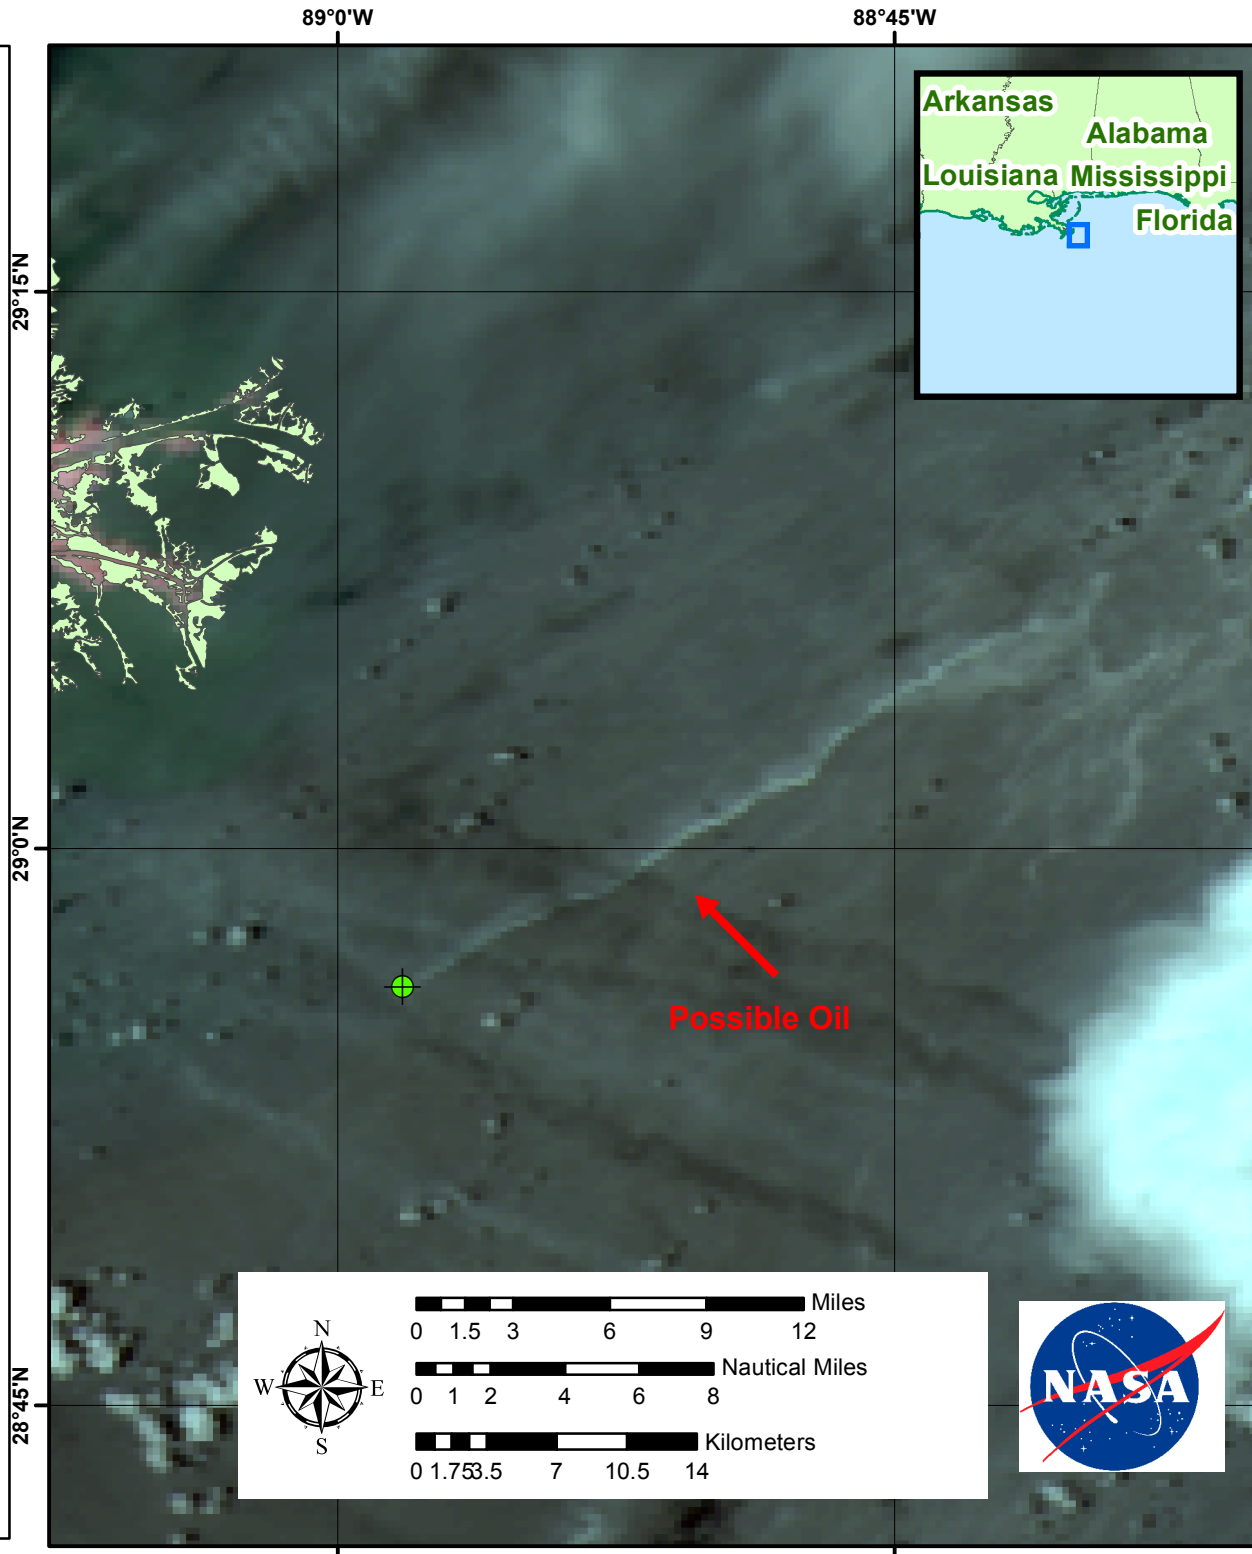
Destroyed Taylor Platform :  
[ 28°56'9" N / 88°58'12" W ]
-

44.2 km<sup>2</sup> Area of Possible Oil

An oil slick extended slightly more than 20 miles to the  
northeast of the destroyed Taylor platform.

Skies were mostly clear and winds were from the  
southwest at 5 knots at the time of the image.
