MARINE POLLUTION SURVEILLANCE REPORT

Analysis Provided by: The National Oceanic and
Atmospheric Administration/National Environmental
Satellite, Data and Information Service (NOAA/NESDIS)

REPORT DATE: JULY 03, 2015
REPORT TIME: 2250Z (1750 CDT)
ANALYST: TURK

DATA SOURCE: EO-1 ALI
MODE: Multispectral
RESOLUTION: 30 meter
IMAGE DATE/TIME: 7/3/2015 1512Z (1012 CDT)

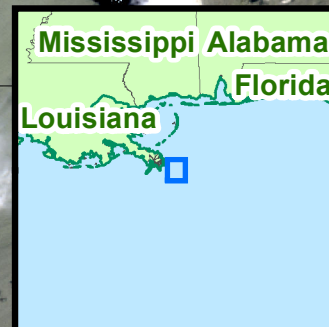
Destroyed Taylor Platform :
[28°56'9" N / 88°58'12" W]
-

39.1 km² Area of Possible Oil

CONFIDENCE: High

An oil slick extended 19.5 miles to the northeast of the
destroyed Taylor platform. The slick was up to 1.7 miles
wide.

Skies were partly cloudy and winds were from the
southwest at 5 knots at the time of the image.
