MARINE POLLUTION SURVEILLANCE REPORT

REPORT DATE: JULY 11, 2015

Destroyed Taylor Platform :
[28°56'9" N / 88°58'12" W]
-

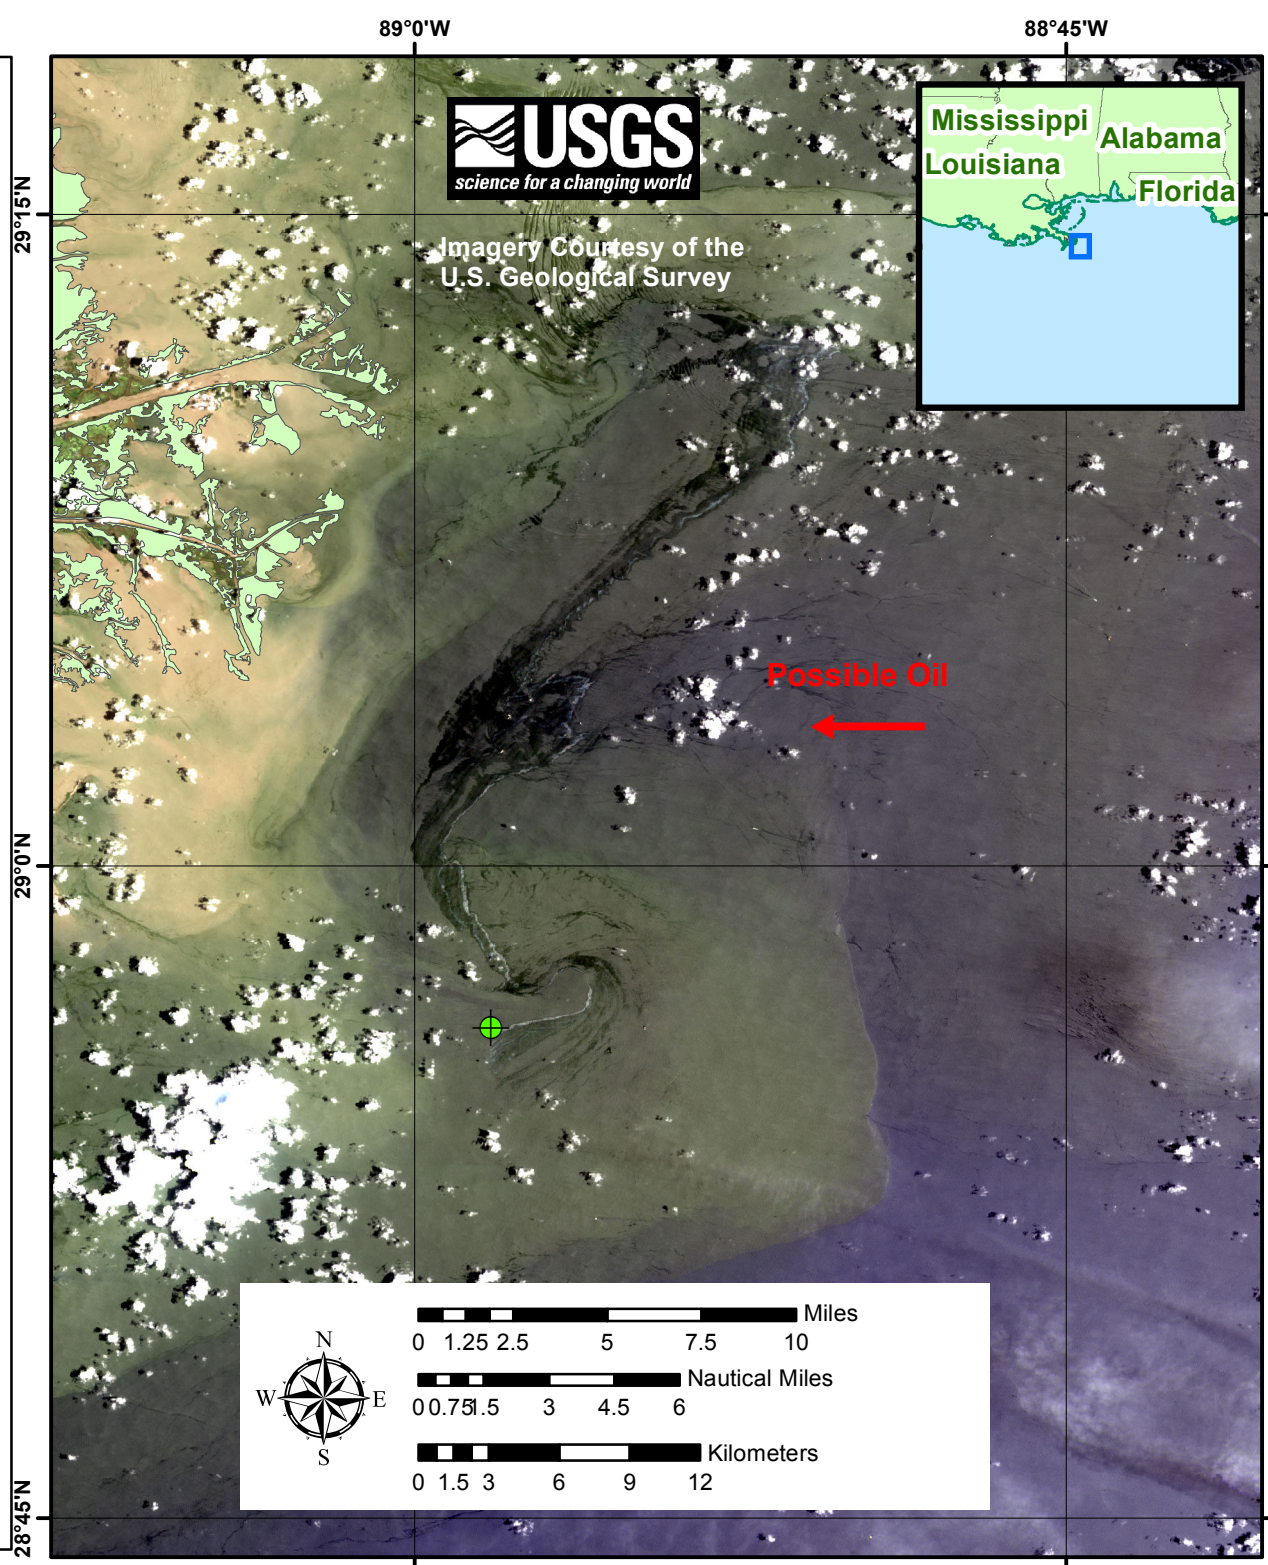
101 km² Area of Possible Oil

CONFIDENCE: Medium-High

A 26.3 mile long slick that was up to 3 miles wide was seen extending north and east from the destroyed Taylor platform. Portions of the slick appear as shimmering white, which is believed to be thicker oil; and this was the basis for the outline of the anomaly, but there remains some uncertainty as to the full extent of the slick. Hence only medium-high confidence for what is a known repeat leak source.

Sky conditions were mostly clear at the time of the image and winds were light from the east at 5 knots.
