MARINE POLLUTION SURVEILLANCE REPORT

Analysis Provided by: The National Oceanic and
Atmospheric Administration/National Environmental
Satellite, Data and Information Service (NOAA/NESDIS)

REPORT DATE: JULY 19, 2015
REPORT TIME: 2249Z (1749 CDT)
ANALYST: JANKOT

DATA SOURCE: AQUA MODIS
MODE: Multispectral
RESOLUTION: 250 meter
IMAGE DATE/TIME: 7/19/2015 1900Z (1400 CDT)

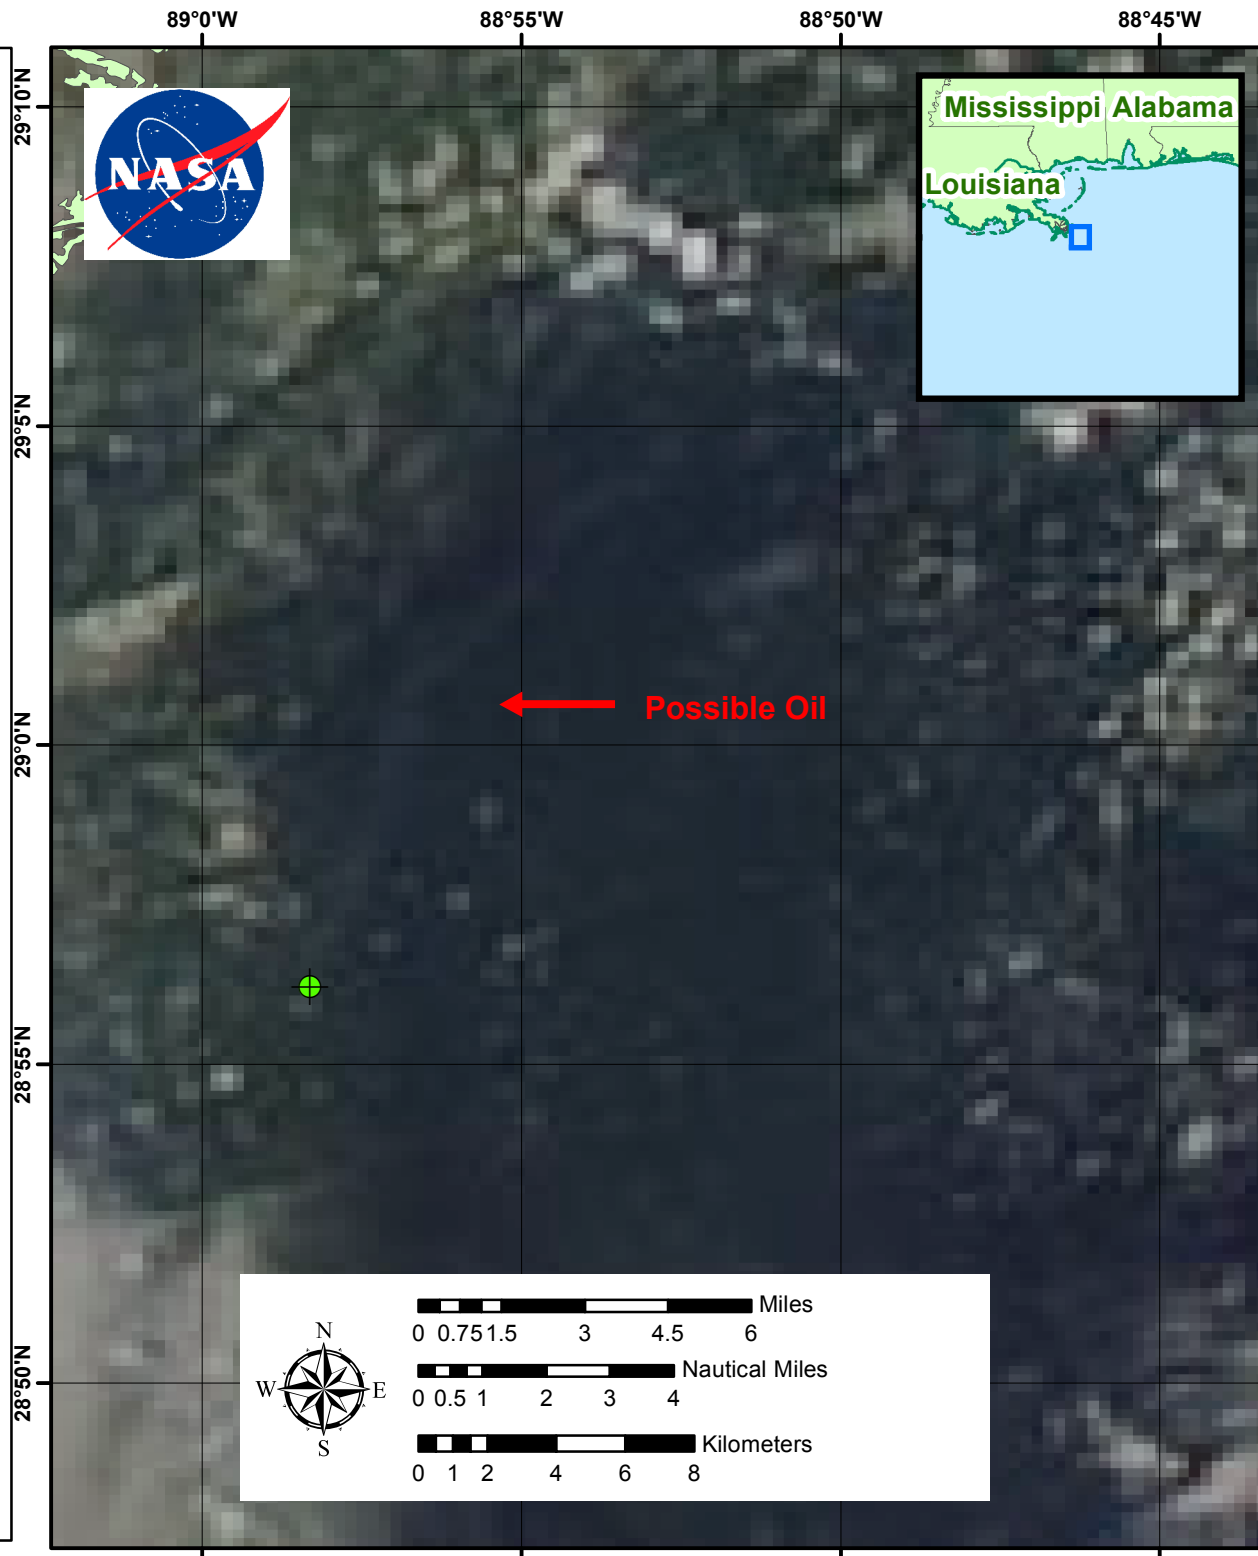
Destroyed Taylor Platform :
[28°56'9" N / 88°58'12" W]
-

14.9 km² Area of Possible Oil

CONFIDENCE: Medium

Possible oil is connected to the Destroyed Taylor Platform, a repeat leak source. Anomaly is outside of sunglint region in this image, lowering confidence. Anomaly is lighter than its surrounding and extends for approximately 10 miles to the northeast of the suspected point source. Surface winds were weak at the time of the image and modeled ocean currents were also weak. Confidence is slightly higher given that NRC report # 1123215 also reported oil seen connected to the Destroyed Taylor Platform but did not confirm orientation of the slick.
