MARINE POLLUTION SURVEILLANCE REPORT

Analysis Provided by: The National Oceanic and
Atmospheric Administration/National Environmental
Satellite, Data and Information Service (NOAA/NESDIS)

REPORT DATE: JUNE 20, 2015
REPORT TIME: 1400Z (0900 CDT)
ANALYST: KEMAL

DATA SOURCE: EO-1 ALI
MODE: Multispectral
RESOLUTION: 30 meter
IMAGE DATE/TIME: 6/19/2015 1456Z (0956 CDT)

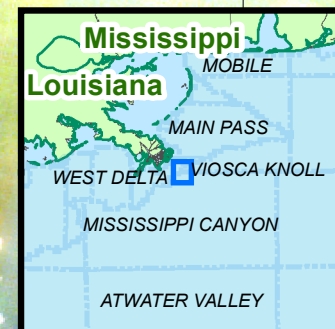
Area of Possible Oil

CONFIDENCE: High

Area of possible oil is seen extending northeast from the Destroyed Taylor Platform. The length of the anomaly is 11.69 miles with a maximum width of 0.39 miles. The direction of the slick is consistent with wind speed and direction. In the northeastern region of the slick, a small portion of the analyzed slick is obscured by cloud coverage.
