# MARINE POLLUTION SURVEILLANCE REPORT

Analysis Provided by: The National Oceanic and  
Atmospheric Administration/National Environmental  
Satellite, Data and Information Service (NOAA/NESDIS)

REPORT DATE: JUNE 30, 2015  
REPORT TIME: 1955Z (1455 CDT)  
ANALYST: VELASCO

DATA SOURCE: TERRA MODIS  
MODE: Multispectral  
RESOLUTION: 250 meter  
IMAGE DATE/TIME: 6/30/2015 1655Z (1155 CDT)

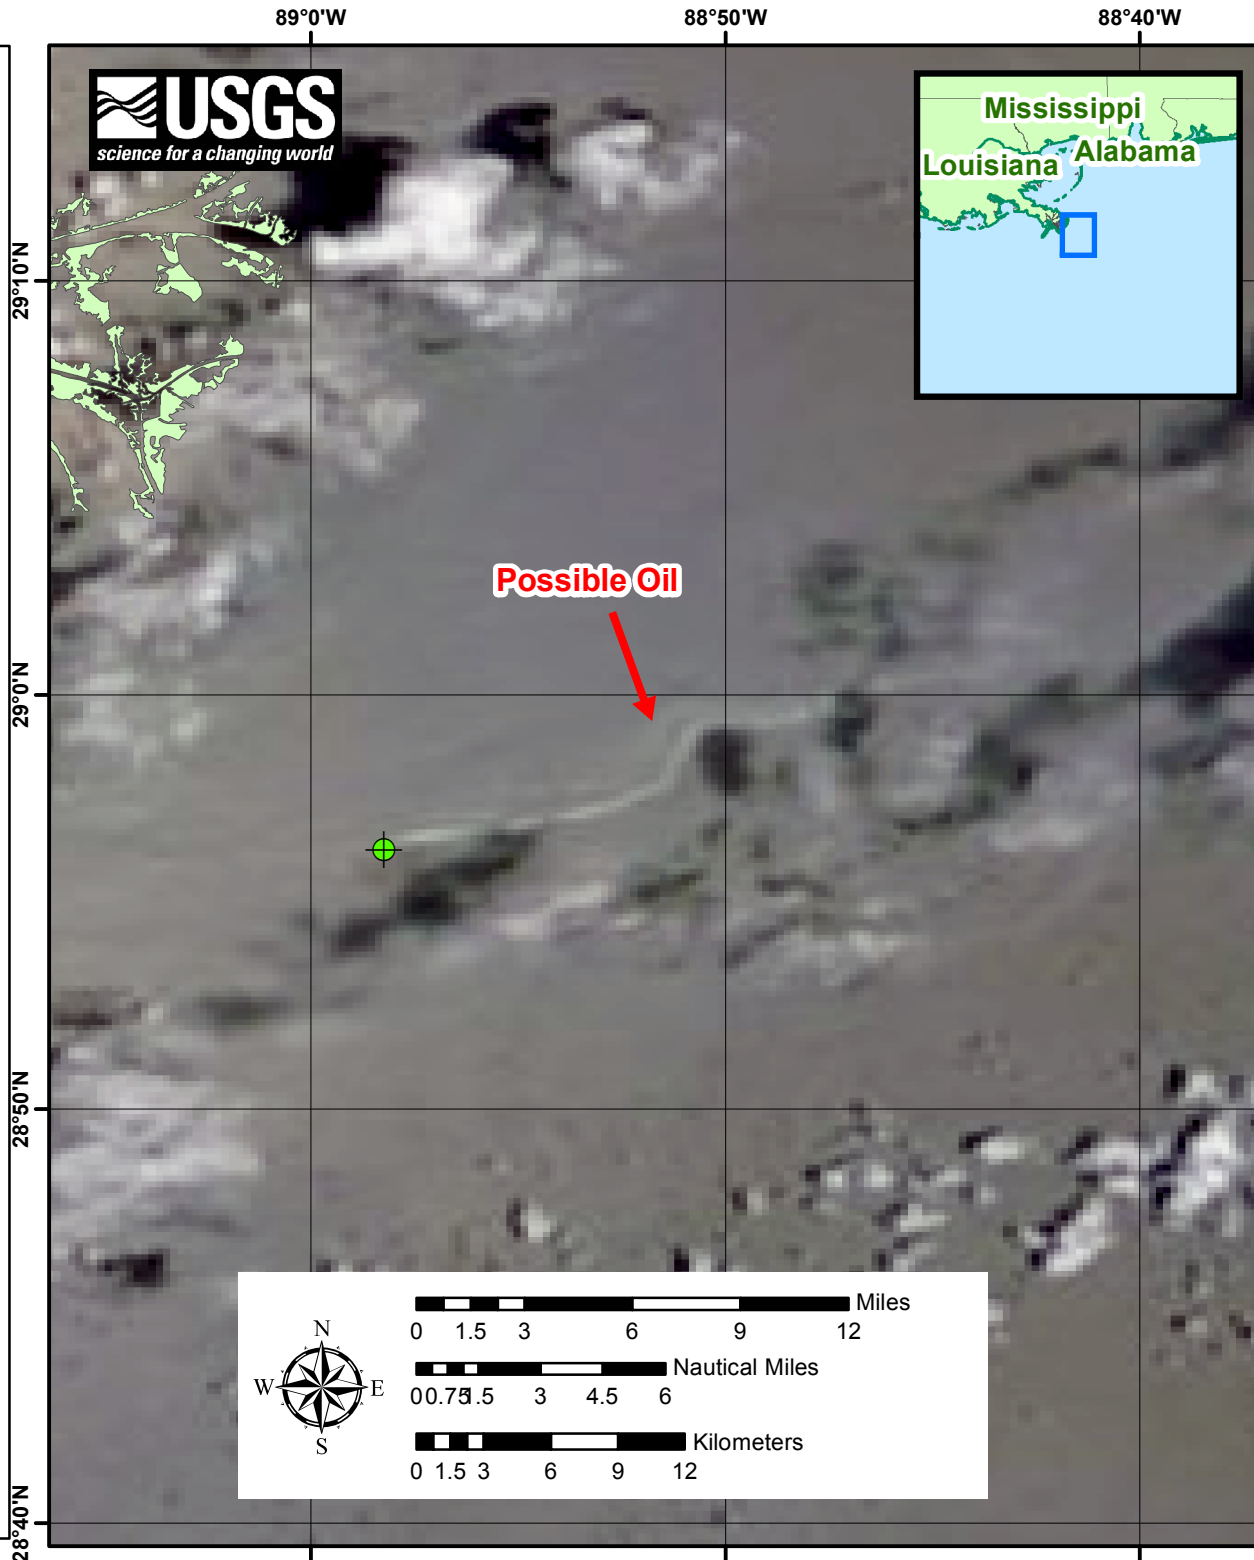
Destroyed Taylor Platform :  
[ 28°56'9" N / 88°58'12" W ]
-

12.6 km<sup>2</sup> Area of Possible Oil

**CONFIDENCE: High**

An anomaly believed to be an oil slick extends 15.7 miles east-northeast from the location of the destroyed Taylor platform. The slick appears to have a white shimmer in sunglint, is distinct from its surroundings, and exhibits sharp turns. The slick's orientation is supported by the direction of the surface winds at the time of the image.
