MARINE POLLUTION SURVEILLANCE REPORT

Analysis Provided by: The National Oceanic and
Atmospheric Administration/National Environmental
Satellite, Data and Information Service (NOAA/NESDIS)

REPORT DATE: MARCH 03, 2015
REPORT TIME: 2345Z (1745 CST)
ANALYST: KEMAL

Destroyed Taylor Platform :
[28°56'9" N / 88°58'12" W]
-

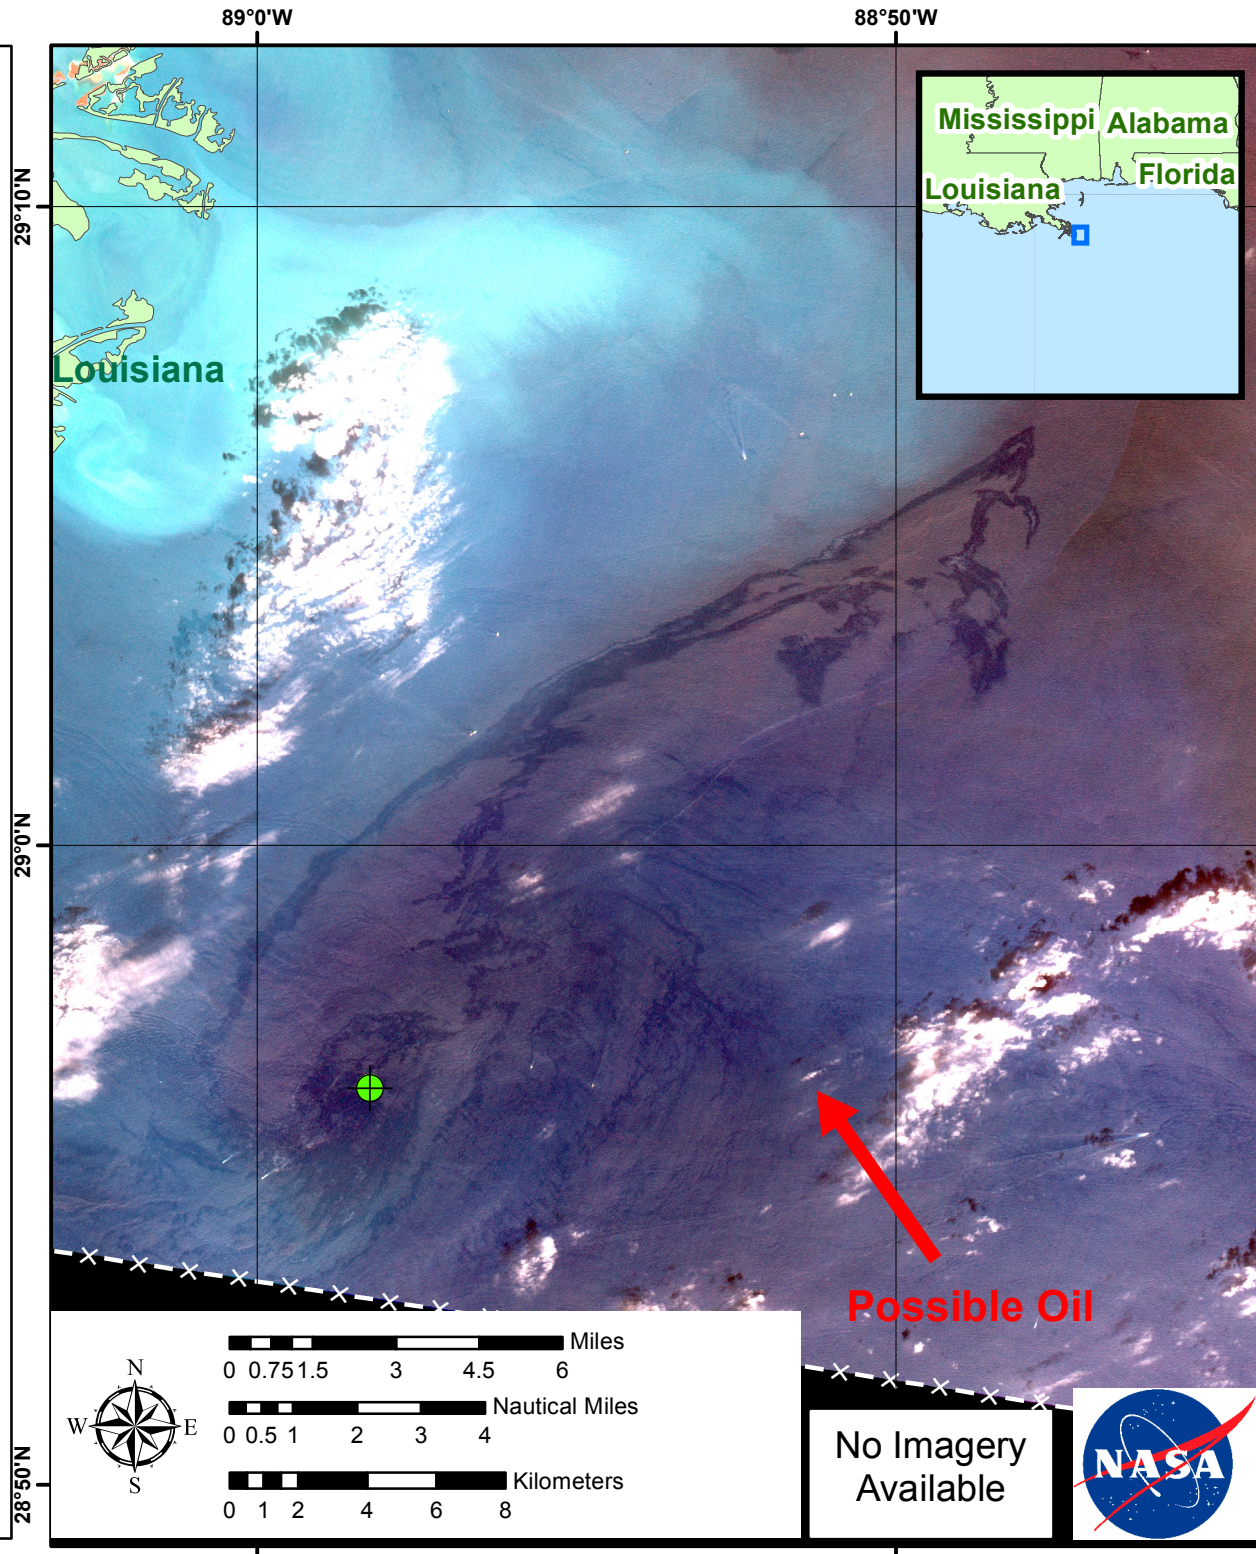
Area of Possible Oil

CONFIDENCE: High

The oil slick appears to be coming from the destroyed Taylor Platform. The slick is 20.65 miles in length with a maximum width of 9.19 miles. Slick orientation is consistent with winds in the area.
