# MARINE POLLUTION SURVEILLANCE REPORT

Analysis Provided by: The National Oceanic and  
Atmospheric Administration/National Environmental  
Satellite, Data and Information Service (NOAA/NESDIS)

REPORT DATE: MARCH 04, 2015  
REPORT TIME: 1930Z (1330 CST)  
ANALYST: KEMAL

DATA SOURCE: ASTER VNIR  
MODE: Multispectral  
RESOLUTION: 15 meter  
IMAGE DATE/TIME: 3/3/2015 1649Z (1049 CST)

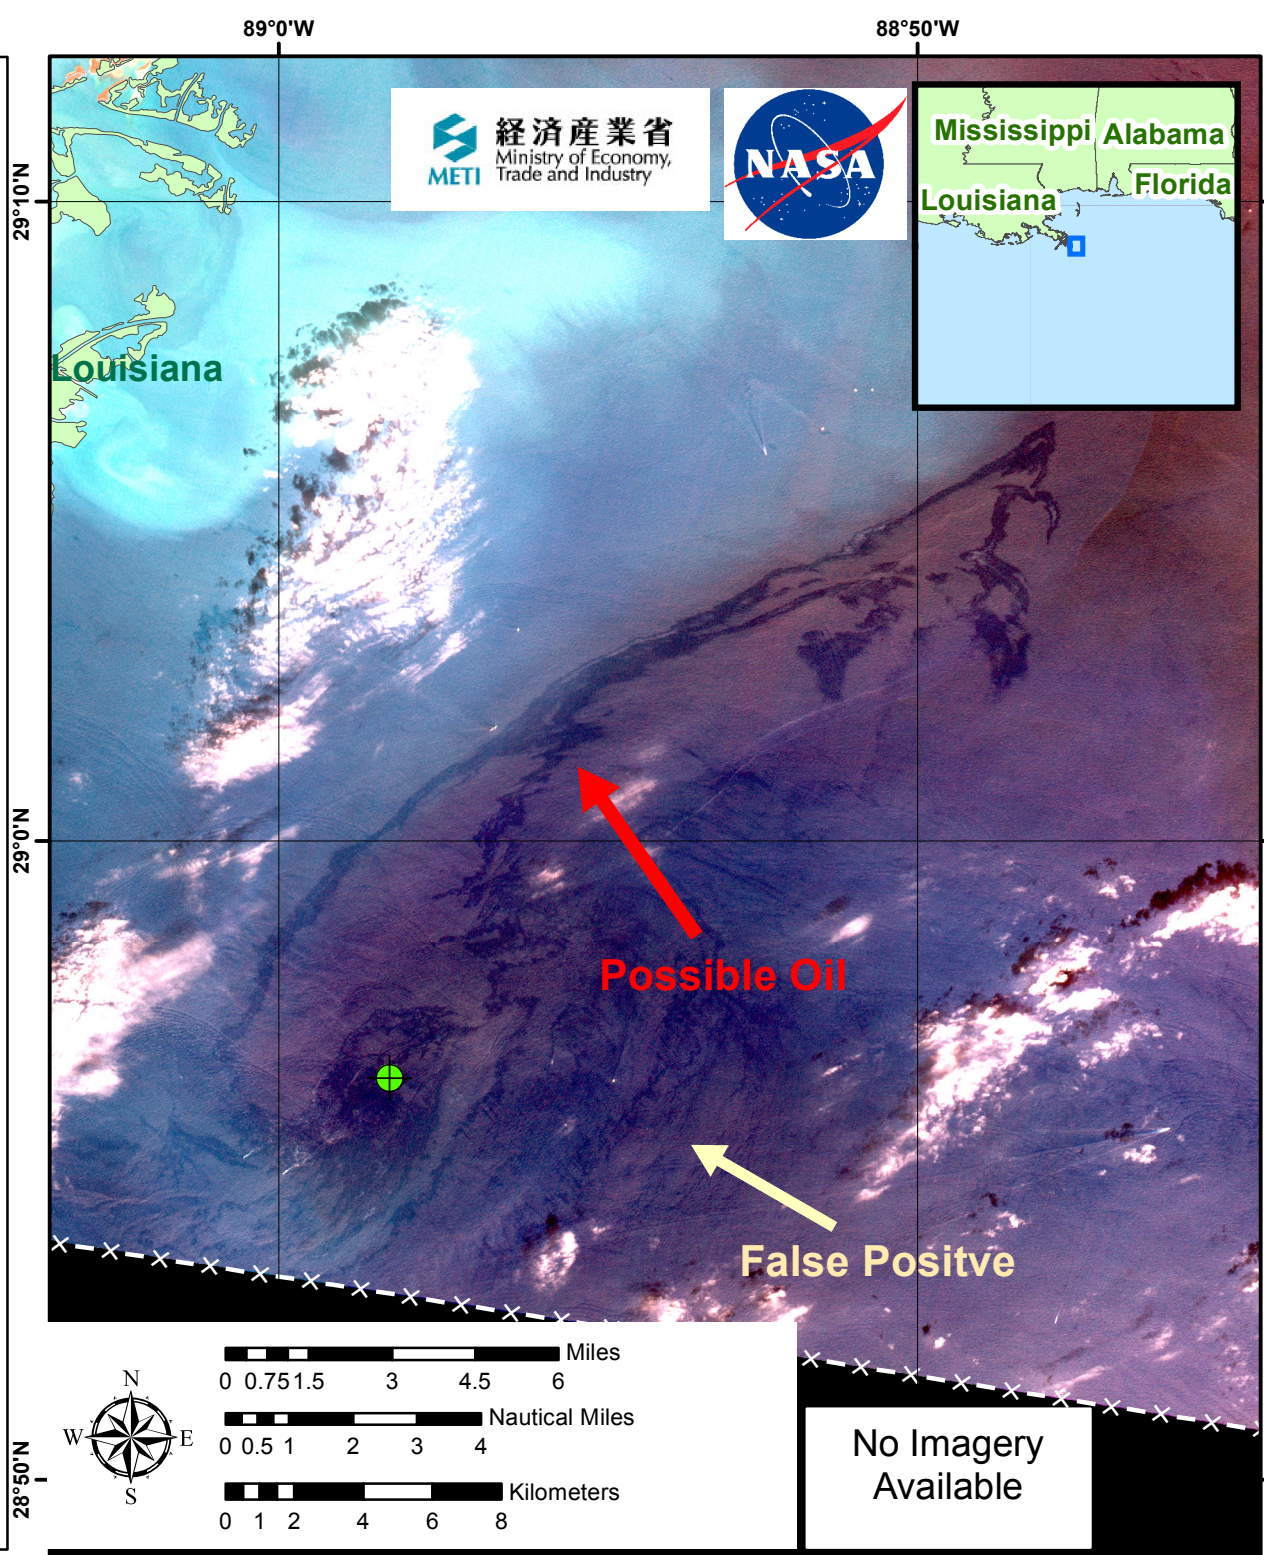
The oil slick appears to be coming from the destroyed Taylor site. The slick is 20.65 miles in length with a maximum width of 1.4 miles. Slick orientation is consistent with winds in the area. Along the southeast side of the slick, there is a lot of contamination from natural biogenic features making it very difficult to determine the full extent of the surface oil and was not analyzed as oil.
