MARINE POLLUTION SURVEILLANCE REPORT

Analysis Provided by: The National Oceanic and
Atmospheric Administration/National Environmental
Satellite, Data and Information Service (NOAA/NESDIS)

REPORT DATE: MARCH 05, 2015
REPORT TIME: 1302Z (0702 CST)
ANALYST: KEMAL/SHEFFLER

DATA SOURCE: LANDSAT-8 OLI
MODE: Multispectral
RESOLUTION: 30 meter
IMAGE DATE/TIME: 3/4/2015 1626Z (1026 CST)

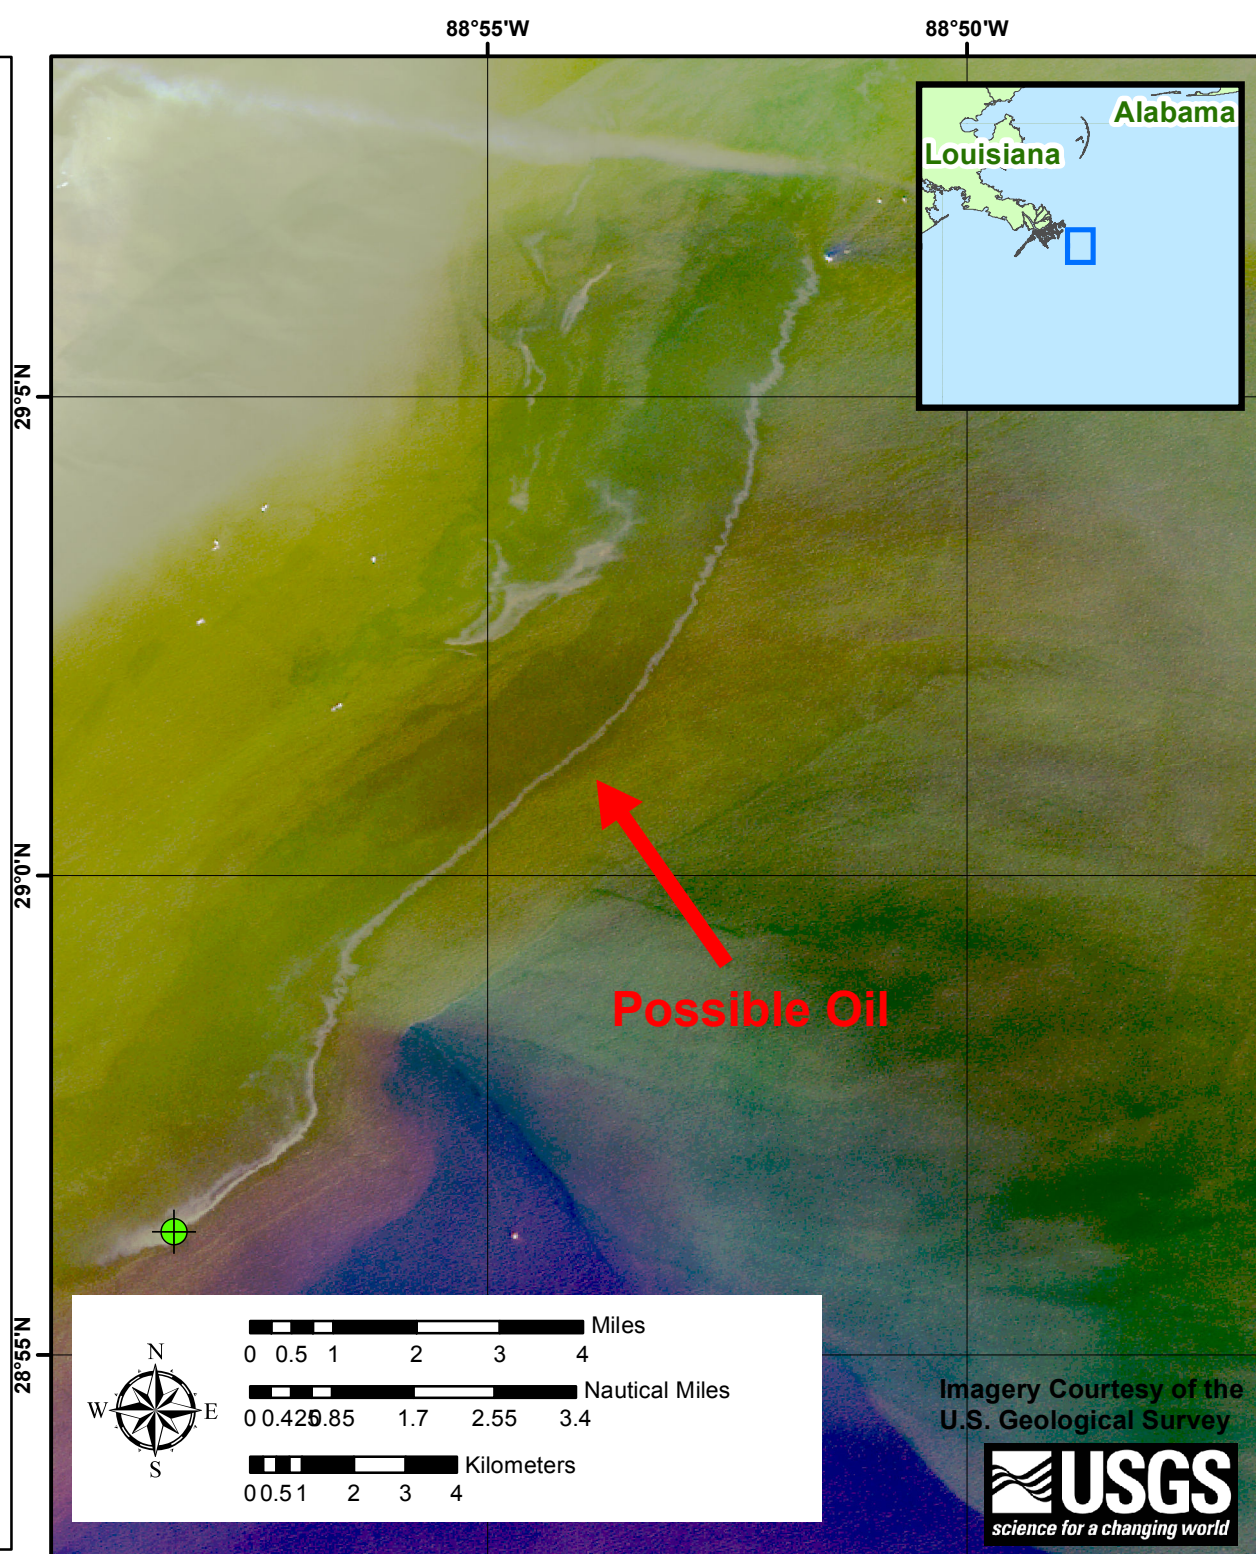
Destroyed Taylor Platform :
[28°56'9" N / 88°58'12" W]
-

8.5 km² Area of Possible Oil

CONFIDENCE: High

The oil slick appears to come from the destroyed Taylor site. The slick is 14.17 miles in length with a maximum width of 0.38 miles. The oil slick appears to be consistent with the orientation of the wind.
